Asbestos Containing Materials in Council Facilities

LOCATION REGISTER

LAST UPDATED: 11th February 2020

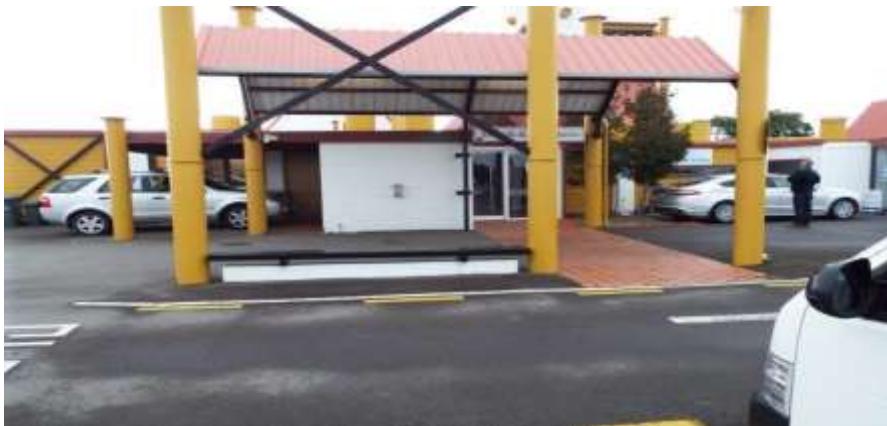
External Columns

1	2	3
Location	Interior Columns and Skylights	Exterior Columns	Ceiling Underlay
Internal/External	Internal	External	Internal
Description	Cement Product	Cement Product	Paper Product
Extent	>50sqm	>50sqm	30sqm
Identification	Tested and Confirmed (24/08/17)	Tested and Confirmed (24/08/17)	Presumed
Asbestos Type	White and Brown	White and Brown	Unknown
Risk Statement	12 = LOW	11 = LOW	9 = LOW
Latest Inspection	09/04/19	09/04/19	09/04/19
Condition	Good	Good	Assumed
Inspection Due	09/04/20	09/04/20	09/04/20
Initial Actions			
Ongoing Action Required	<p>Should be inspected on a YEARLY cycle. Monitoring is required, as deterioration may occur over time. Any change in circumstances may require reassessment of priority rating</p>	<p>Should be inspected on a YEARLY cycle. Monitoring is required, as deterioration may occur over time. Any change in circumstances may require reassessment of priority rating</p>	<p>Should be inspected on a YEARLY cycle. Monitoring is required, as deterioration may occur over time. Any change in circumstances may require reassessment of priority rating</p>

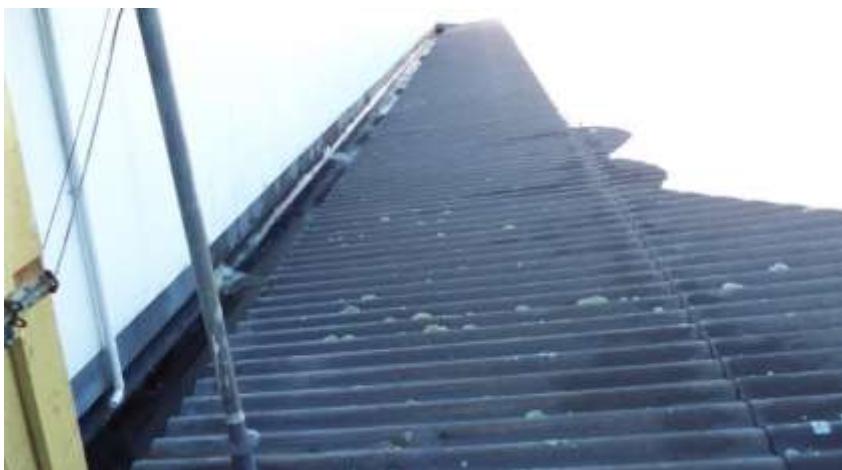
1	2	3	4
Location	Roof	Soffit	Entrance Canopy	Toilet Ceiling
Internal/External	External	External	External	Internal
Description	Cement Based Tiles	Fibre Cement Board	Fibre Cement Board	Textured Ceiling
Extent	>50sqm	>50sqm	>50sqm	>50sqm
Identification	Presumed	Tested and Confirmed 19/07/2017	Presumed	Tested and Confirmed 12/06/2017
Asbestos Type	Unknown	White and Brown	Unknown	White
Risk Statement	9 = LOW	10 = LOW	10 = LOW	10 = LOW
Latest Inspection	30/08/2018	30/08/2018	30/08/2018	30/08/2018
Condition	Good	Good	Good	Good
Inspection Due	30/08/2019	30/08/2019	30/08/2019	30/08/2019
Initial Actions				
Ongoing Action Required	Should be inspected on a YEARLY cycle. Monitoring is required, as deterioration may occur over time. Any change in circumstances may require reassessment of priority rating	Should be inspected on a YEARLY cycle. Monitoring is required, as deterioration may occur over time. Any change in circumstances may require reassessment of priority rating	Should be inspected on a YEARLY cycle. Monitoring is required, as deterioration may occur over time. Any change in circumstances may require reassessment of priority rating	Should be inspected on a YEARLY cycle. Monitoring is required, as deterioration may occur over time. Any change in circumstances may require reassessment of priority rating

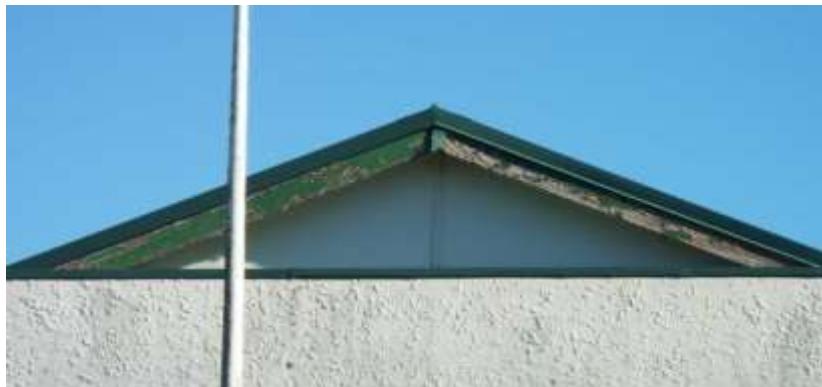
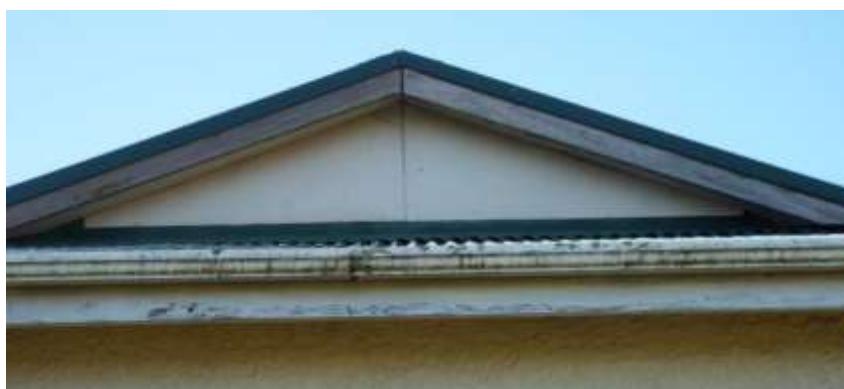
1	2
Location	Soffit	Gable
Internal/External	External	External
Description	Fibre Cement Board	Fibre Cement Board
Extent	30sqm	20sqm
Identification	Tested and Confirmed 08/11/18	Tested and Confirmed 08/11/18
Asbestos Type	White and Brown	White and Brown
Risk Statement	6 = LOW	6 = LOW
Latest Inspection	27/05/2019	27/05/2019
Condition	Good	Good
Inspection Due	27/05/2021	27/05/2021
Initial Actions		
Ongoing Action Required	Should be inspected on a TWO YEARLY cycle. Monitoring is required, as deterioration may occur over time. Any change in circumstances may require reassessment of priority rating	Should be inspected on a TWO YEARLY cycle. Monitoring is required, as deterioration may occur over time. Any change in circumstances may require reassessment of priority rating

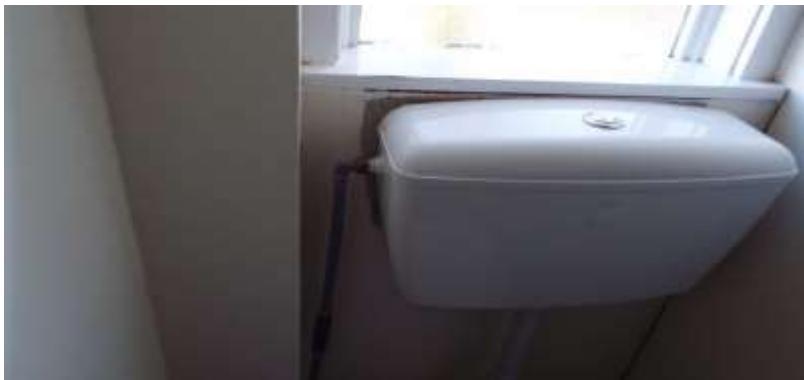
1	2	3	4	5
Location	Soffit	Western Entrance	Men's Toilet Walls	Women's Toilet	Waiting Room Vinyl
Internal/External	External	External	Internal	Internal	Internal
Description	Fibre Cement Board	Fibre Cement Board	Fibre Cement Board	Fibre Cement Board	Vinyl Flooring Backing
Extent	25sqm	10sqm	12sqm	5sqm	20sqm
Identification	Presumed	Tested/Confirmed 24/08/17	Tested/Confirmed 06/10/17	Tested/Confirmed 06/10/17	Tested and Confirmed 28/09/2018
Asbestos Type	Unknown	White and Brown			White
Risk Statement	5 = LOW	8 = MODERATE	9 = MODERATE	9 = MODERATE	6 = LOW
Latest Inspection	26/09/2018	26/09/2018	26/09/2018	26/09/2018	28/09/2018
Condition	Good	Good	Good	Good	Medium
Inspection Due	26/09/2020	26/09/2019	26/09/2019	26/09/2019	28/09/2020
Initial Actions					
Ongoing Action Required	Should be inspected on a TWO YEARLY cycle. Monitoring is required, as deterioration may occur over time. Any change in circumstances may require reassessment of priority rating	Should be inspected on a YEARLY cycle. Monitoring is required, as deterioration may occur over time. Any change in circumstances may require reassessment of priority rating	Should be inspected on a YEARLY cycle. Monitoring is required, as deterioration may occur over time. Any change in circumstances may require reassessment of priority rating	Should be inspected on a YEARLY cycle. Monitoring is required, as deterioration may occur over time. Any change in circumstances may require reassessment of priority rating	Should be inspected on a TWO YEARLY cycle. Monitoring is required, as deterioration may occur over time. Any change in circumstances may require reassessment of priority rating

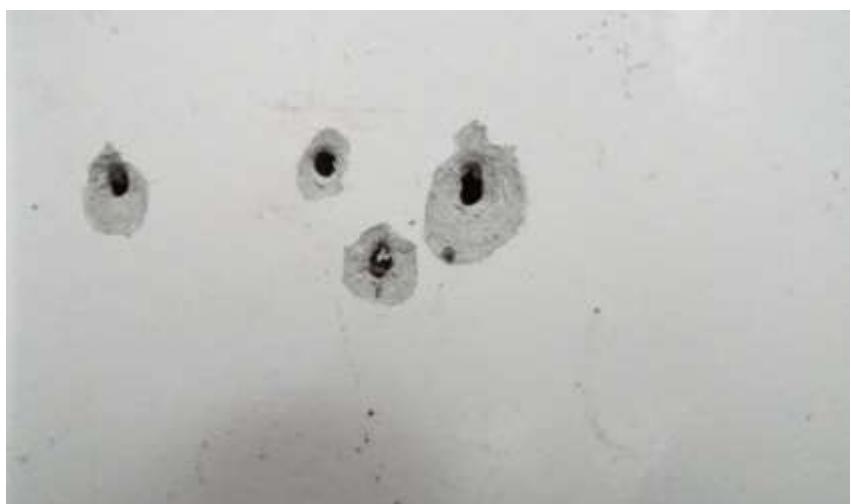
1	2
Location	Cladding	Toilet Walls
Internal/External	External	Internal
Description	Fibre Cement	Fibre Cement
Extent	>50sqm	20sqm
Identification	Tested/Confirmed 11/07/2017	Tested/Confirmed 11/07/2017
Asbestos Type	White and Brown	White
Risk Statement	10 = MODERATE	8 = MODERATE
Latest Inspection	30/07/2019	30/07/2019
Condition	Low	Low
Inspection Due	30/07/2021	30/07/2021
Initial Actions		
Ongoing Action Required	<p style="color: red;">Should be inspected on a TWO YEARLY cycle.</p> <p>Monitoring is required, as deterioration may occur over time. Any change in circumstances may require reassessment of priority rating</p>	<p style="color: red;">Should be inspected on a TWO YEARLY cycle.</p> <p>Monitoring is required, as deterioration may occur over time. Any change in circumstances may require reassessment of priority rating</p>

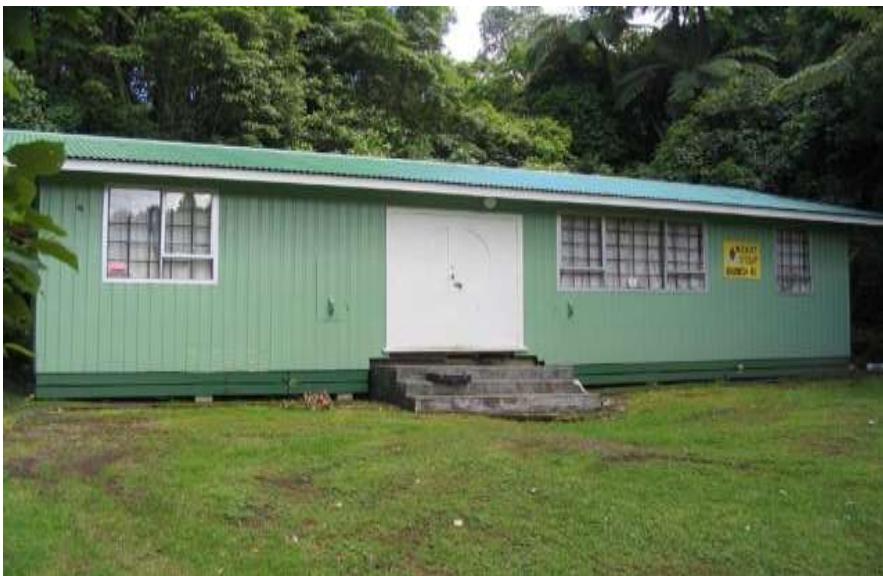
Exterior Cladding

1
Location	Cladding
Internal/External	External
Description	Fibre Cement
Extent	>50sqm
Identification	Tested/Confirmed 16/06/2017
Asbestos Type	White and Brown
Risk Statement	8 = MODERATE
Latest Inspection	27/05/2019
Condition	Good
Inspection Due	27/05/2021
Initial Actions	
Ongoing Action Required	Should be inspected on a TWO YEARLY cycle. Monitoring is required, as deterioration may occur over time. Any change in circumstances may require reassessment of priority rating

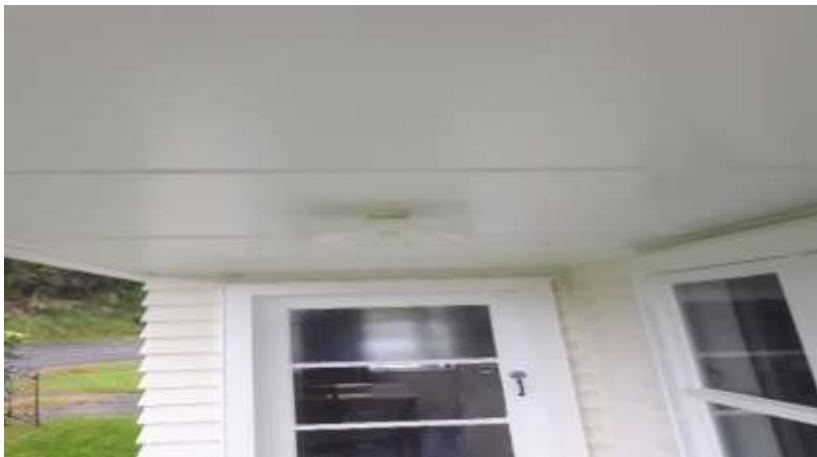
Verandah Ceiling

1	2
Location	Main Soffit	Verandah Soffit
Internal/External	External	External
Description	Fibre Cement	Fibre Cement
Extent	40sqm	10sqm
Identification	Presumed	Presumed
Asbestos Type	Unknown	Unknown
Risk Statement	8 = MODERATE	8 = MODERATE
Latest Inspection	27/05/2019	27/05/2019
Condition	Good	Good
Inspection Due	27/05/2020	27/05/2020
Initial Actions		
Ongoing Action Required	<p style="color: red;">Should be inspected on a YEARLY cycle.</p> <p>Monitoring is required, as deterioration may occur over time. Any change in circumstances may require reassessment of priority rating</p>	<p style="color: red;">Should be inspected on a YEARLY cycle.</p> <p>Monitoring is required, as deterioration may occur over time. Any change in circumstances may require reassessment of priority rating</p>

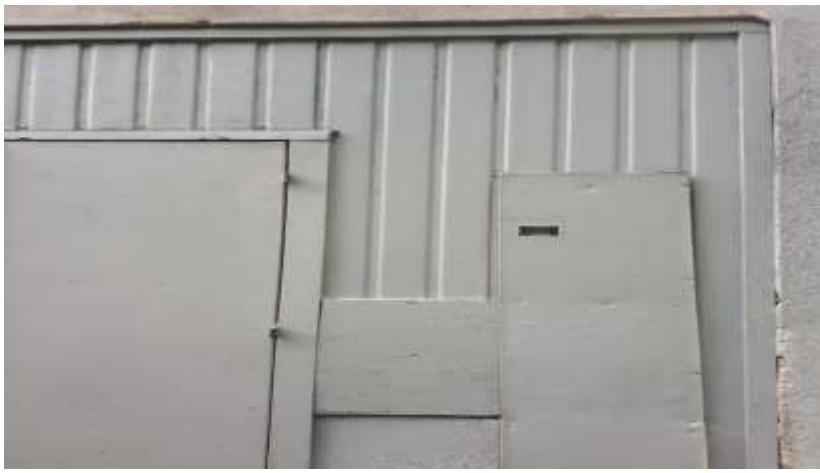
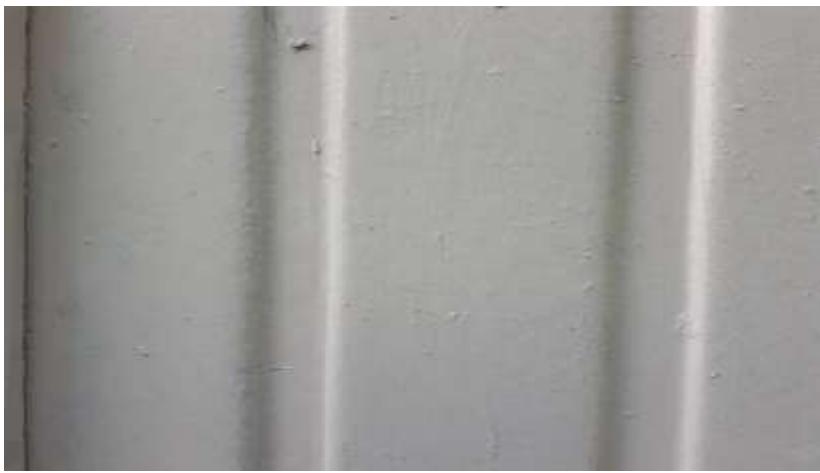
Exterior Cladding at Back Door

1
Location	External Cladding
Internal/External	External
Description	Fibre Cement
Extent	10sqm
Identification	Tested and Confirmed (03/11/17)
Asbestos Type	White and Brown
Risk Statement	8 = MODERATE
Date	03/12/2018
Condition	Low
	03/12/2019
Initial Actions	
Ongoing Action Required	Should be inspected on a YEARLY cycle. Monitoring is required, as deterioration may occur over time. Any change in circumstances may require reassessment of priority rating

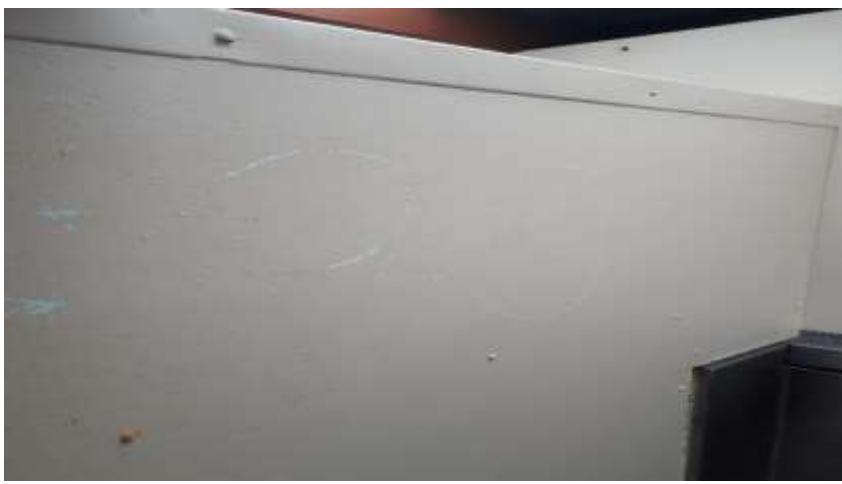
1
Location	Internal Partitions
Internal/External	Internal
Description	Fibre Cement
Extent	25sqm
Identification	Tested and Confirmed (19/07/17)
Asbestos Type	White and Brown
Risk Statement	10 = MODERATE
Latest Inspection	29/07/2019
Condition	Good
Inspection Due	29/07/2020
Initial Actions	
Ongoing Action Required	Should be inspected on a YEARLY cycle. Monitoring is required, as deterioration may occur over time. Any change in circumstances may require reassessment of priority rating

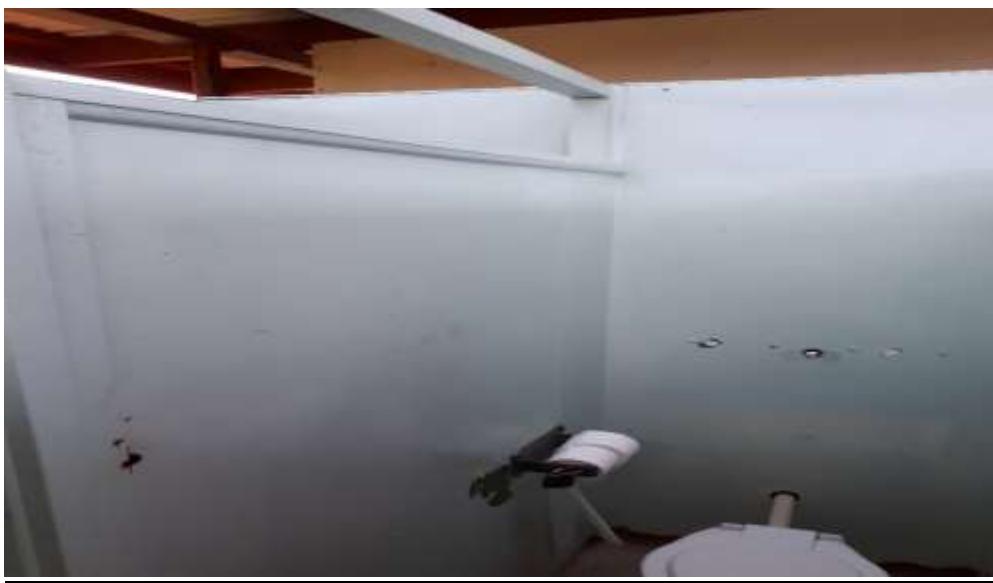
1
Location	Internal Partitions
Internal/External	Internal
Description	Fibre Cement
Extent	25sqm
Identification	Tested and Confirmed (19/07/17)
Asbestos Type	White
Risk Statement	11 = MODERATE
Latest Inspection	17/07/2019
Condition	Good
Inspection Due	19/07/2020
Initial Actions	
Ongoing Action Required	Should be inspected on a YEARLY cycle. Monitoring is required, as deterioration may occur over time. Any change in circumstances may require reassessment of priority rating

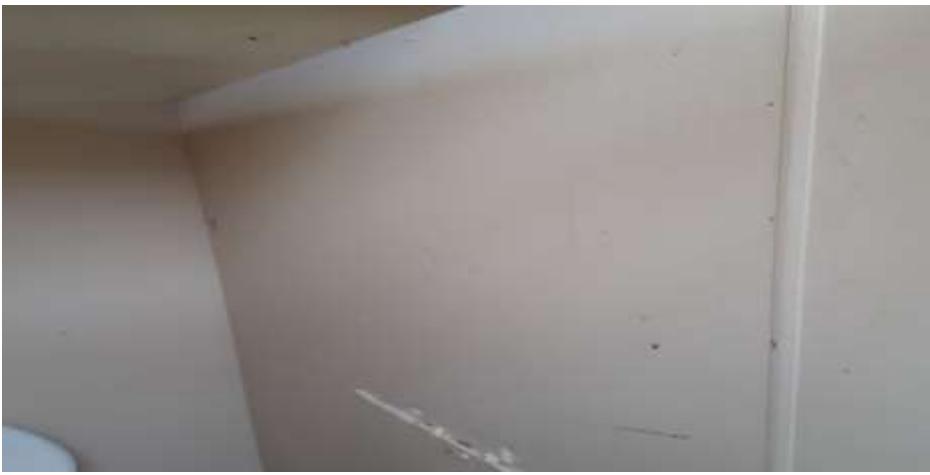
1
Location	Internal Partitions
Internal/External	Internal
Description	Fibre Cement
Extent	25sqm
Identification	Tested and Confirmed (19/07/17)
Asbestos Type	White and Brown
Risk Statement	9 = MODERATE
Latest Inspection	17/07/2019
Condition	Good
Inspection Due	17/07/2020
Initial Actions	
Ongoing Action Required	Should be inspected on a YEARLY cycle. Monitoring is required, as deterioration may occur over time. Any change in circumstances may require reassessment of priority rating

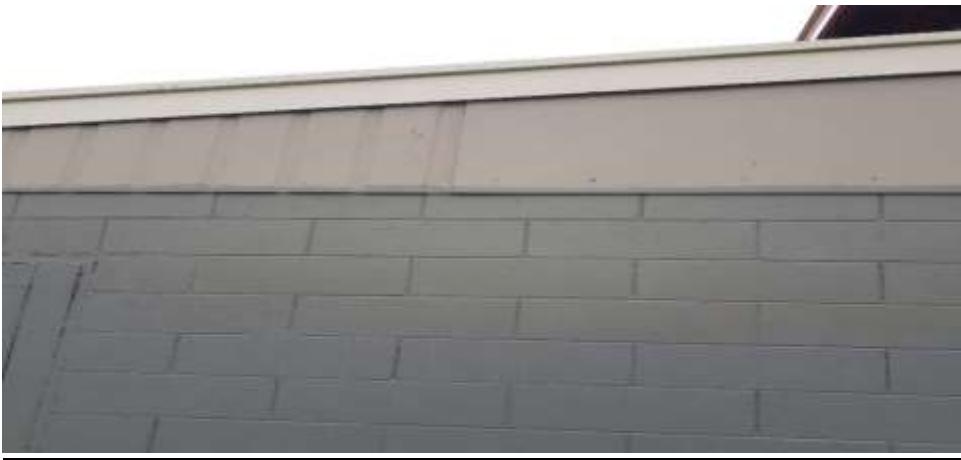
1	2
Location	Internal Lining	Exterior Cladding
Internal/External	Internal	External
Description	Fibre Cement	Fibre Cement
Extent	30sqm	25sqm
Identification	Tested and Confirmed (19/07/17)	Tested and Confirmed (19/07/17)
Asbestos Type	White	White and Brown
Risk Statement	9 = MODERATE	7 = LOW
Latest Inspection	19/07/2017	19/07/2017
Condition	Good	Good
Inspection Due	19/07/2017	19/07/2018
Initial Actions		
Ongoing Action Required	<p style="color: red;">Should be inspected on a YEARLY cycle.</p> <p>Monitoring is required, as deterioration may occur over time. Any change in circumstances may require reassessment of priority rating</p>	<p style="color: red;">Should be inspected on a TWO YEARLY cycle.</p> <p>Monitoring is required, as deterioration may occur over time. Any change in circumstances may require reassessment of priority rating</p>

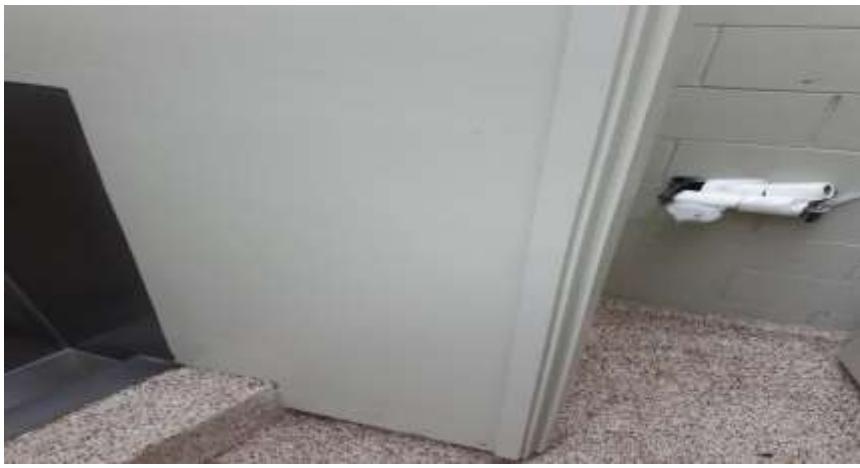
1
Location	Internal Partitions
Internal/External	Internal
Description	Fibre Cement
Extent	25sqm
Identification	Tested and Confirmed (19/07/17)
Asbestos Type	White
Risk Statement	9 = MODERATE
Latest Inspection	17/07/2019
Condition	Low
Inspection Due	17/07/2020
Initial Actions	
Ongoing Action Required	Should be inspected on a YEARLY cycle. Monitoring is required, as deterioration may occur over time. Any change in circumstances may require reassessment of priority rating

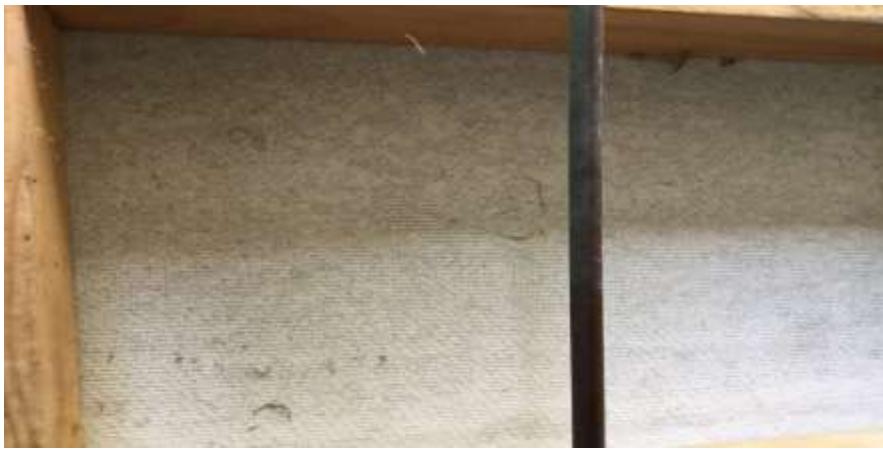
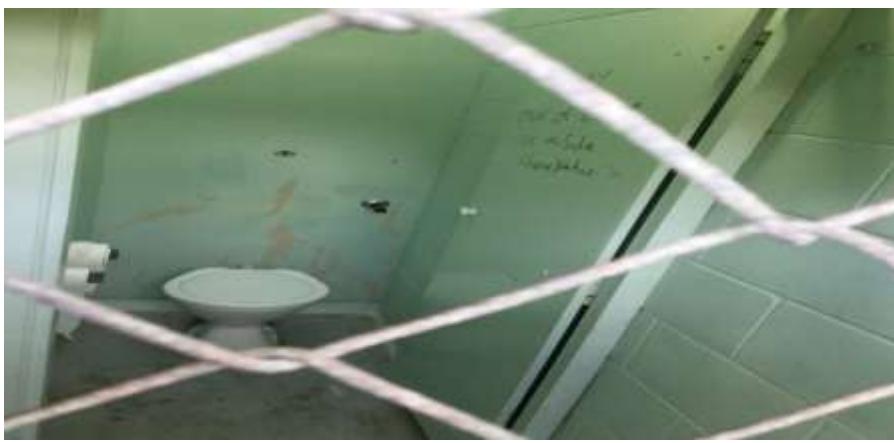
1
Location	Service Room Wall
Internal/External	Internal
Description	Fibre Cement
Extent	30sqm
Identification	Tested and Confirmed (17/08/17)
Asbestos Type	White and Brown
Risk Statement	9 = MODERATE
Latest Inspection	17/08/2017
Condition	Low
Inspection Due	17/08/2018
Initial Actions	
Ongoing Action Required	Should be inspected on a YEARLY cycle. Monitoring is required, as deterioration may occur over time. Any change in circumstances may require reassessment of priority rating

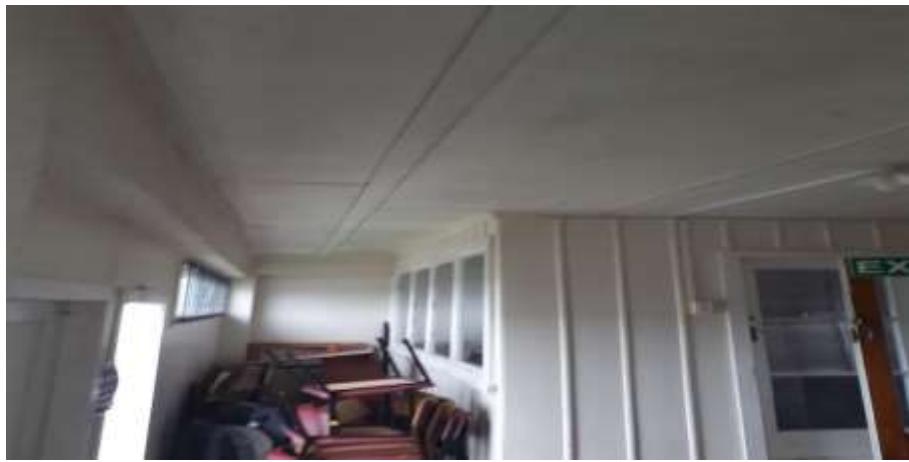
1	2
Location	Entrance Ceiling and Walls	Cladding
Internal/External	External	External
Description	Fibre Cement	Fibre Cement
Extent	40sqm	10sqm
Identification	Presumed	Presumed
Asbestos Type	Unknown	Unknown
Risk Statement	8 = MODERATE	7 = LOW
Latest Inspection	21/07/2017	21/07/2017
Condition	Good	Good
Inspection Due	21/7/2019	21/07/2019
Initial Actions		
Ongoing Action Required	<p style="color: red;">Should be inspected on a YEARLY cycle.</p> <p>Monitoring is required, as deterioration may occur over time. Any change in circumstances may require reassessment of priority rating</p>	<p style="color: red;">Should be inspected on a TWO YEARLY cycle.</p> <p>Monitoring is required, as deterioration may occur over time. Any change in circumstances may require reassessment of priority rating</p>

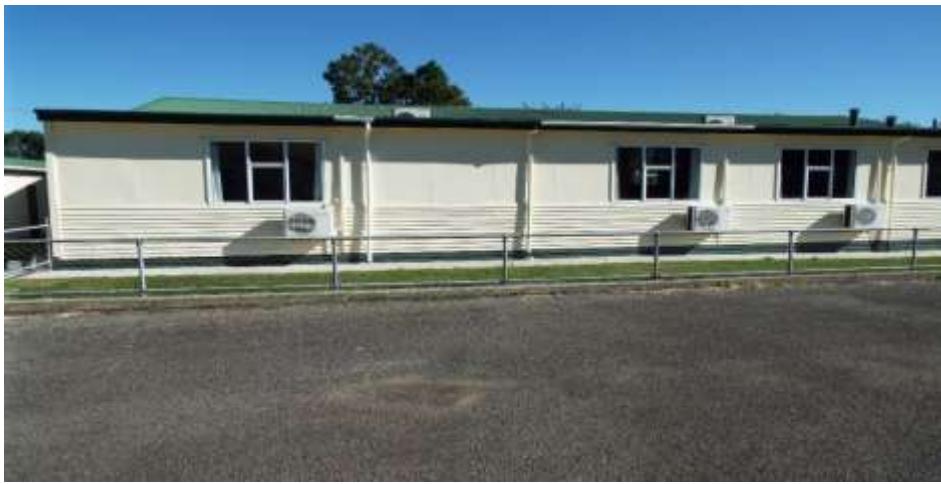
1	2	3
Location	Soffits (excluding Eastern side)	Cladding (Eastern Side)	Entrance/Backdoor Ceilings and Walls
Internal/External	External	External	External
Description	Fibre Cement	Fibre Cement	Fibre Cement
Extent	40sqm	40sqm	40sqm
Identification	Presumed	Tested and Confirmed (24/08/17)	Tested and Confirmed (24/08/17)
Asbestos Type	Unknown	White	White
Risk Statement	6 = LOW	8 = MODERATE	8 = MODERATE
Latest Inspection	17/07/2019	17/07/2019	17/07/2019
Condition	Good	Good	Good
Inspection Due	17/07/2021	17/07/2020	17/07/2020
Initial Actions			
Ongoing Action Required	Should be inspected on a TWO YEARLY cycle. Monitoring is required, as deterioration may occur over time. Any change in circumstances may require reassessment of priority rating	Should be inspected on a YEARLY cycle. Monitoring is required, as deterioration may occur over time. Any change in circumstances may require reassessment of priority rating	Should be inspected on a YEARLY cycle. Monitoring is required, as deterioration may occur over time. Any change in circumstances may require reassessment of priority rating

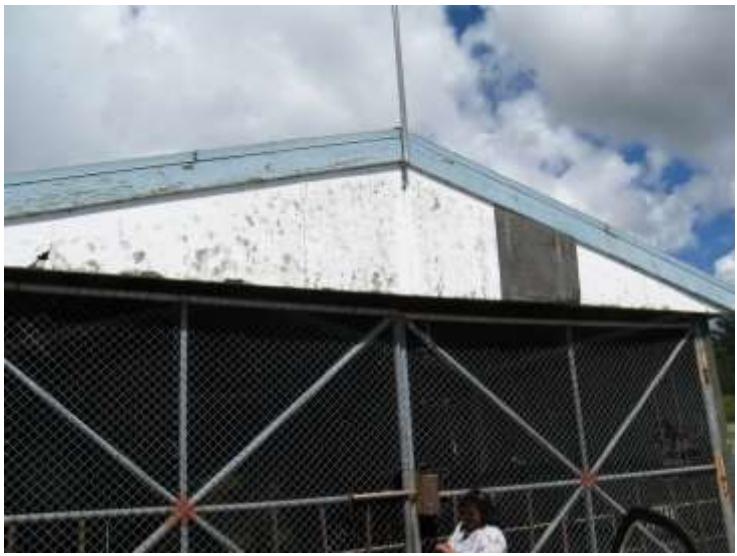
Exterior Lining

1
Location	Cladding
Internal/External	External
Description	Fibre Cement
Extent	20sqm
Identification	Tested and Confirmed (08/08/17)
Asbestos Type	White
Risk Statement	7 = LOW
Latest Inspection	08/08/2017
Condition	Low
Inspection Due	08/08/2019
Initial Actions	
Ongoing Action Required	<p>Should be inspected on a TWO YEARLY cycle. Monitoring is required, as deterioration may occur over time. Any change in circumstances may require reassessment of priority rating</p>

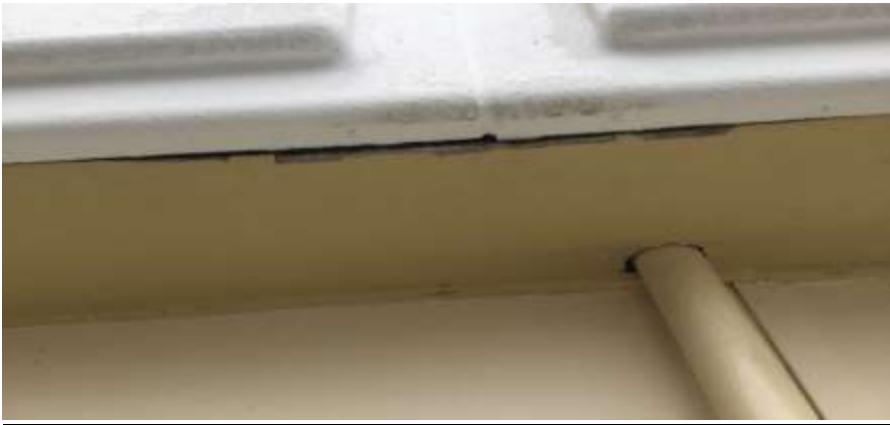
1	2	3
Location	Soffit	Exterior Panels	Exterior Pelmet
Internal/External	External	External	External
Description	Fibre Cement	Fibre Cement	Fibre Cement
Extent	40sqm	30sqm	>50sqm
Identification	Tested and Confirmed (06/10/17)	Tested and Confirmed (06/10/17)	Tested and Confirmed (01/10/18)
Asbestos Type	White	White and Brown	White and Brown
Risk Statement	8 = MODERATE	9 = MODERATE	10 = MODERATE
Latest Inspection	06/10/2017	06/10/2017	01/10/2017
Condition	Good	Good	Good
Inspection Due	01/10/2019	01/10/2019	01/10/2019
Initial Actions			
Ongoing Action Required	Should be inspected on a YEARLY cycle. Monitoring is required, as deterioration may occur over time. Any change in circumstances may require reassessment of priority rating	Should be inspected on a YEARLY cycle. Monitoring is required, as deterioration may occur over time. Any change in circumstances may require reassessment of priority rating	Should be inspected on a YEARLY cycle. Monitoring is required, as deterioration may occur over time. Any change in circumstances may require reassessment of priority rating

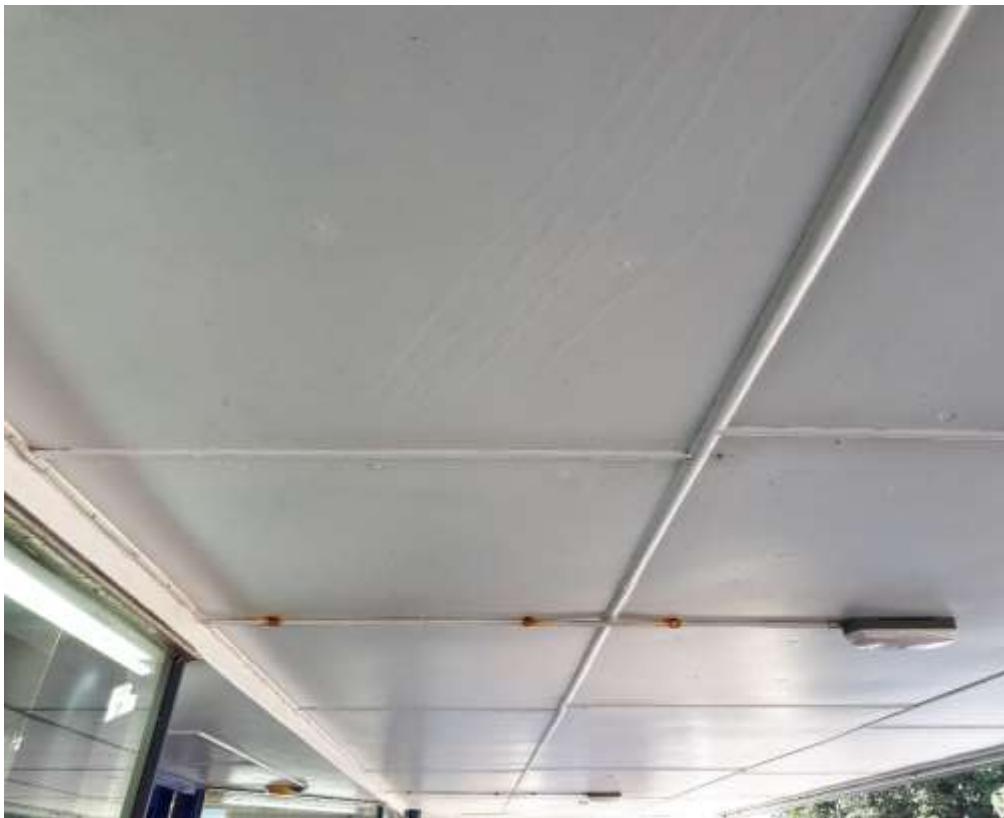
1
Location	Front Entrance Ceiling
Internal/External	External
Description	Fibre Cement
Extent	30sqm
Identification	Presumed
Asbestos Type	Unknown
Risk Statement	7 = LOW
Latest Inspection	10/10/2017
Condition	Good
Inspection Due	10/10/2019
Initial Actions	
Ongoing Action Required	Should be inspected on a TWO YEARLY cycle. Monitoring is required, as deterioration may occur over time. Any change in circumstances may require reassessment of priority rating

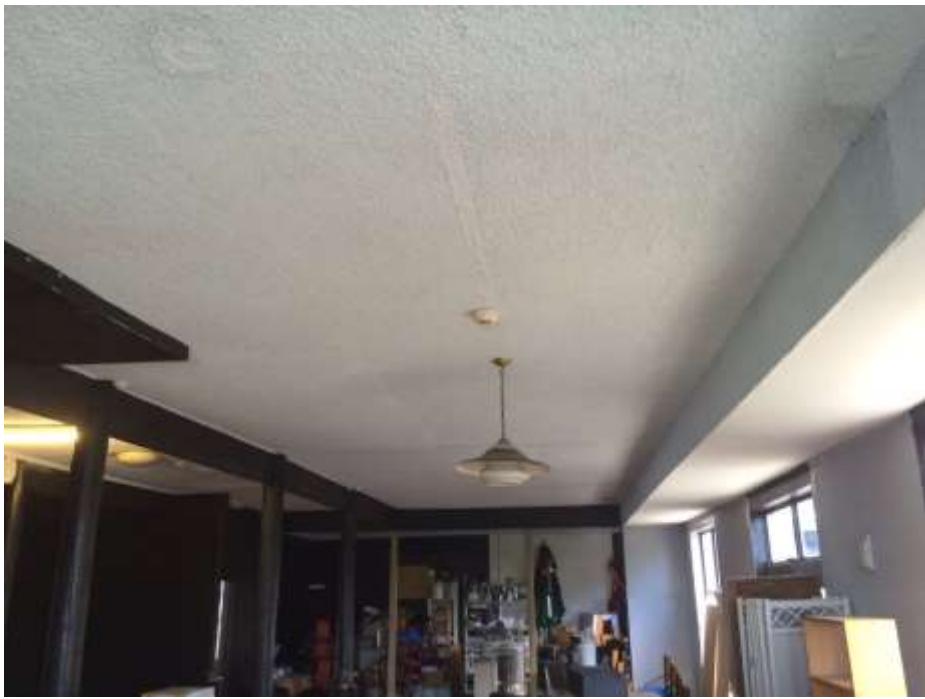
1
Location	Upper Floor Ceiling
Internal/External	Internal
Description	Textured Ceiling
Extent	185sqm
Identification	Tested and Confirmed (12/12/2016)
Asbestos Type	White
Risk Statement	10 = Moderate
Latest Inspection	03/12/2018
Condition	High
Initial Actions	AREA HAS BEEN ISOLATED. NO ACCESS
Ongoing Action Required	Should be inspected on a YEARLY cycle. Monitoring is required, as deterioration may occur over time. Any change in circumstances may require reassessment of priority rating

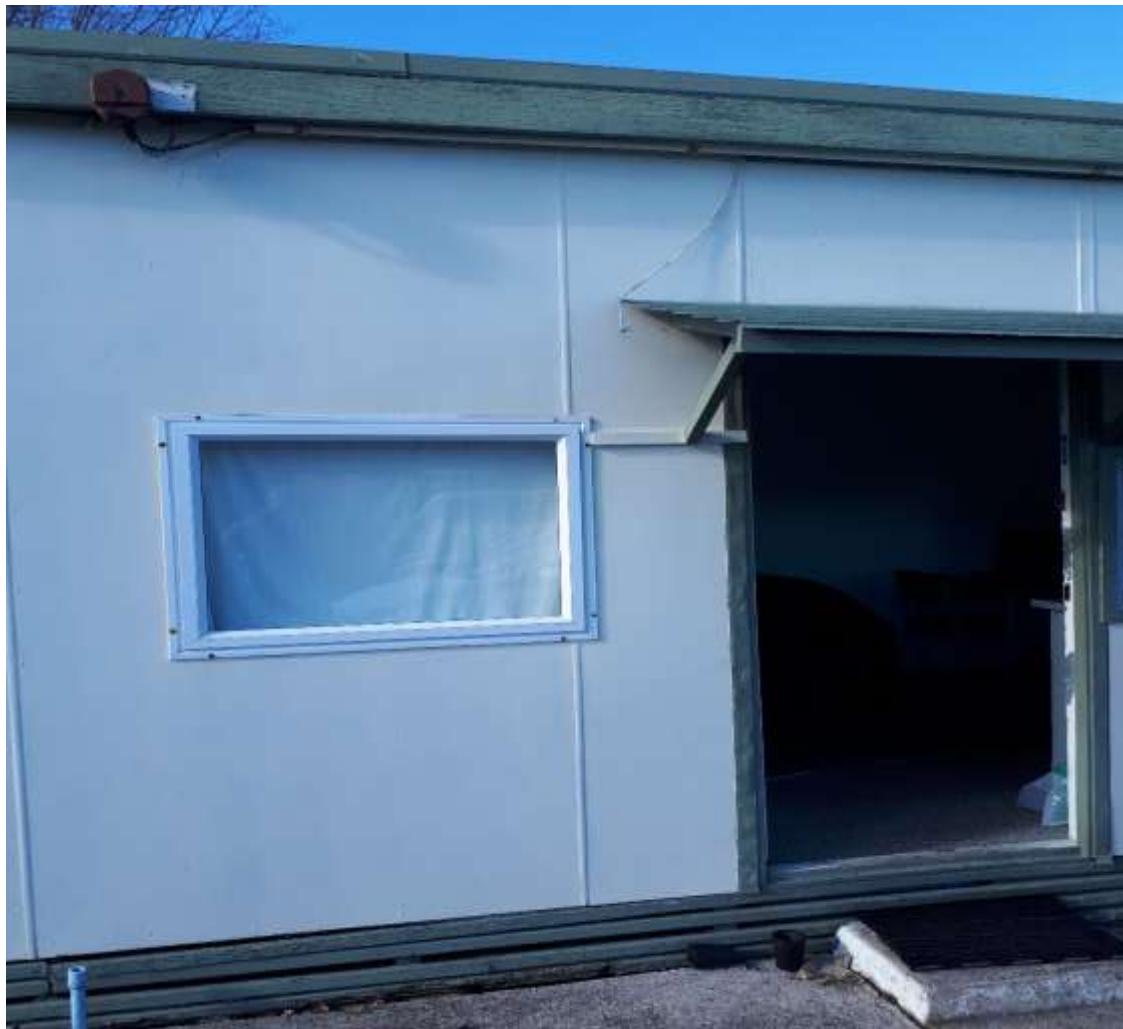
1
Location	External Cladding
Internal/External	External
Description	Fibre Cement
Extent	50sqm
Identification	Tested positive 19/06/18
Asbestos Type	White, Brown and Blue Asbestos
Risk Statement	12 = MODERATE
Latest Inspection	27/05/2019
Condition	LOW
Inspection Due	27/05/2020
Initial Actions	
Ongoing Action Required	Should be inspected on a YEARLY cycle. It may be necessary for the asbestos to be REMOVED ON A PROGRAMMED BASIS. Emergency repair and sealing operations should be undertaken where any deterioration or damage occurs.

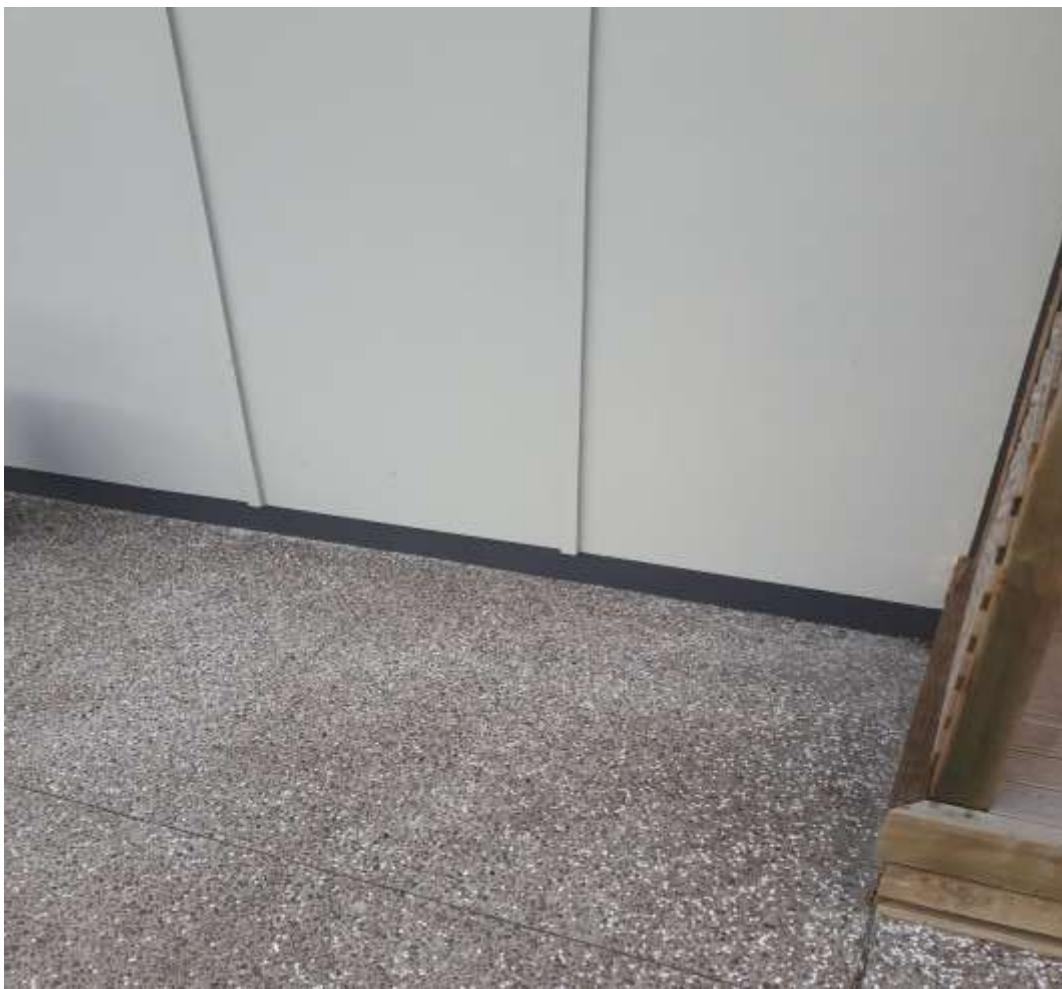
Baseboard

1
Location	Baseboards
Internal/External	External
Description	Fibre Cement Sheets
Extent	30sqm
Identification	Tested positive 16/06/18
Asbestos Type	White
Risk Statement	9 = Moderate
Latest Inspection	27/05/2019
Condition	GOOD
Inspection Due	27/05/2020
Initial Actions	
Ongoing Action Required	Should be inspected on a YEARLY cycle. Monitoring is required, as deterioration may occur over time. Any change in circumstances may require reassessment of priority rating

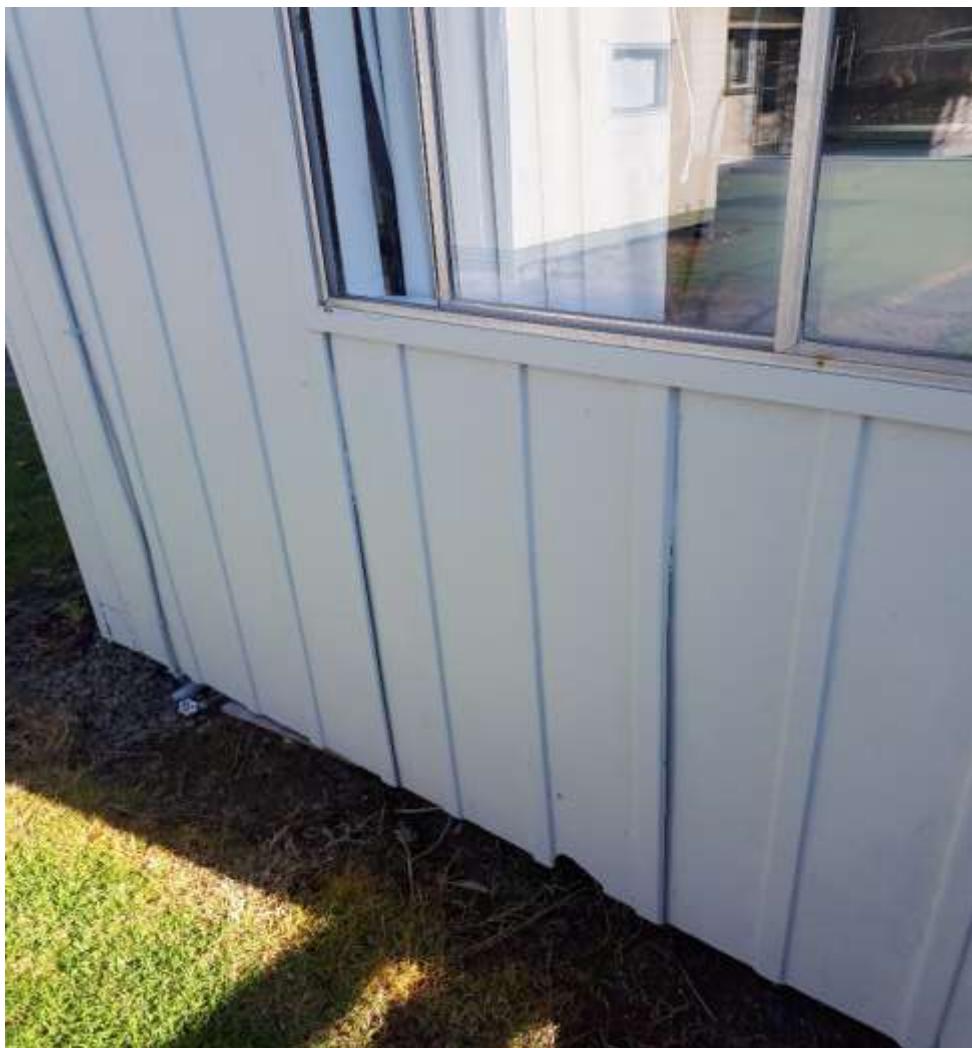
Side and Back External Cladding

1	2
Location	Back and Side External Cladding	Soffit
Internal/External	External	External
Description	Fibre Cement	Fibre Cement
Extent	20sqm	10sqm
Identification	Tested positive 19/06/18	Tested positive 19/06/18
Asbestos Type	White, Brown and Blue Asbestos	White and Brown Asbestos
Risk Statement	12 = MODERATE	10 = MODERATE
Latest Inspection	27/05/2019	27/05/2019
Condition	LOW	LOW
Inspection Due	27/05/2020	27/05/2020
Initial Actions		
Ongoing Action Required	<p style="color: red;">Should be inspected on a YEARLY cycle.</p> <p>Monitoring is required, as deterioration may occur over time. Any change in circumstances may require reassessment of priority rating</p>	<p style="color: red;">Should be inspected on a YEARLY cycle.</p> <p>Monitoring is required, as deterioration may occur over time. Any change in circumstances may require reassessment of priority rating</p>

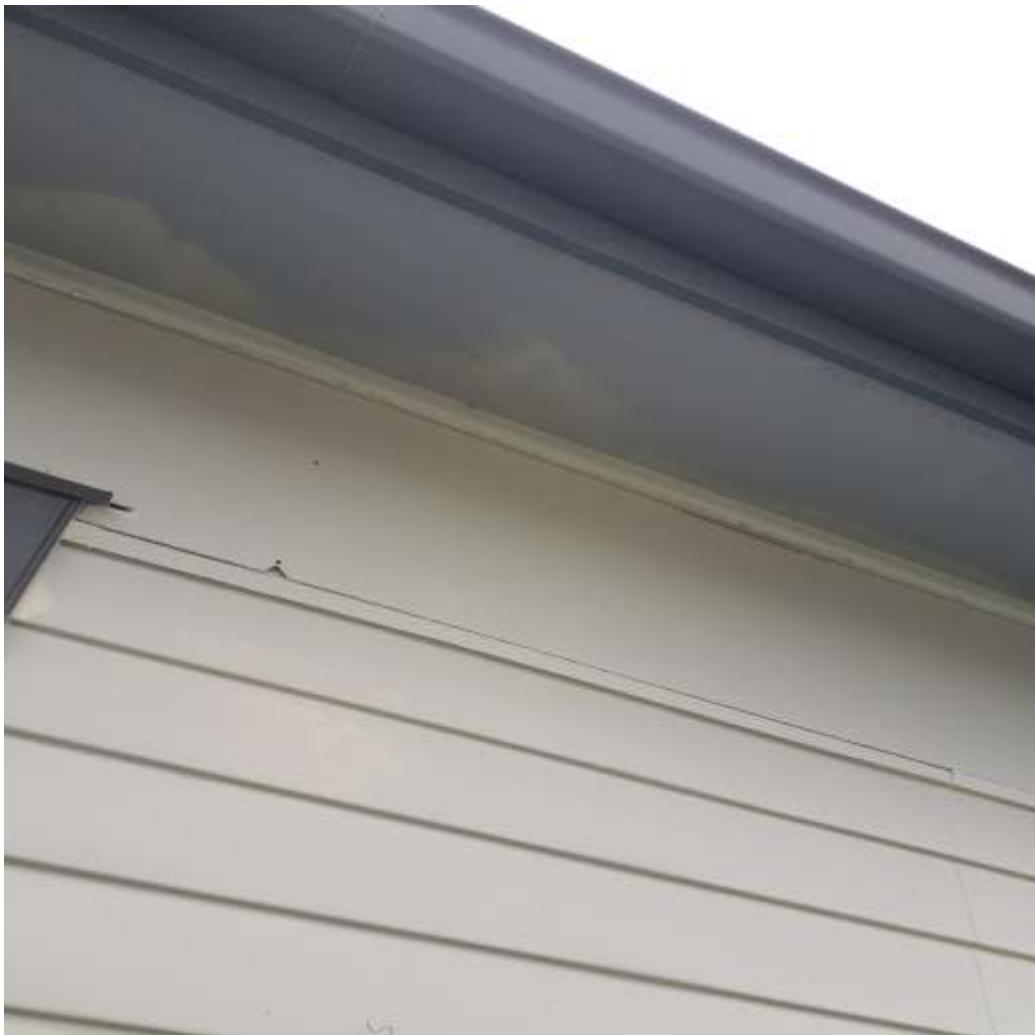
Soffit and Cladding (Top)

1	2	3
Location	Baseboards	External Cladding	Soffit
Internal/External	External	External	External
Description	Fibre Cement	Fibre Cement	Fibre Cement
Extent	25sqm	>50sqm	>50sqm
Identification	Tested positive 16/06/18	Tested positive 16/06/18	Tested positive 16/06/18
Asbestos Type	White	White	White
Risk Statement	9 = Moderate	11 = Moderate	11 = Moderate
Latest Inspection	27/05/2019	27/05/2019	27/05/2019
Condition	GOOD	GOOD	GOOD
Inspection Due	27/05/2020	27/05/2020	27/05/2020
Initial Actions			
Ongoing Action Required	<p>Should be inspected on a YEARLY cycle.</p> <p>Monitoring is required, as deterioration may occur over time. Any change in circumstances may require reassessment of priority rating</p>	<p>Should be inspected on a YEARLY cycle.</p> <p>Monitoring is required, as deterioration may occur over time. Any change in circumstances may require reassessment of priority rating</p>	<p>Should be inspected on a YEARLY cycle.</p> <p>Monitoring is required, deterioration may occur over time. Any change in circumstances may require reassessment of priority rating</p>

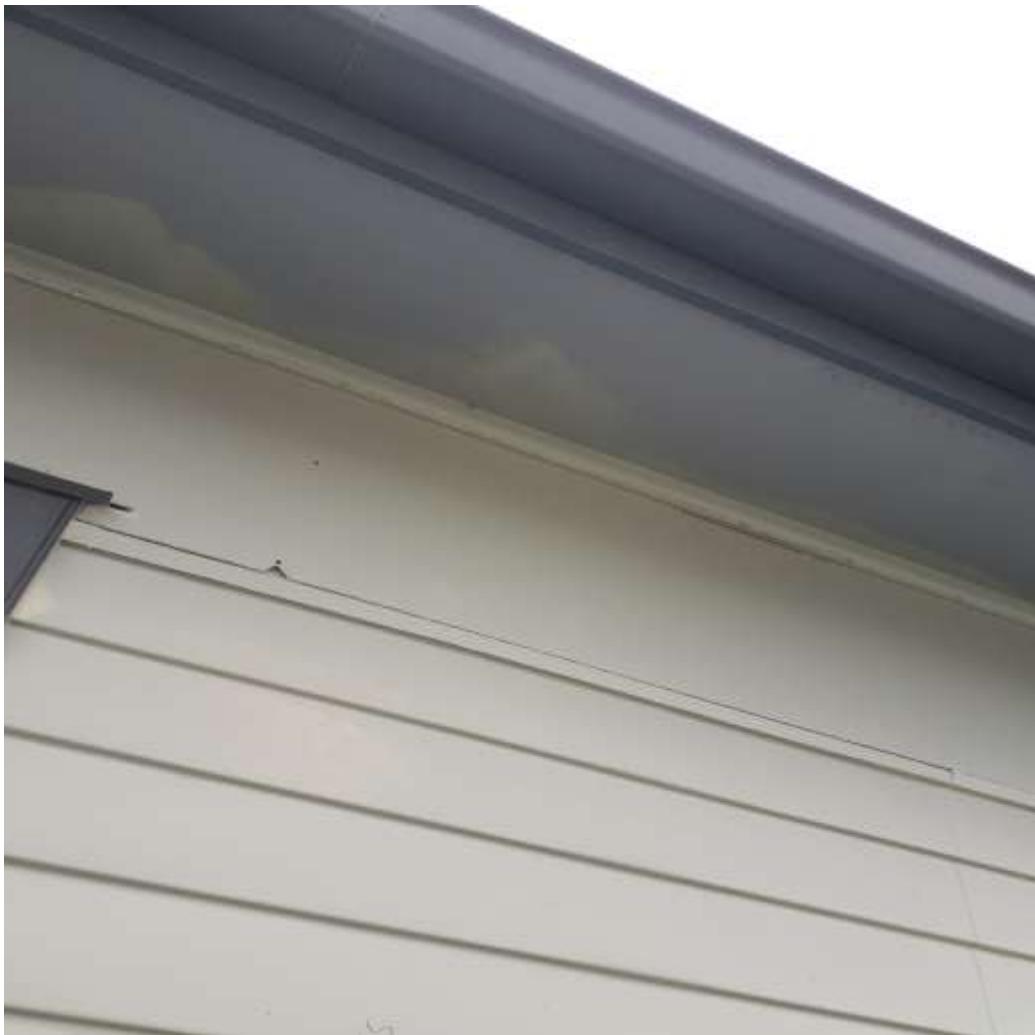
Soffit and Cladding (Top)

1	2	3
Location	Baseboards	External Cladding	Soffit
Internal/External	External	External	External
Description	Fibre Cement	Fibre Cement	Fibre Cement
Extent	30sqm	>50sqm	>50sqm
Identification	Tested positive 16/06/18	Tested positive 16/06/18	Tested positive 16/06/18
Asbestos Type	White	White	White
Risk Statement	11 = Moderate	11 = Moderate	11 = Moderate
Latest Inspection	27/05/2019	27/05/2019	27/05/2019
Condition	GOOD	GOOD	GOOD
Inspection Due	27/05/2020	27/05/2020	27/05/2020
Initial Actions			
Ongoing Action Required	Should be inspected on a YEARLY cycle. Monitoring is required, as deterioration may occur over time. Any change in circumstances may require reassessment of priority rating	Should be inspected on a YEARLY cycle. Monitoring is required, as deterioration may occur over time. Any change in circumstances may require reassessment of priority rating	Should be inspected on a YEARLY cycle. Monitoring is required, as deterioration may occur over time. Any change in circumstances may require reassessment of priority rating

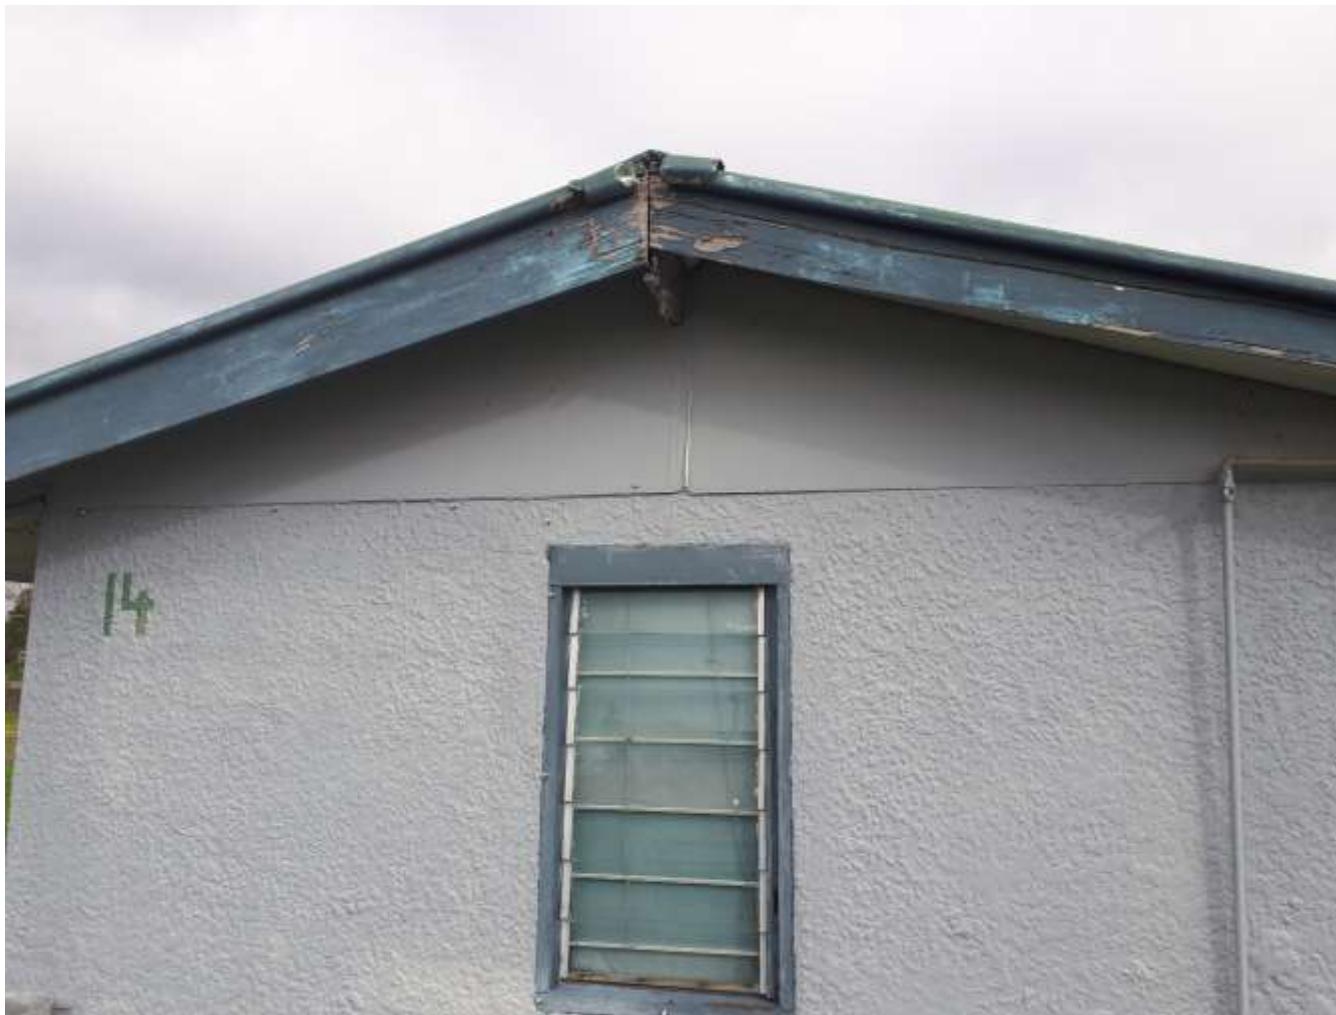
Gable

1
Location	Gables
Internal/External	External
Description	Fibre Cement Board
Extent	15sqm
Identification	Tested positive 16/06/18
Asbestos Type	White
Risk Statement	10 = Moderate
Latest Inspection	27/05/2019
Condition	LOW
Inspection Due	27/05/2020
Initial Actions	
Ongoing Action Required	Should be inspected on a YEARLY cycle. Monitoring is required, as deterioration may occur over time. Any change in circumstances may require reassessment of priority rating
