Asbestos Containing Materials in Council Facilities

LOCATION REGISTER

LAST UPDATED: 11th February 2020

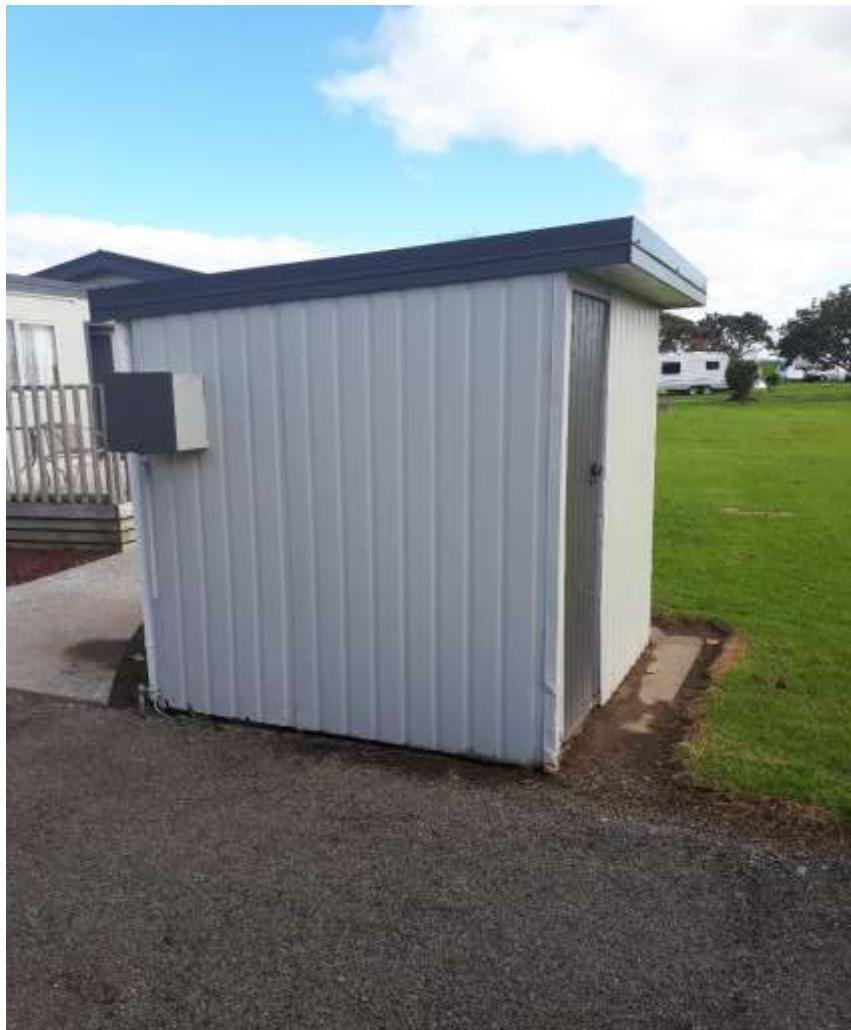
1
Location	External Cladding
Internal/External	Both
Description	Fibre Cement
Extent	25sqm
Identification	Tested positive 16/06/18
Asbestos Type	White and Brown
Risk Statement	13 = High
Latest Inspection	27/05/2019
Condition	LOW
Inspection Due	27/11/2019
Initial Actions	Scheduled for removal in July 2019
Ongoing Action Required	Should be inspected on a 6 Monthly cycle. Monitoring is required, as deterioration may occur over time. Any change in circumstances may require reassessment of priority rating

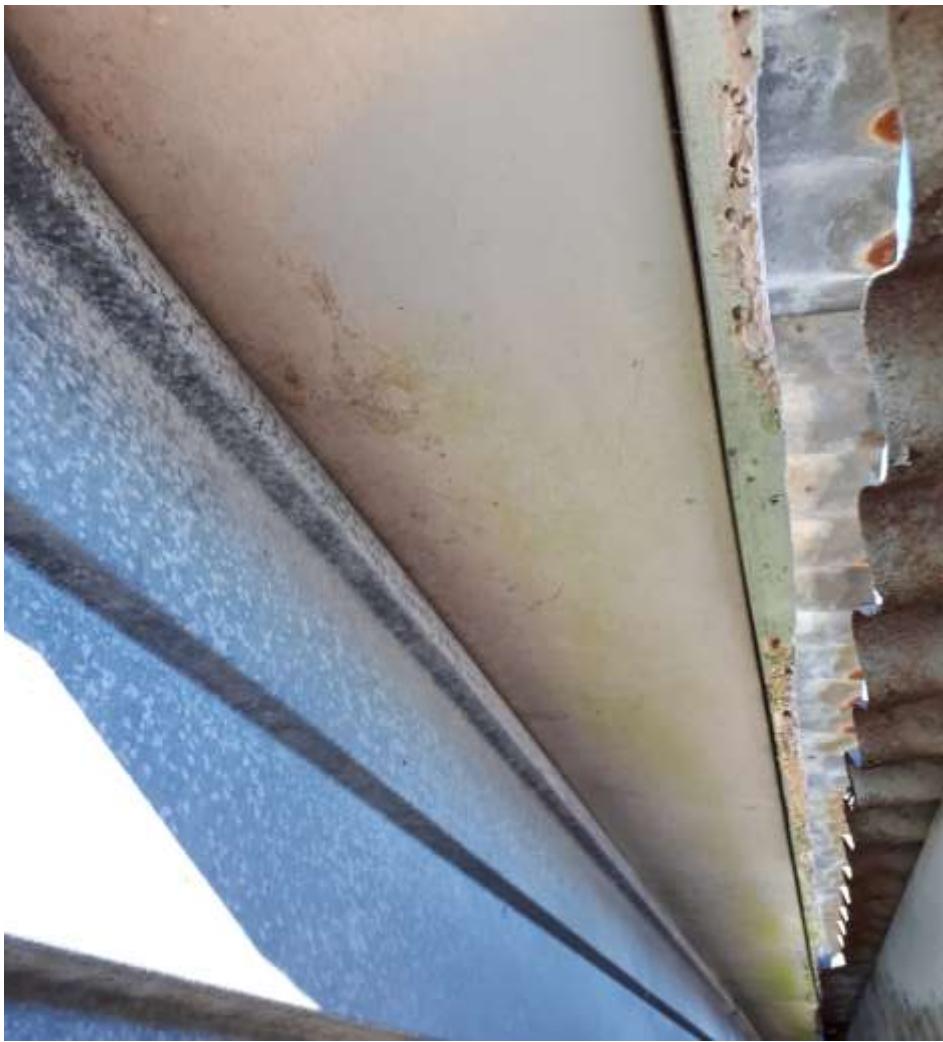
1	2
Location	Soffit	Gable/Barge Board
Internal/External	External	External
Description	Fibre Cement	Fibre Cement
Extent	25sqm	15sqm
Identification	Tested positive 16/06/18	Tested positive 16/06/18
Asbestos Type	White	White
Risk Statement	11 = MODERATE	11 = MODERATE
Latest Inspection	27/05/2019	27/05/2019
Condition	GOOD	LOW
Inspection Due	27/05/2020	27/05/2020
Initial Actions		
Ongoing Action Required	<p style="color: red;">Should be inspected on a YEARLY cycle.</p> <p>Monitoring is required, as deterioration may occur over time. Any change in circumstances may require reassessment of priority rating</p>	<p style="color: red;">Should be inspected on a YEARLY cycle.</p> <p>Monitoring is required, as deterioration may occur over time. Any change in circumstances may require reassessment of priority rating</p>

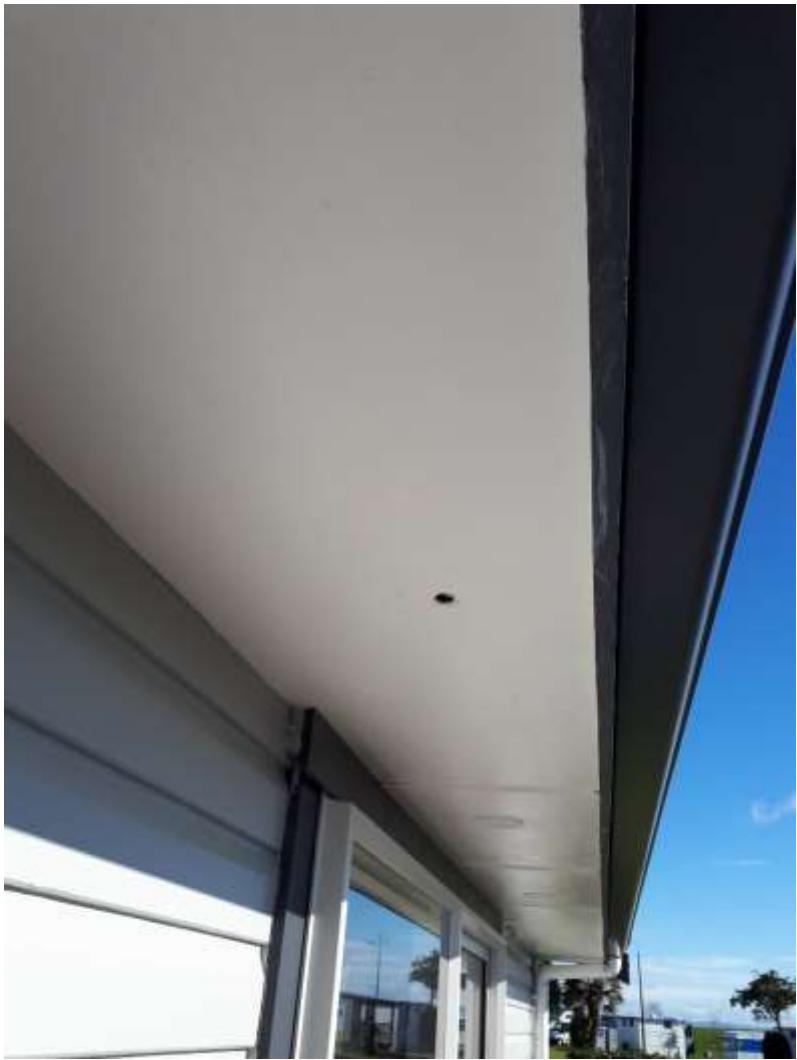
1
Location	Soffit
Internal/External	External
Description	Fibre Cement
Extent	40sqm
Identification	Tested positive 16/06/18
Asbestos Type	White
Risk Statement	9 = MODERATE
Latest Inspection	27/05/2019
Condition	GOOD
Inspection Due	27/05/2020
Initial Actions	
Ongoing Action Required	Should be inspected on a YEARLY cycle. Monitoring is required, as deterioration may occur over time. Any change in circumstances may require reassessment of priority rating

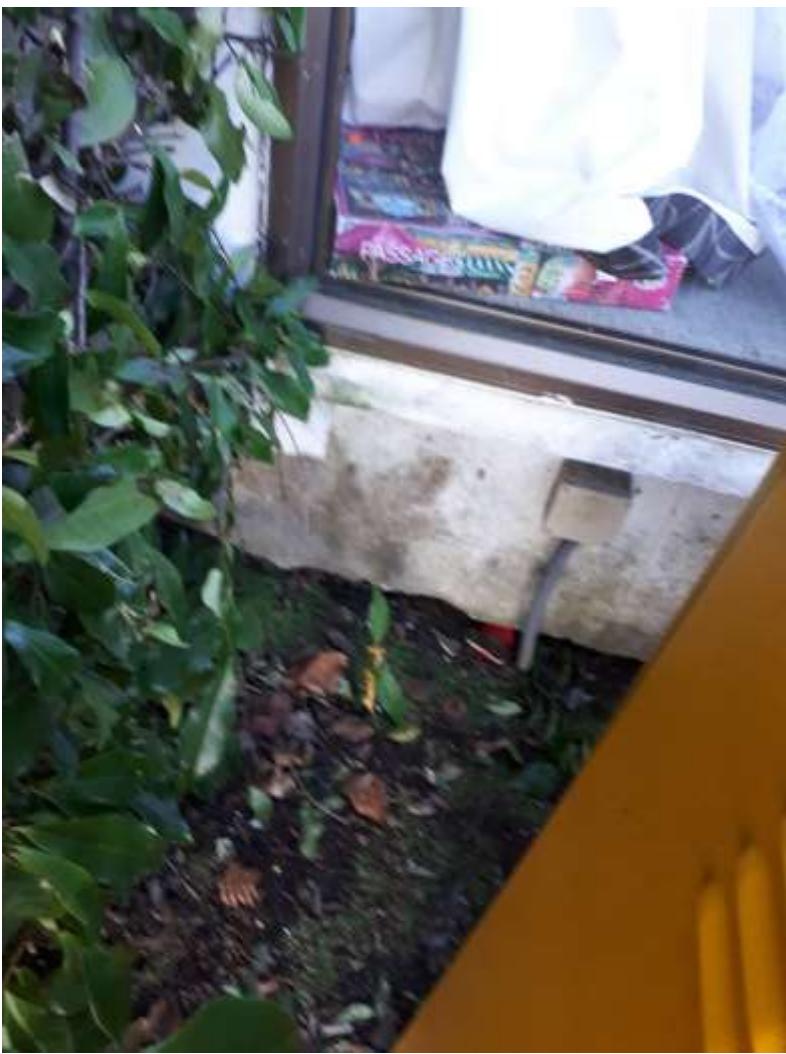
1	2	3
Location	Front Cladding	House Baseboard	Garage External Cladding
Internal/External	External	External	Both
Description	Fibre Cement	Fibre Cement	Fibre Cement
Extent	20sqm	<10sqm	12sqm
Identification	Tested positive 16/06/18	Tested positive 16/06/18	Tested positive 21/06/18
Asbestos Type	White	White	White and Brown
Risk Statement	10 = MODERATE	10 = MODERATE	12 = MODERATE
Latest Inspection	27/05/2019	27/05/2019	27/05/2019
Condition	LOW	LOW	MEDIUM
Inspection Due	27/05/2020	27/05/2020	27/05/2020
Initial Actions			
Ongoing Action Required	Should be inspected on a YEARLY cycle. Monitoring is required, as deterioration may occur over time. Any change in circumstances may require reassessment of priority rating	Should be inspected on a YEARLY cycle. Monitoring is required, as deterioration may occur over time. Any change in circumstances may require reassessment of priority rating	Should be inspected on a YEARLY cycle. Monitoring is required, as deterioration may occur over time. Any change in circumstances may require reassessment of priority rating

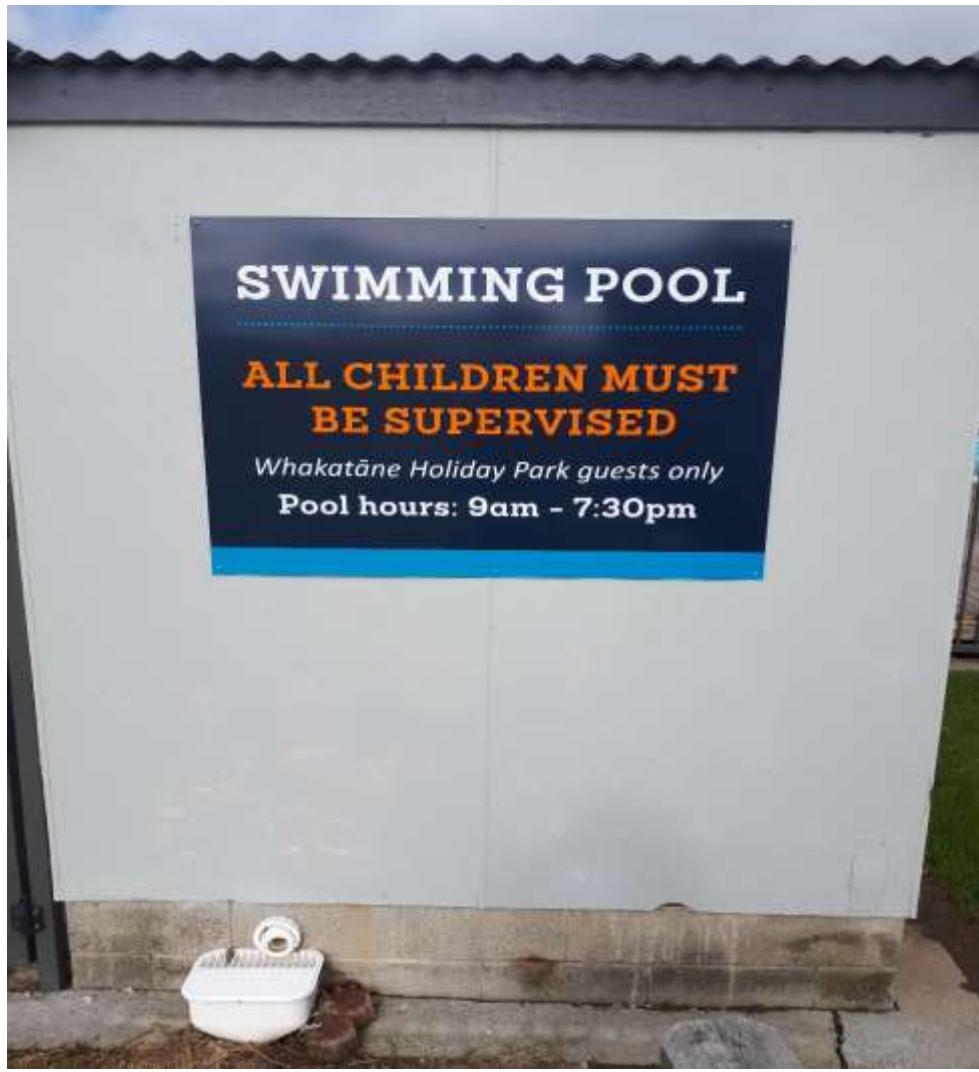
1
Location	External Cladding
Internal/External	External
Description	Fibre Cement
Extent	20sqm
Identification	Tested positive 16/06/18
Asbestos Type	White
Risk Statement	9 = MODERATE
Latest Inspection	27/05/2019
Condition	GOOD
Inspection Due	27/05/2020
Initial Actions	
Ongoing Action Required	Should be inspected on a YEARLY cycle. Monitoring is required, as deterioration may occur over time. Any change in circumstances may require reassessment of priority rating

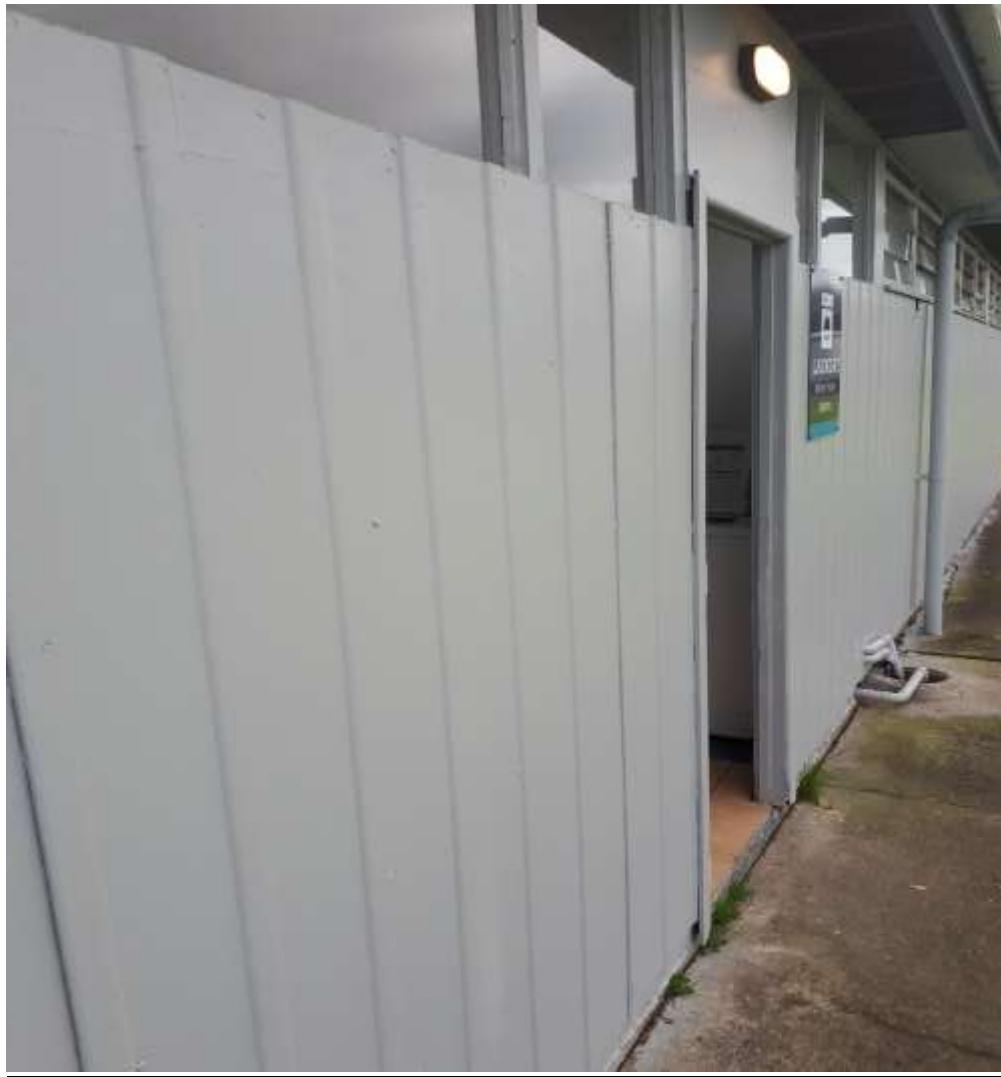
1
Location	External Cladding
Internal/External	External
Description	Fibre Cement
Extent	25sqm
Identification	Tested positive 16/06/18
Asbestos Type	White
Risk Statement	12 = MODERATE
Latest Inspection	27/05/2019
Condition	GOOD
Inspection Due	27/05/2020
Initial Actions	
Ongoing Action Required	<p style="color: red;">Should be inspected on a YEARLY cycle.</p> <p>Monitoring is required, as deterioration may occur over time. Any change in circumstances may require reassessment of priority rating</p>

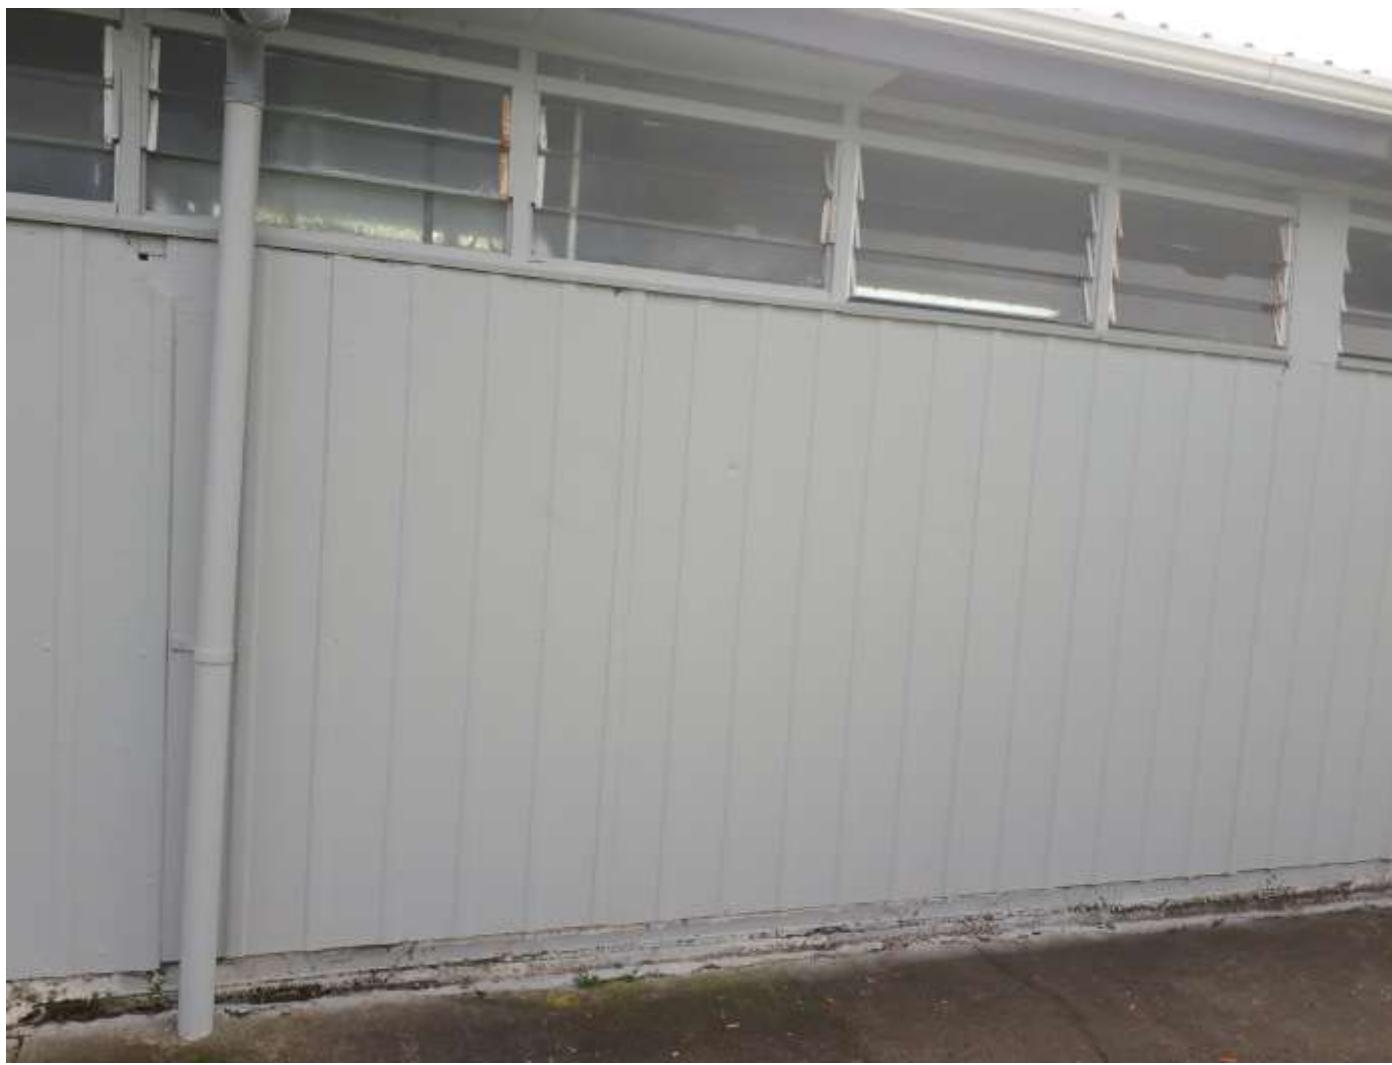
1	2
Location	External Cladding	Internal Wall Linings (not shower cubicles)
Internal/External	External	Internal
Description	Fibre Cement	Fibre Cement
Extent	>50sqm	>50sqm
Identification	Tested positive 16/06/18	Tested
Asbestos Type	White and Brown Asbestos	White Asbestos
Risk Statement	12 = MODERATE	9 = MODERATE
Latest Inspection	27/05/2019	27/05/2019
Condition	GOOD	GOOD
Inspection Due	27/05/2020	27/05/2020
Initial Actions		
Ongoing Action Required	<p style="color: red;">Should be inspected on a YEARLY cycle.</p> <p>Monitoring is required, as deterioration may occur over time. Any change in circumstances may require reassessment of priority rating</p>	<p style="color: red;">Should be inspected on a YEARLY cycle.</p> <p>Monitoring is required, as deterioration may occur over time. Any change in circumstances may require reassessment of priority rating</p>
