**Asbestos Management Survey of
Whakatane Holiday Park, McGarvey Road,
Whakatane**

**Prepared for Whakatane District Council
as at 16 April 2019**

Report Number: **19-060460**

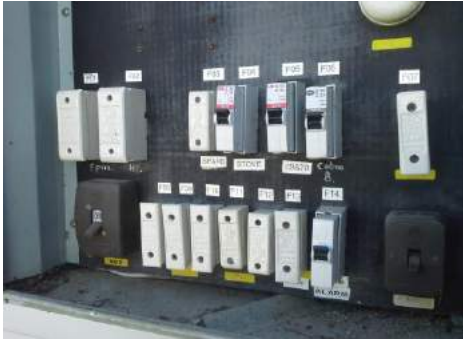
Room/Area: Floor 0, Room/Area 01x (Units 1-5 externals) 10 items

Description: Presumed flashguards within fuse cases to fuseboard - Textiles

Recommendations: Do not disturb prior to material being investigated (following isolation).

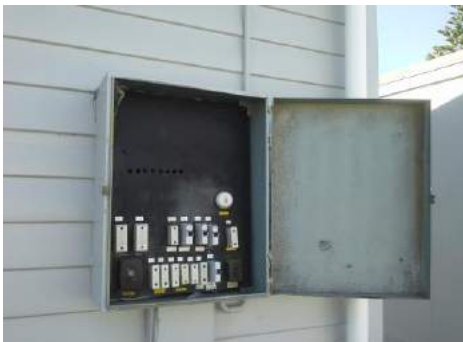
Room/Area: Floor 0, Room/Area 01x (Units 1-5 externals) 2500 cm²

Description: Fuseboard within south wall boxing - Composite board

Recommendations: Monitor condition and reinspect periodically.

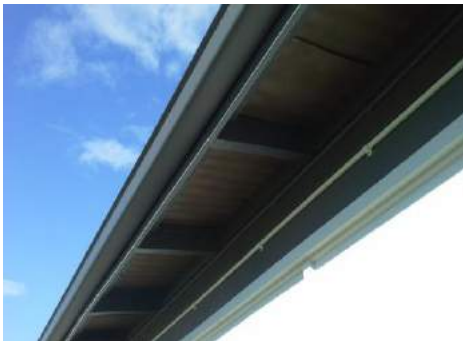
Room/Area: Floor 0, Room/Area 01x (Units 1-5 externals) 20 m

Description: North side roof underlining - Builder's paper

Recommendations: No further action required.

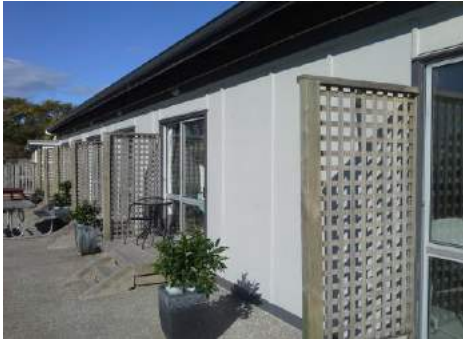
Room/Area: Floor 0, Room/Area 01x (Units 1-5 externals) 20 m2

Description: Doorside wall cladding - Fibre cement

Recommendations: Encapsulate exposed sections using an appropriately licensed asbestos removal contractor.

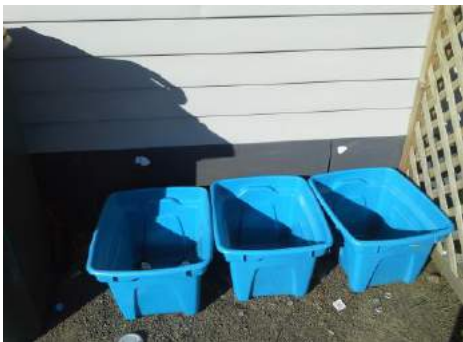
Room/Area: Floor 0, Room/Area 01x (Units 1-5 externals) 4 m2

Description: Baseboards to west side - Fibre cement

Recommendations: No further action required.

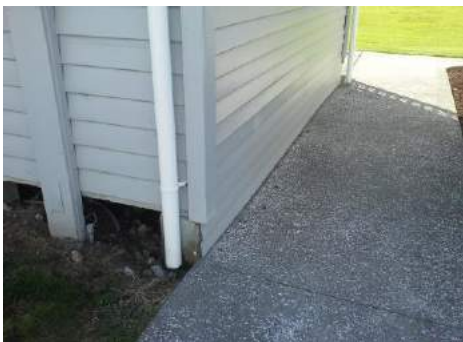
Room/Area: Floor 0, Room/Area 01x (Units 1-5 externals) 4 m2

Description: Baseboards to east side behind metal - Fibre cement

Recommendations: Monitor condition and reinspect periodically.

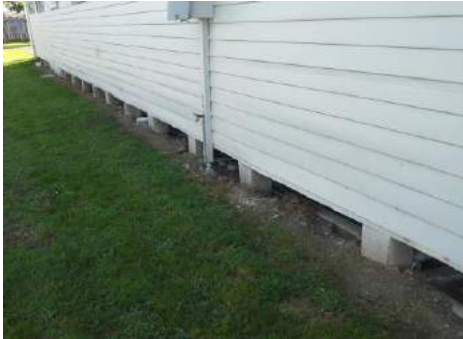
Room/Area: Floor 0, Room/Area 01x (Units 1-5 externals) 20 m

Description: Damp proof patches to concrete columns along lower south wall - Bitumen felt

Recommendations: No further action required.

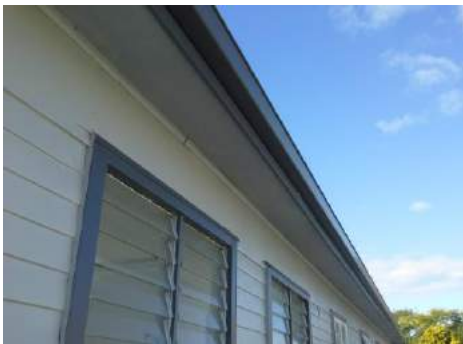
Room/Area: Floor 0, Room/Area 01x (Units 1-5 externals) 20 m²

Description: South side soffit and upper wall cladding - Fibre cement

Recommendations: Monitor condition and reinspect periodically. Maintain paint finish.

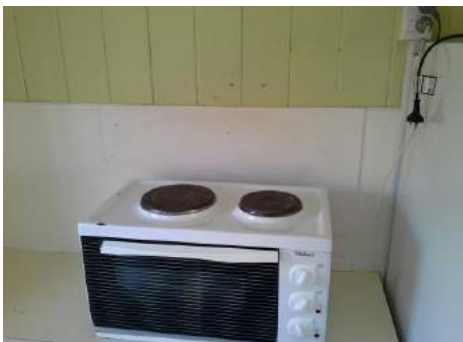
Room/Area: Floor 0, Room/Area 06i (Unit 6 internals) 1 m²

Description: Wall panel behind oven - Fibre cement

Recommendations: No further action required.

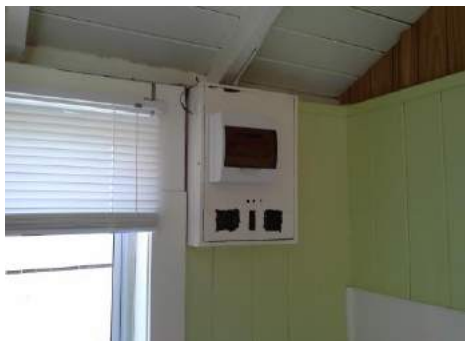
Room/Area: Floor 0, Room/Area 06i (Unit 6 internals) 1200 cm²

Description: Electrical boxing front panel - Composite board

Recommendations: Monitor condition and reinspect periodically. Maintain paint finish.

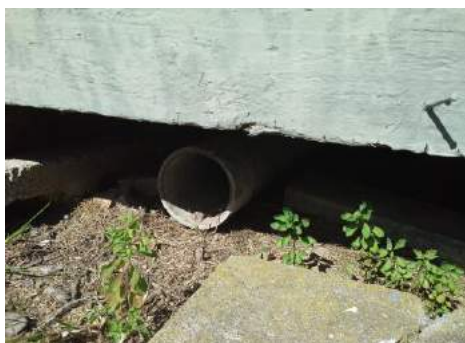
Room/Area: Floor 0, Room/Area 07x (Unit 7 external) 3 m

Description: Pipe beneath unit - Fibre cement

Recommendations: Monitor condition and reinspect periodically.

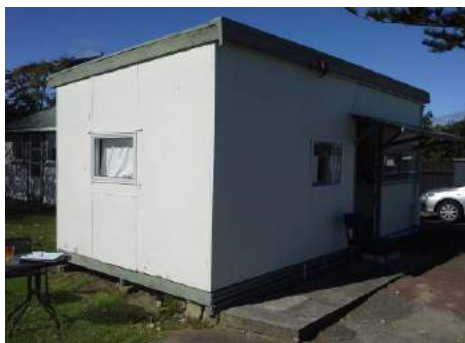
Room/Area: Floor 0, Room/Area 07x (Unit 7 externals) 50 m²

Description: Wall cladding - Fibre cement

Recommendations: Encapsulate exposed sections using an appropriately licensed asbestos removal contractor.

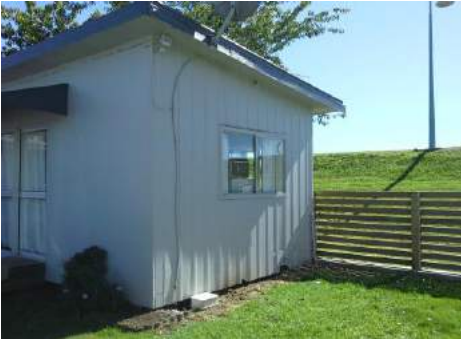
Room/Area: Floor 0, Room/Area 09x (Unit 9 externals) 30 m²

Description: Sides and rear wall cladding - Fibre cement

Recommendations: Encapsulate exposed edges using an appropriately licensed asbestos removal contractor.

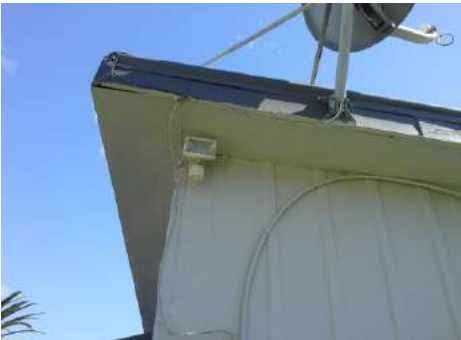
Room/Area: Floor 0, Room/Area 09x (Unit 9 externals) 10 m

Description: Perimeter soffit - Fibre cement

Recommendations: Monitor condition and reinspect periodically. Maintain paint finish.

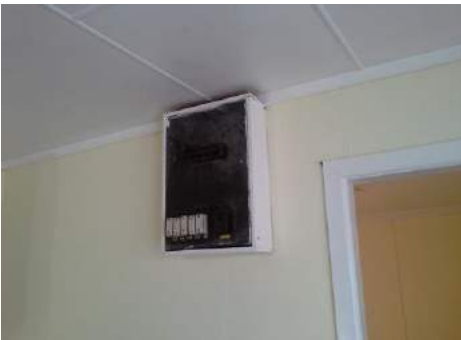
Room/Area: Floor 0, Room/Area 12i (Unit 12 internals) 1200 cm²

Description: Electrical boxing front panel - Composite board

Recommendations: Monitor condition and reinspect periodically.

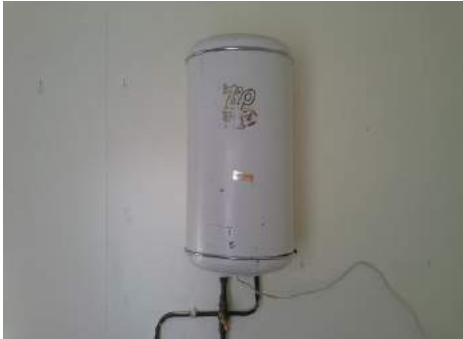
Room/Area: Floor 0, Room/Area 12i (Unit 12 internals) 1 m2

Description: Presumed insulation sealed within metal cladding to water cylinder - Loose insulation

Recommendations: Monitor condition and reinspect periodically.

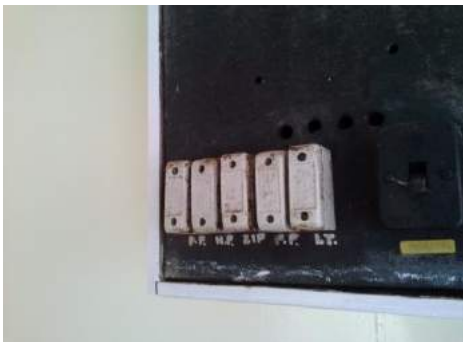
Room/Area: Floor 0, Room/Area 12i (Unit 12 internals) 5 items

Description: Presumed flashguards within fuse cases to electrical board - Textiles

Recommendations: Do not disturb prior to material being investigated (following isolation).

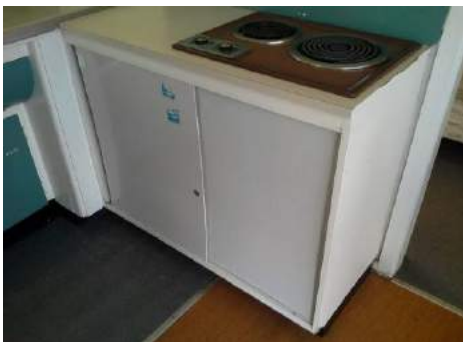
Room/Area: Floor 0, Room/Area 12i (Unit 12 internals) 1 m2

Description: Kitchen cupboard sliding doors - Fibre cement

Recommendations: No further action required.

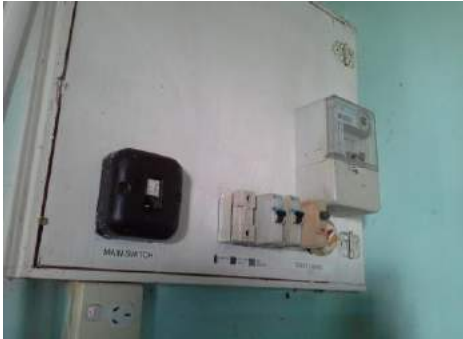
Room/Area: Floor 0, Room/Area 14i (Unit 14 internals) 1 items

Description: Presumed flashguard within fuse case to electrical board - Textiles

Recommendations: Do not disturb prior to material being investigated (following isolation).

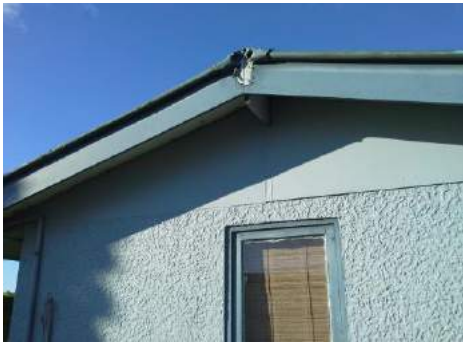
Room/Area: Floor 0, Room/Area 14x (Unit 14 externals) 4 m2

Description: Gables - Fibre cement

Recommendations: Monitor condition and reinspect periodically. Maintain paint finish.

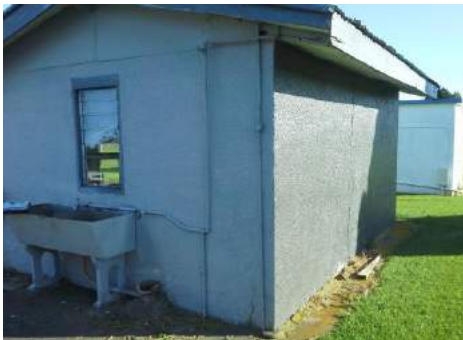
Room/Area: Floor 0, Room/Area 14x (Unit 14 externals) 40 m2

Description: To concrete walls throughout - Non-friable textured coating

Recommendations: No further action required.

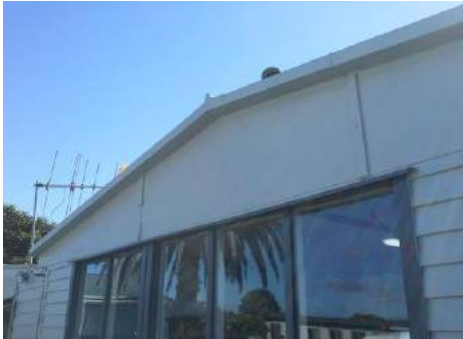
Room/Area: Floor 0, Room/Area Ax (Laundry Unit externals) 5 m2

Description: Gables - Fibre cement

Recommendations: Monitor condition and reinspect periodically. Maintain paint finish.

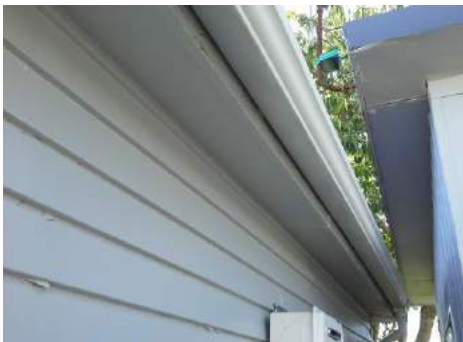
Room/Area: Floor 0, Room/Area Ax (Laundry Unit externals) 8 m

Description: Soffits - Fibre cement

Recommendations: Monitor condition and reinspect periodically. Maintain paint finish.

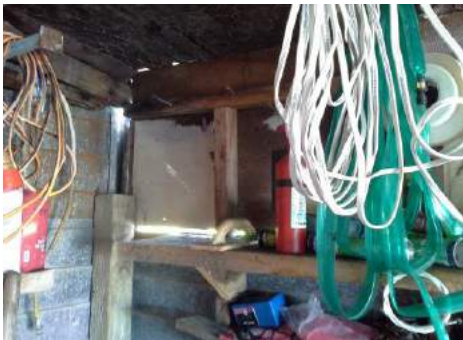
Room/Area: Floor 0, Room/Area B (Garage) 1 m2

Description: Window infill to northeast corner - Fibre cement

Recommendations: No further action required.

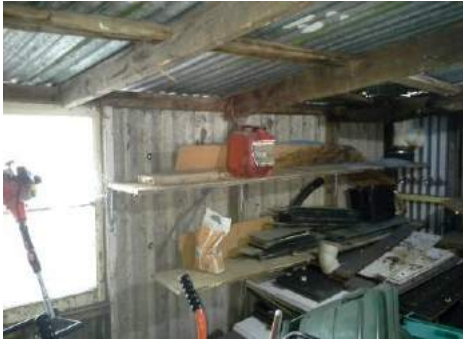
Room/Area: Floor 0, Room/Area B (Garage) 15 m²

Description: West wall "supersix" cladding - Fibre cement

Recommendations: Encapsulate material using an appropriately licensed asbestos removal contractor.

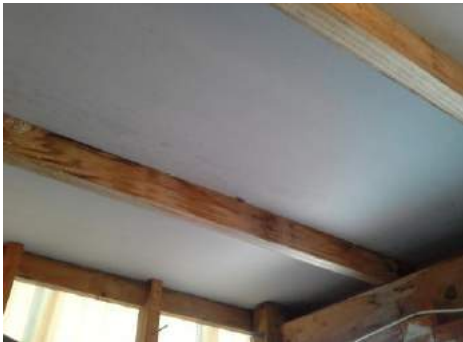
Room/Area: Floor 0, Room/Area Ci (Manager's House internals) 4 m²

Description: Wash room ceiling - Fibre cement

Recommendations: No further action required.

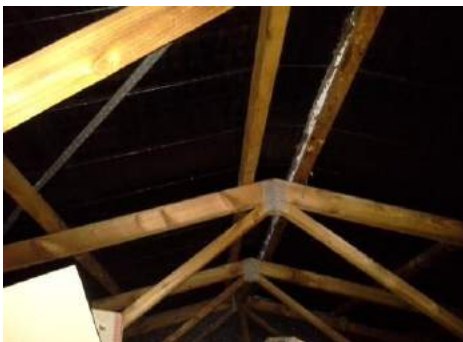
Room/Area: Floor 0, Room/Area Ci (Manager's House internals) 200 m²

Description: Roof lining - Builder's paper

Recommendations: No further action required.

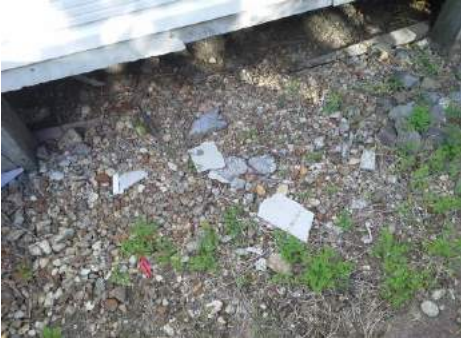
Room/Area: Floor 0, Room/Area Cx (Manager's House externals) 1 m²

Description: Debris by north wall - Fibre cement

Recommendations: No further action required.

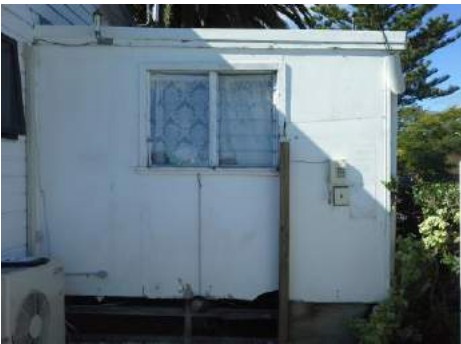
Room/Area: Floor 0, Room/Area Cx (Manager's House externals) 20 m²

Description: Wall cladding to southern end - Fibre cement

Recommendations: Encapsulate exposed sections using an appropriately licensed asbestos removal contractor.

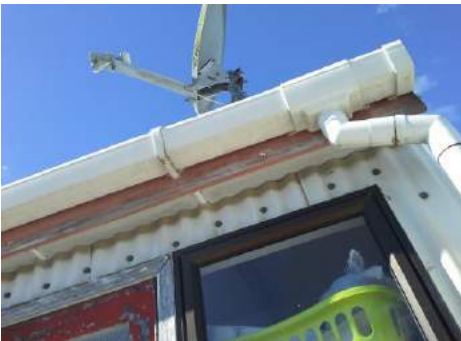
Room/Area: Floor 0, Room/Area Cx (Manager's House externals) 3 m

Description: Narrow soffit to west side - Fibre cement

Recommendations: No further action required.

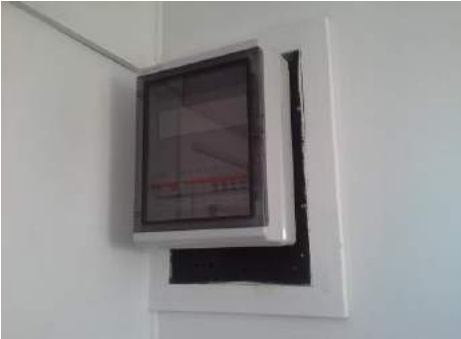
Room/Area: Floor 0, Room/Area Di (Main Office internals) 1200 cm2

Description: Electrical board - Composite board

Recommendations: Monitor condition and reinspect periodically. Maintain paint finish.

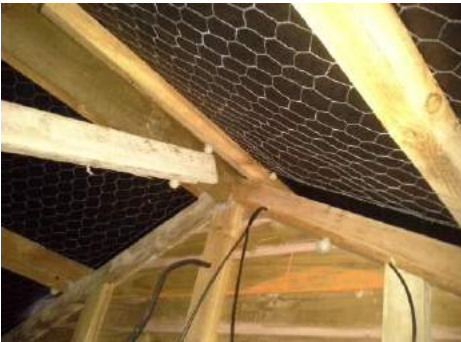
Room/Area: Floor 0, Room/Area Di (Main Office internals) 150 m2

Description: Roof lining - Builder's paper

Recommendations: No further action required.

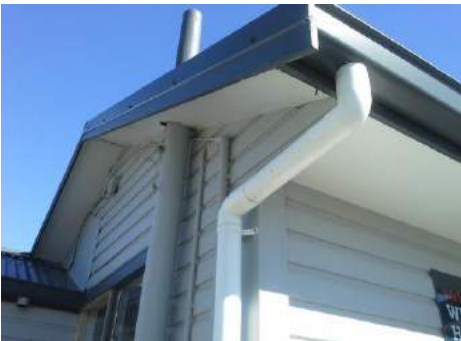
Room/Area: Floor 0, Room/Area Dx (Main Office externals) 25 m

Description: Perimeter soffit - Fibre cement

Recommendations: Seal damaged sections using an appropriately licensed asbestos removal contractor.

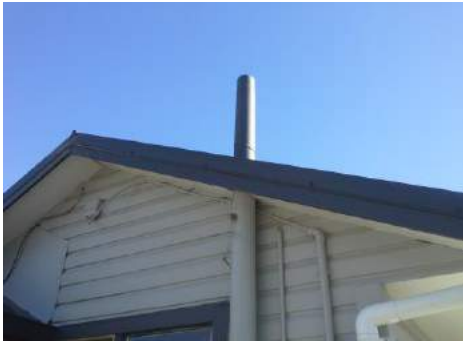
Room/Area: Floor 0, Room/Area Dx (Main Office externals) 4 m

Description: Flue - Fibre cement

Recommendations: Monitor condition and reinspect periodically. Maintain paint finish.

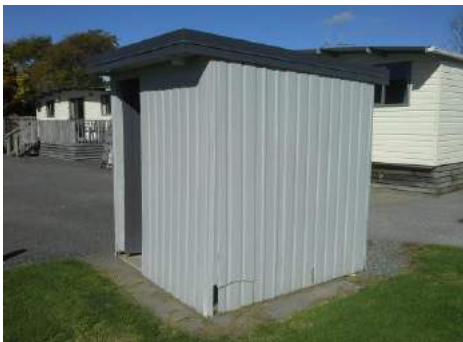
Room/Area: Floor 0, Room/Area E (Electrical Shed) 20 m2

Description: Wall cladding - Fibre cement

Recommendations: Encapsulate exposed sections using an appropriately licensed asbestos removal contractor.

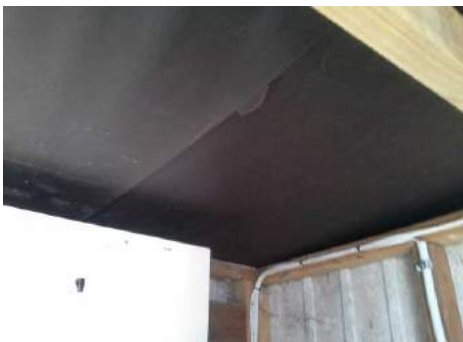
Room/Area: Floor 0, Room/Area E (Electrical Shed) 4 m2

Description: Roof lining - Builder's paper

Recommendations: No further action required.

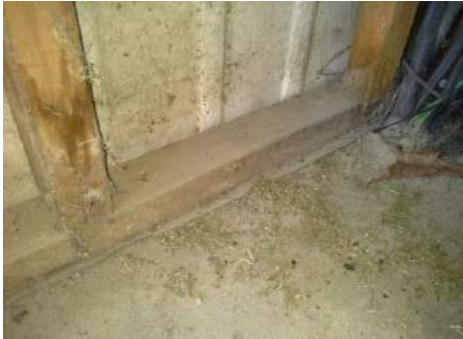
Room/Area: Floor 0, Room/Area E (Electrical Shed) 7 m

Description: Damp proof course to perimeter floor - Bitumen felt

Recommendations: No further action required.

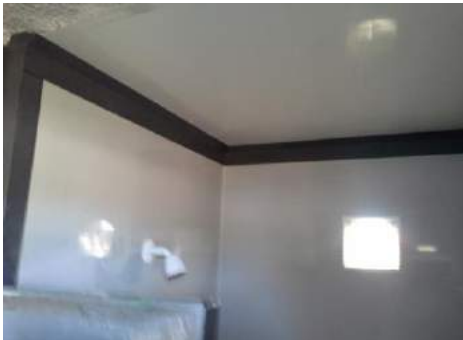
Room/Area: Floor 0, Room/Area F (Toilet Block internals) 6 m2

Description: Aquapanel shower lining - Fibre cement

Recommendations: No further action required.

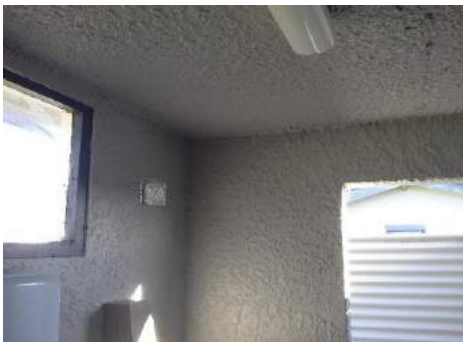
Room/Area: Floor 0, Room/Area F (Toilet Block internals) 30 m2

Description: Concrete wall and ceiling coatings throughout - Non-friable textured coating

Recommendations: No further action required.

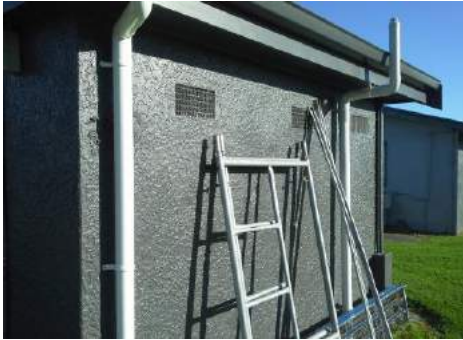
Room/Area: Floor 0, Room/Area Fx (Toilet Block externals) 40 m²

Description: To concrete walls throughout - Non-friable textured coating

Recommendations: No further action required.

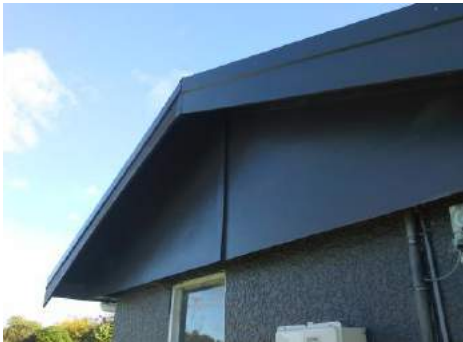
Room/Area: Floor 0, Room/Area Fx (Toilet Block externals) 12 m²

Description: Soffits and gables - Fibre cement

Recommendations: No further action required.

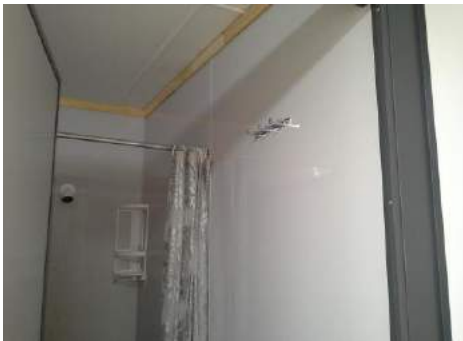
Room/Area: Floor 0, Room/Area Gi (New Shower Toilet Kitchen Building internals) 24 m²

Description: Men's and women's shower wall linings behind laminate - Fibre cement

Recommendations: No further action required.

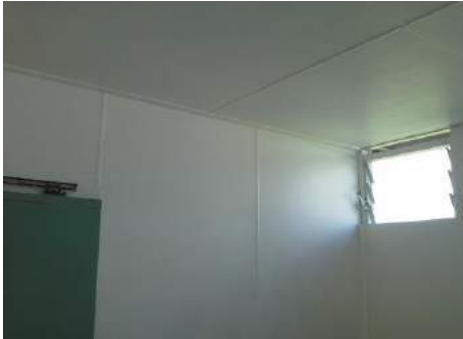
Room/Area: Floor 0, Room/Area Gi (New Shower Toilet Kitchen Building internals) 200 m2

Description: Men's and women's toilets and showers wall and ceiling linings throughout - Fibre cement

Recommendations: No further action required.

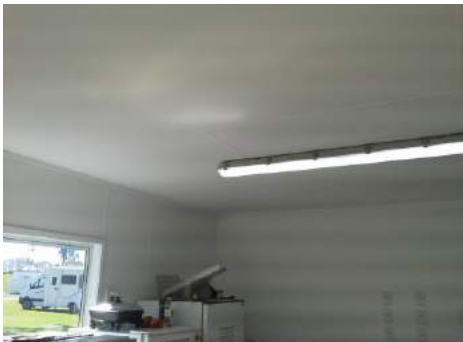
Room/Area: Floor 0, Room/Area Gi (New Shower Toilet Kitchen Building internals) 110 m2

Description: Kitchen wall and ceiling linings throughout - Fibre cement

Recommendations: No further action required.

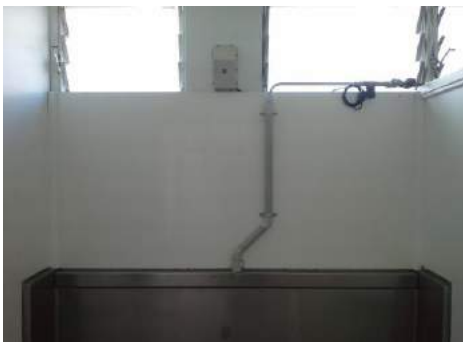
Room/Area: Floor 0, Room/Area Gi (New Shower Toilet Kitchen Building internals) 2 m2

Description: Tile-effect aquapanel wall lining above urinal - Fibre cement

Recommendations: No further action required.

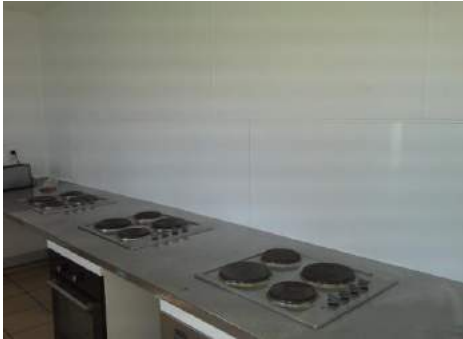
Room/Area: Floor 0, Room/Area Gi (New Shower Toilet Kitchen Building internals) 5 m2

Description: Tile-effect aquapanel wall lining above kitchen stoves - Fibre cement

Recommendations: No further action required.

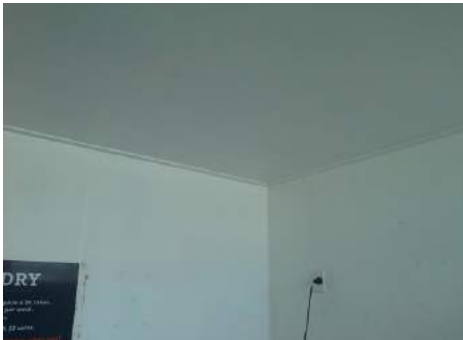
Room/Area: Floor 0, Room/Area Gi (New Shower Toilet Kitchen Building internals) 90 m2

Description: Wall and ceiling linings throughout laundry and store - Fibre cement

Recommendations: No further action required.

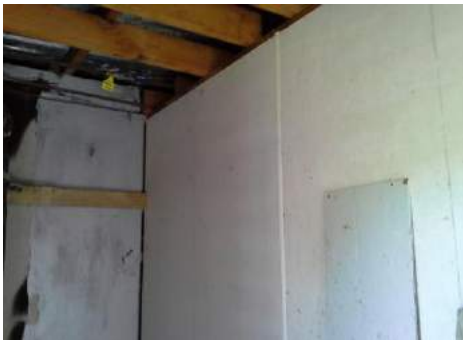
Room/Area: Floor 0, Room/Area Gi (New Shower Toilet Kitchen Building internals) 18 m2

Description: Boiler room wall linings - Fibre cement

Recommendations: No further action required.

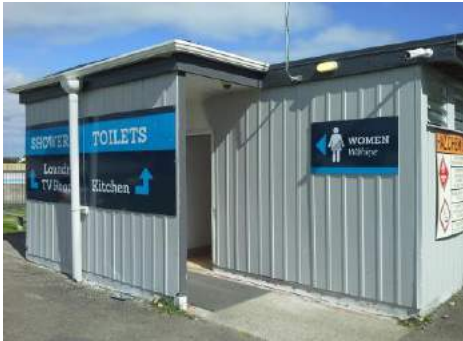
Room/Area: Floor 0, Room/Area Gx (New Shower Toilet Kitchen Building externals) 90 m2

Description: Laundry + shower section wall cladding - Fibre cement

Recommendations: Monitor condition and reinspect periodically. Maintain paint finish.

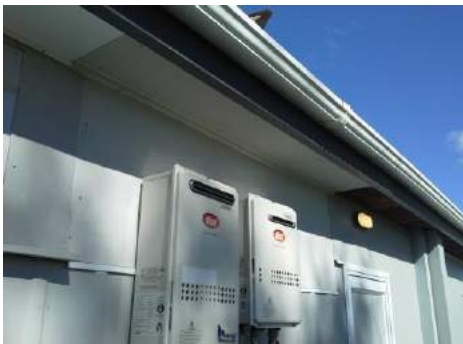
Room/Area: Floor 0, Room/Area Gx (New Shower Toilet Kitchen Building externals) 2 m2

Description: Window overboard and soffit outside boiler room - Fibre cement

Recommendations: No further action required.

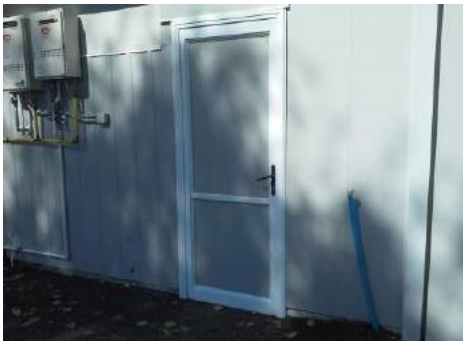
Room/Area: Floor 0, Room/Area Gx (New Shower Toilet Kitchen Building externals) 2 m2

Description: Boiler room door infills - Fibre cement

Recommendations: No further action required.

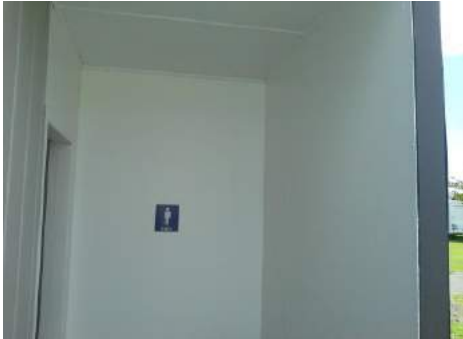
Room/Area: Floor 0, Room/Area Gx (New Shower Toilet Kitchen Building externals) 20 m2

Description: Wall cladding to men's and women's toilet entrances - Fibre cement

Recommendations: Monitor condition and reinspect periodically. Maintain paint finish.

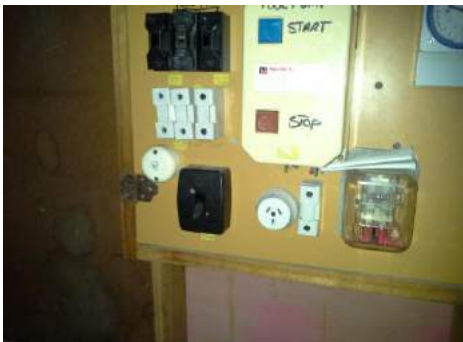
Room/Area: Floor 0, Room/Area H (Pool Plant Room) 4 items

Description: Presumed flashguards within fuse cases to electrical board - Textiles

Recommendations: No further action required.

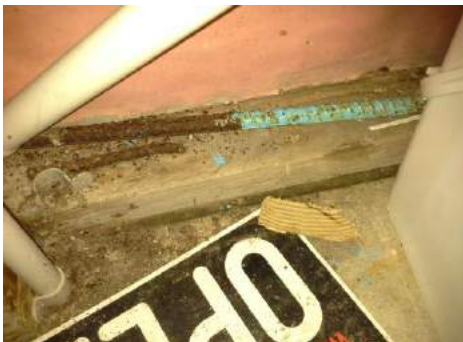
Room/Area: Floor 0, Room/Area H (Pool Plant Room) 8 m

Description: Damp proof course to perimeter floor. - Bitumen felt

Recommendations: No further action required.
