ESR MATATA PUBLIC HEALTH RISK ASSESSMENT

Report CSC12009 June 2012

This report provides an assessment of the impacts of the existing septic systems on health risks in Matata.

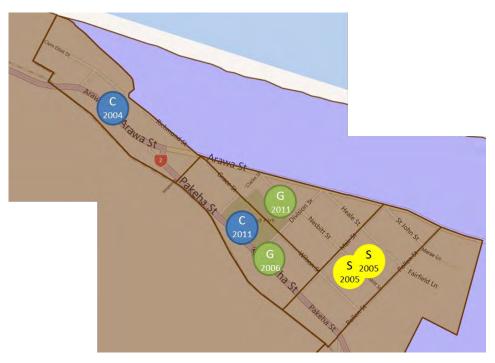
Figure 1 Meshblock levels locations of notifications. Note the home addresses of cases could be anywhere within the meshblock shown for the cases. Where C = campylobacteriosis, G = giardiasis and S = salmonellosis.

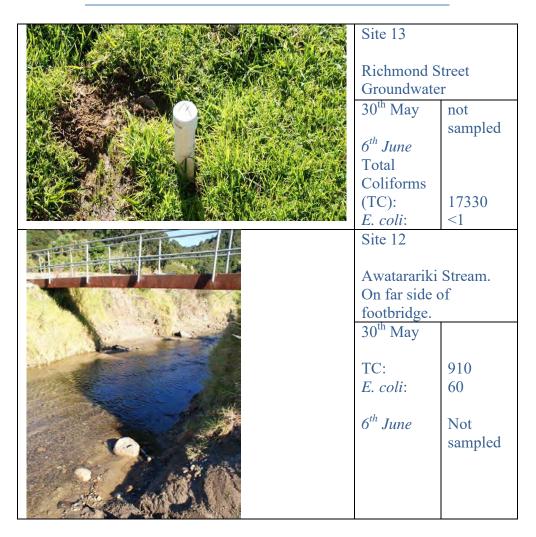
2012 ESR Testing of Awatarariki Stream and Groundwater

Testing of Richmond Street ground water and Awatarariki Stream show low levels of *E. coli*, and so no evidence of contamination from faecal sources, which is consistent with sampling conducted by Bay of Plenty Regional Council in 2011 and 2012.

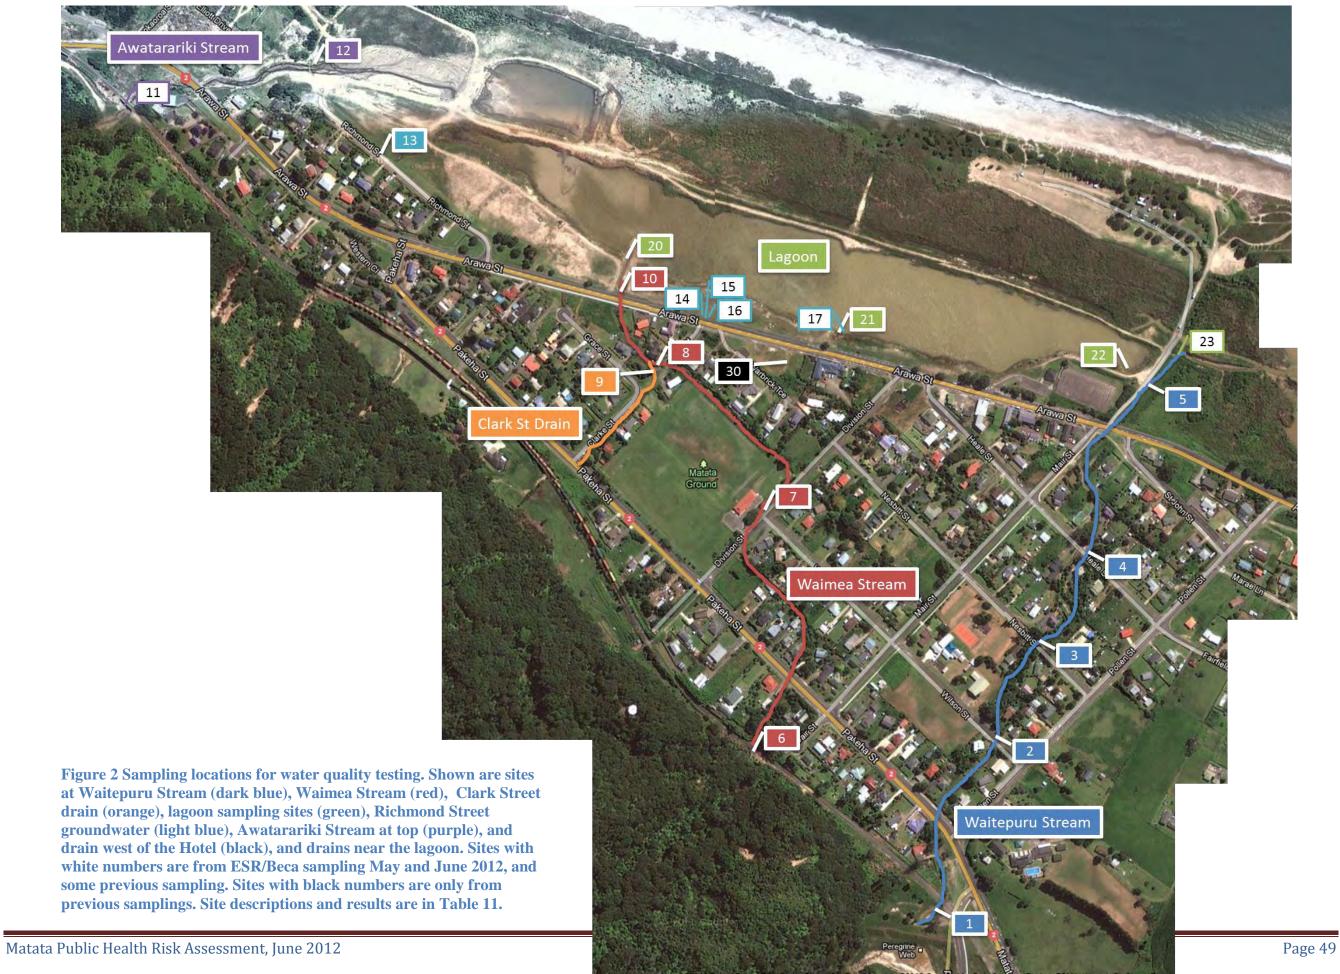
Appendix 4 – Water Sampling Sites and Combined Table of Results

Water samples were collected from 15 sites on 30^{th} May (between 11 am and 1 pm) and 11 sites on 6^{th} June 2012 (between 9 am and 11 am). Sampling locations are shown in Appendix 4. On the 30^{th} May conditions were dry and clear. There had been 36 mm of rain in the previous 72 hours. Ground conditions were soft, but not sodden. On the 6^{th} June it was overcast with light rain during sampling. The previous day there had been heavy rain. The ground was sodden/saturated.

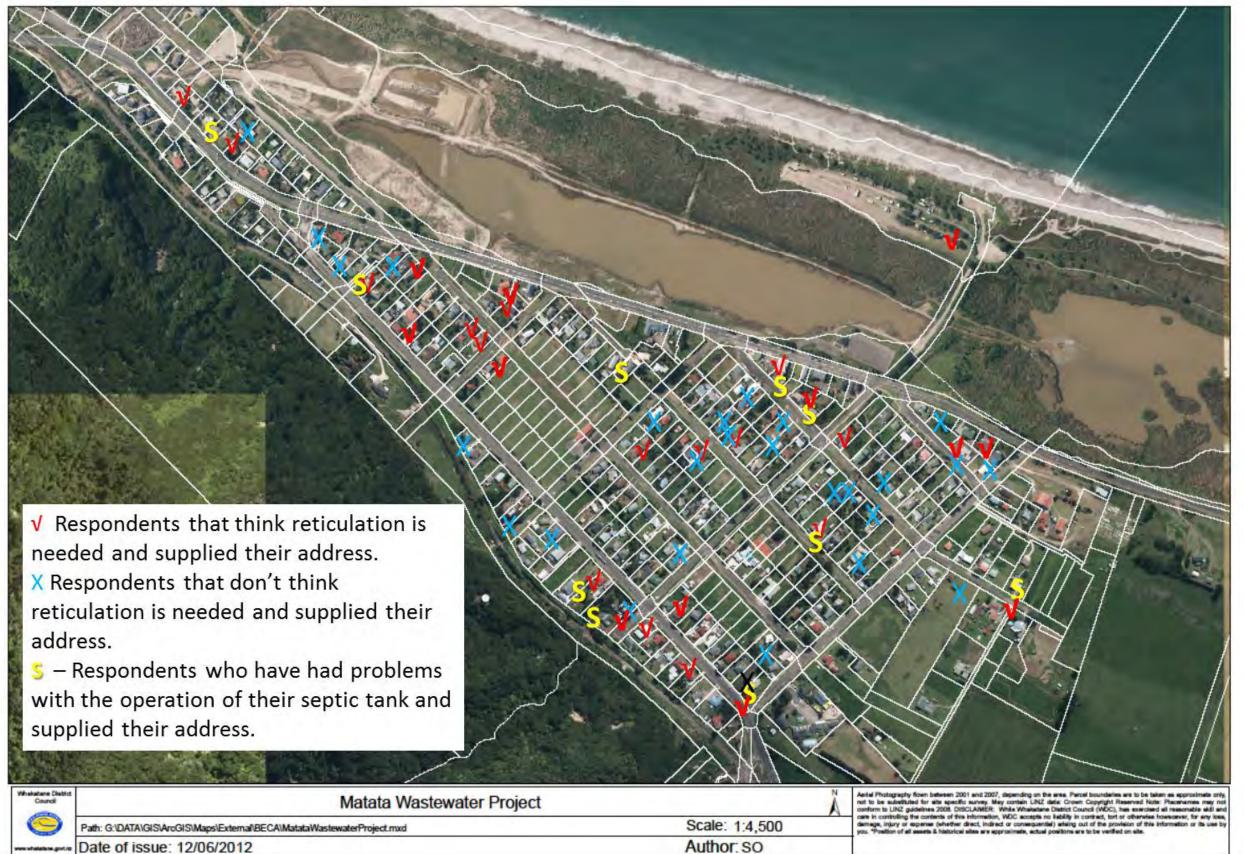
Appendix 5. Approximate locations of self reported septic tank problems and residents favouring or not favouring sewage reticulation.

Figure 3 Spatial mapping of survey responses. Note positions are approximate only.
