Projects and Services Committee

Thursday, 19 February 2026

6.4 Nga Tapuwae o Toi Walkway Reinstatement Options Report(Cont.)

6.4.2 Appendix B - Avalon Geotechnical Services West End Walkway Slip Inspection report 20 April 2024

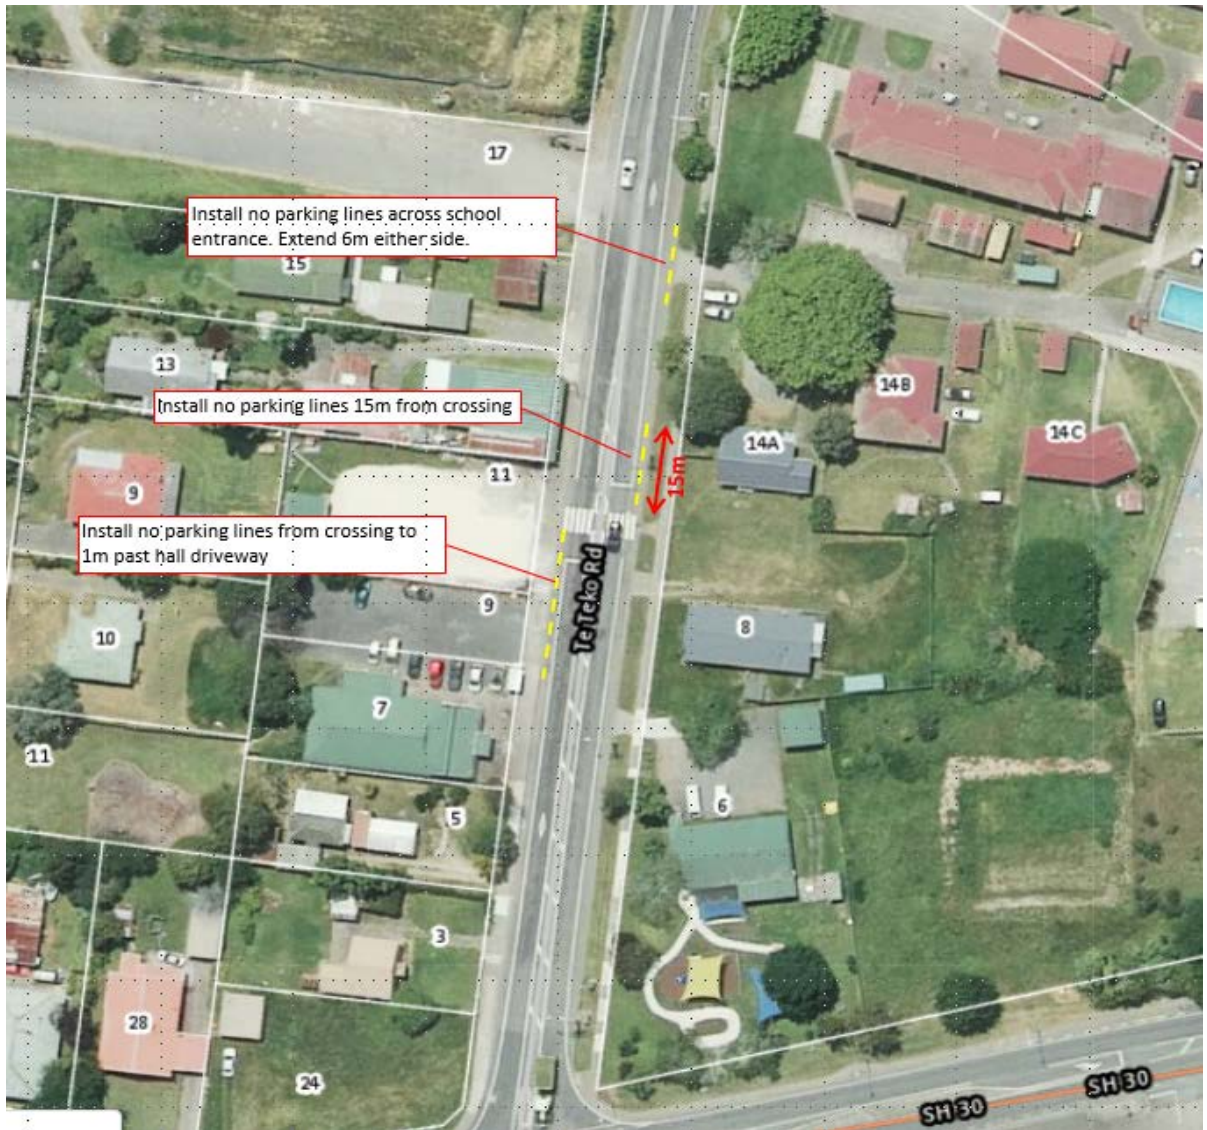
Addition of broken yellow lines outside Te Kura o Te Teko

Reference Appendix 1 – Schedule Item 1.2 Addition of broken yellow lines on outside Te Kura o Te Teko,

Reference Appendix 2 – Schedule Item 2.2 Addition of broken yellow lines outside Te Kura o Te Teko.

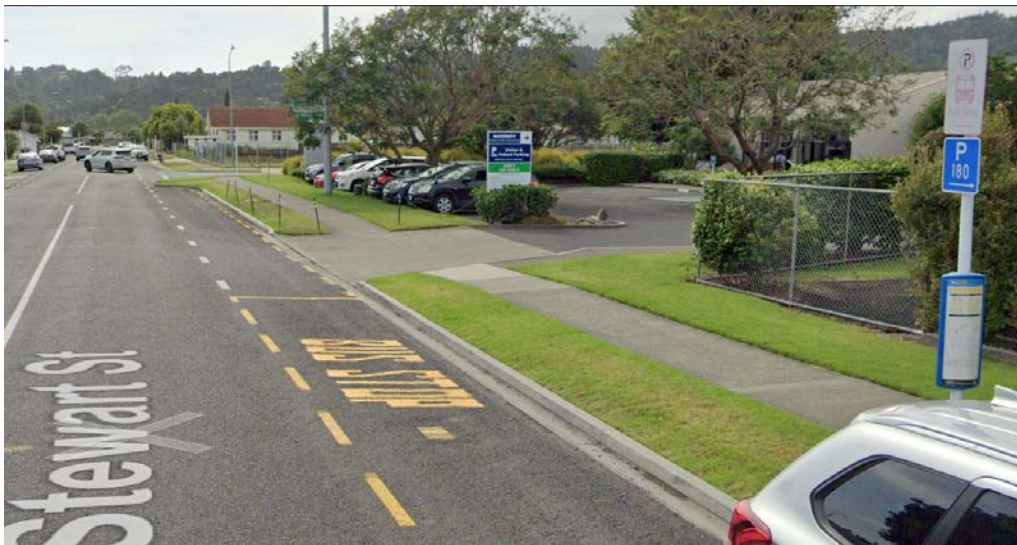
Proposed changes to Stewart Street, relocate current Bus Stop from the western side of the maternity clinic to the eastern side.

4.3. Proposal to relocate bus stop on Stewart Street from the western side of the maternity clinic driveway to the eastern side along with the removal of 25metres of yellow broken lines to create additional carparks.

*Refer Appendix 3 – Schedule Item 3.1 Proposed relocation of the bus stop to create two new carparks.
Refer Appendix 3 – Schedule Item 3.2 Removal of broken yellow lines to create four new carparks.*

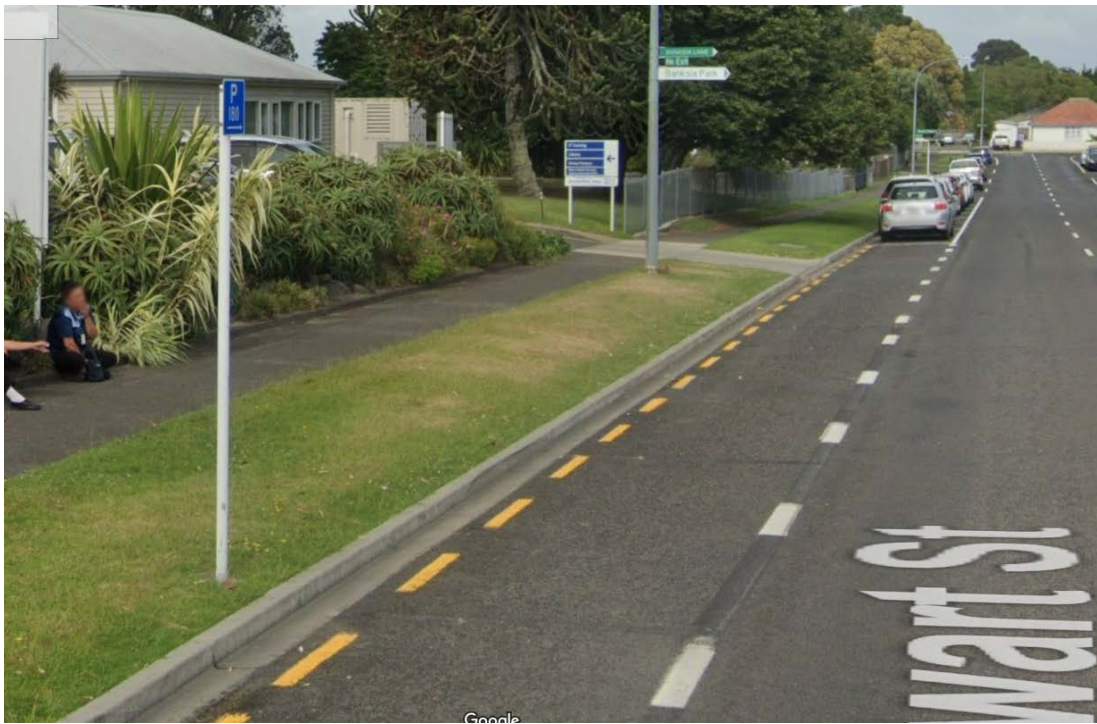
Proposed changes to Stewart Street, removing broken yellow lines, creating additional carparks.

The Transportation Team also propose removing 25m of yellow broken lines further west on Stewart Street to create an additional four (4) carparks. This will create a total of six new carparks (refer appendix 3). Ultimately more parking in this area assists access to hospital services. Consultation with the Whakatāne Hospital and BOP Regional Council has been undertaken.

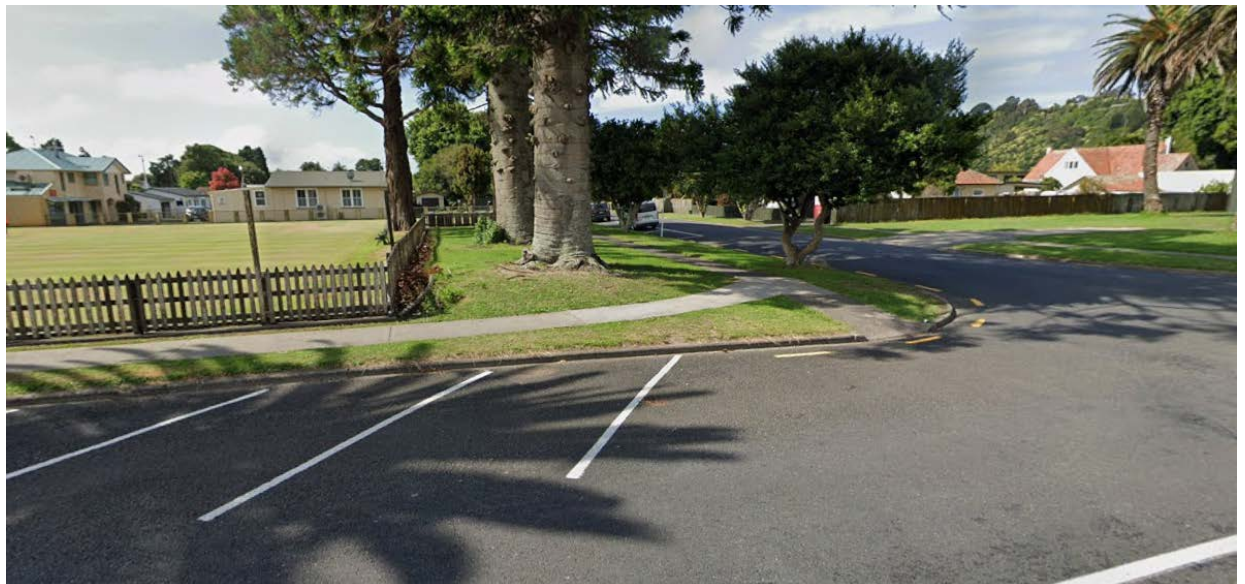
3.4

Proposed disability carpark Short Street, outside the croquet club.

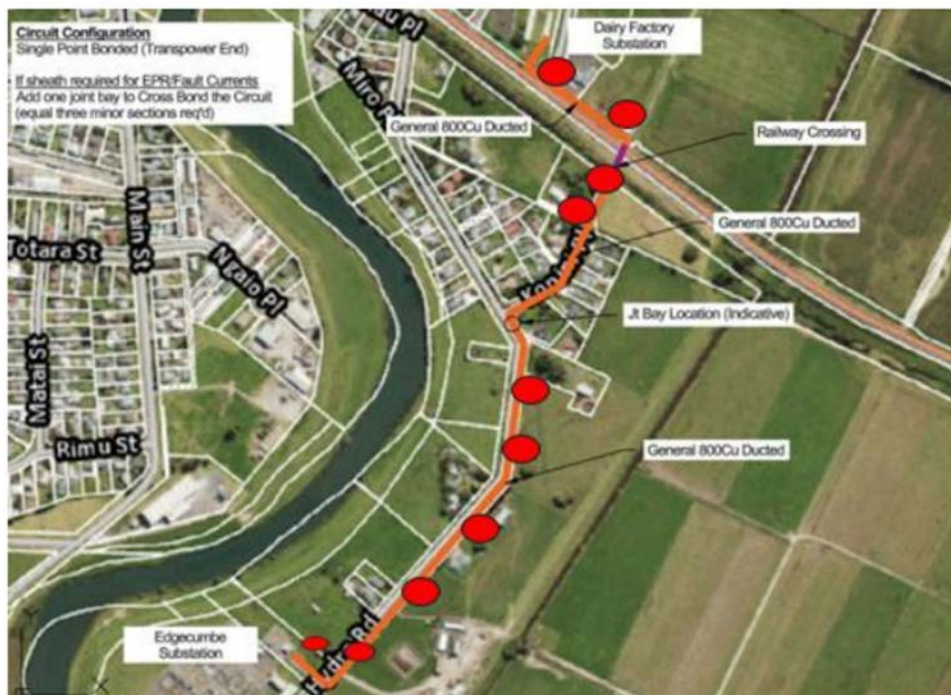
Figure 3: Indicative cable route

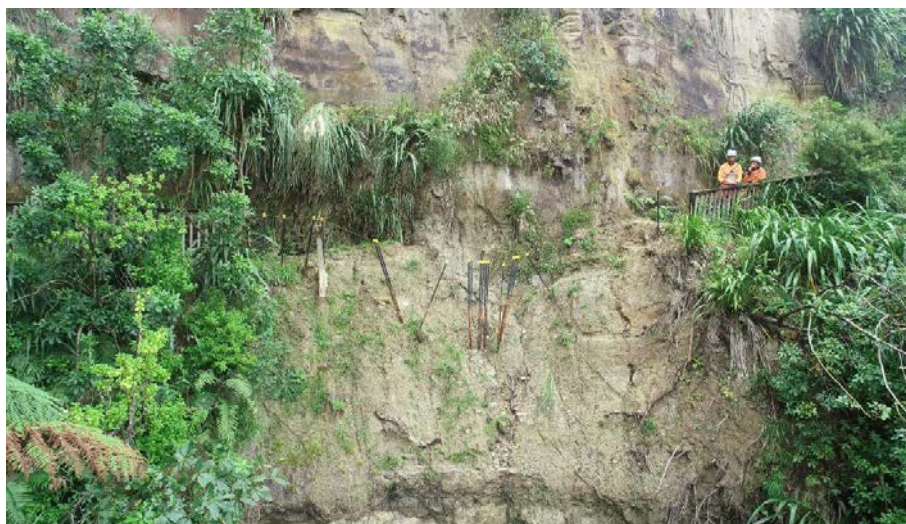
Figure 3 (2024): Landslide 2 – an underslip where most surface material has slid off exposing the sandstone underneath.

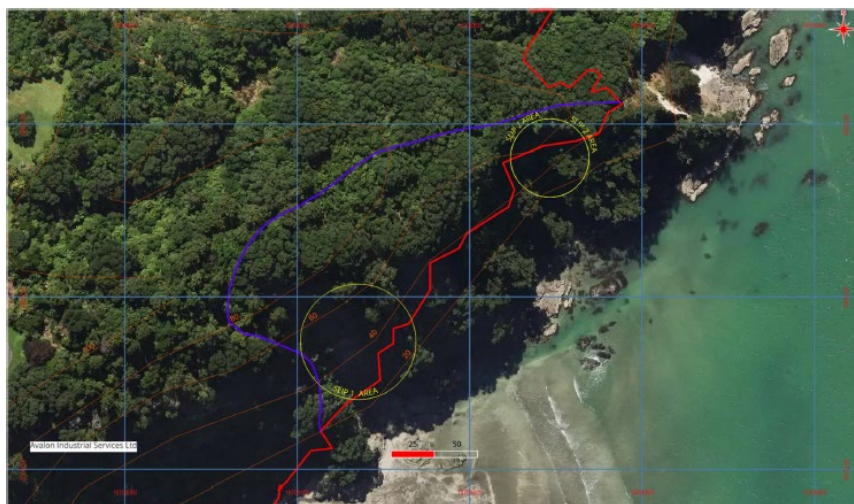
Figure 5: Ngā Tapuwae o Toi Existing Route 1 (red line) and new alternate Route 2 (Blue line)
Route 1 – Reinstating the existing track

Between 2023 and 2025 a series of technical reports were commissioned to determine the cause of landsliding, to identify potential mitigation measures to allow the walkway to reopen and to better understand the on-going risks to the walkway and its users. Several approaches to stabilise and reinstate the track have been developed, on two alternate routes discussed below and illustrated on Figure 5.

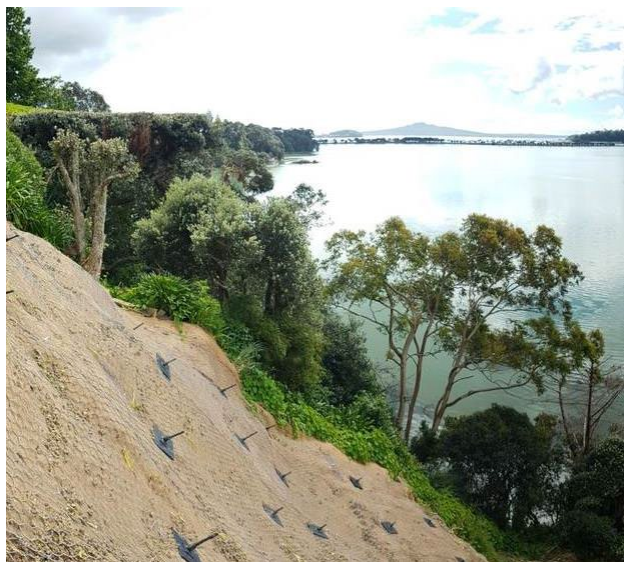
Figure 6: Example of rock anchors and rock mesh at the top of a slope to prevent future ground movement

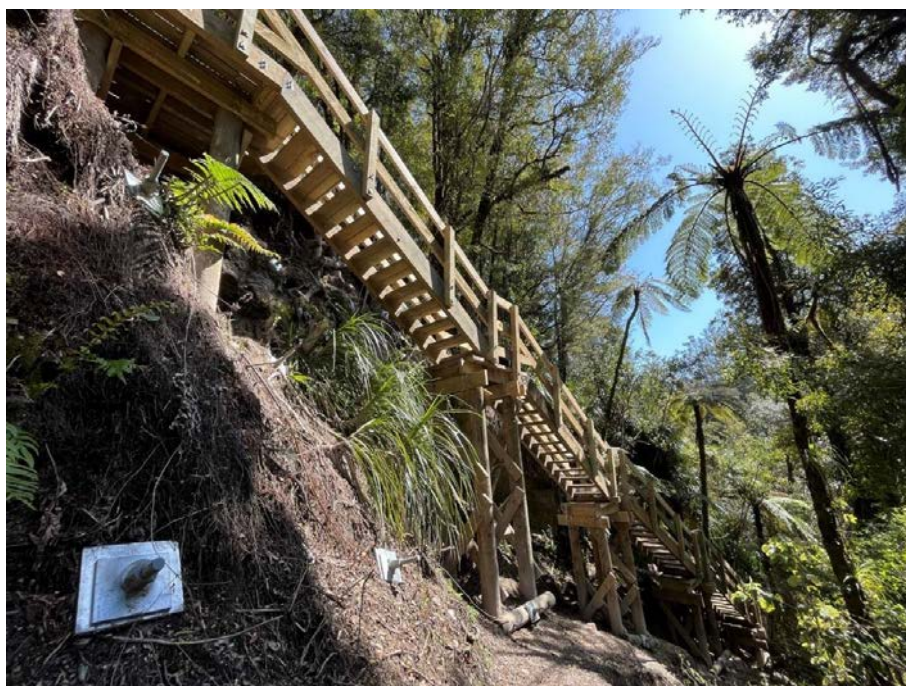
Figure 7: Example of similar staircase up a steep rock face on the Omanawa Falls Track

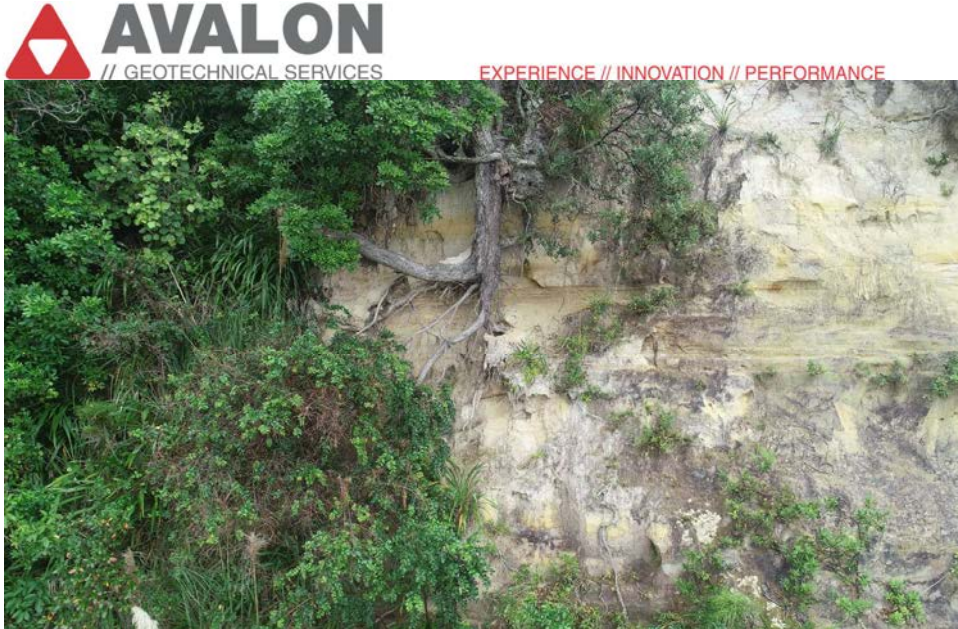
Left of face above track at slip 2 typical conditions large overhanging Pohutukawa root

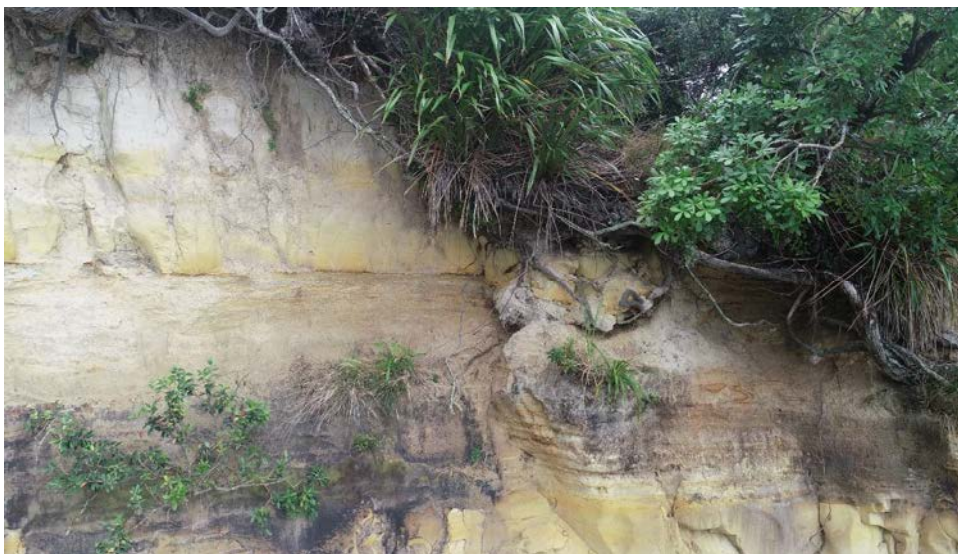
Right of face above Slip 2 track typical conditions – overhanging foliage, roots and sandstone blocks

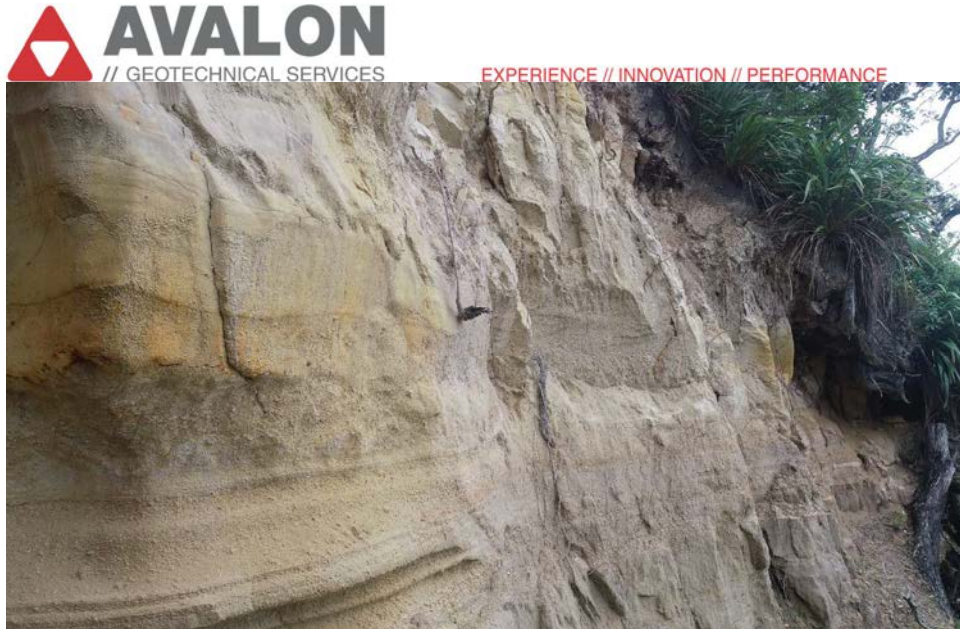
Right of the face above Slip Area 2 typical conditions – overhanging foliage, roots and sandstone blocks, note vertical joint exposed by the previous landslide.

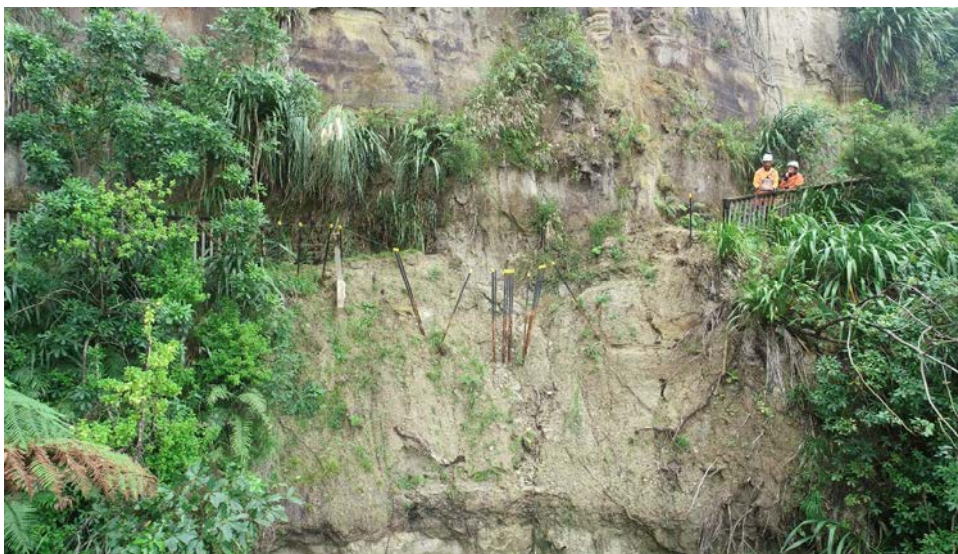
Underslip at Slip Area 2 – note most surface material has slid off exposing the sandstone underneath. Future failures are more likely to occur within the sandstone along the joints and other defects as part of more larger landslide event. Further failures are more likely to occur on either side of the existing failure due to similar shallow soils overlying the sandstone below.

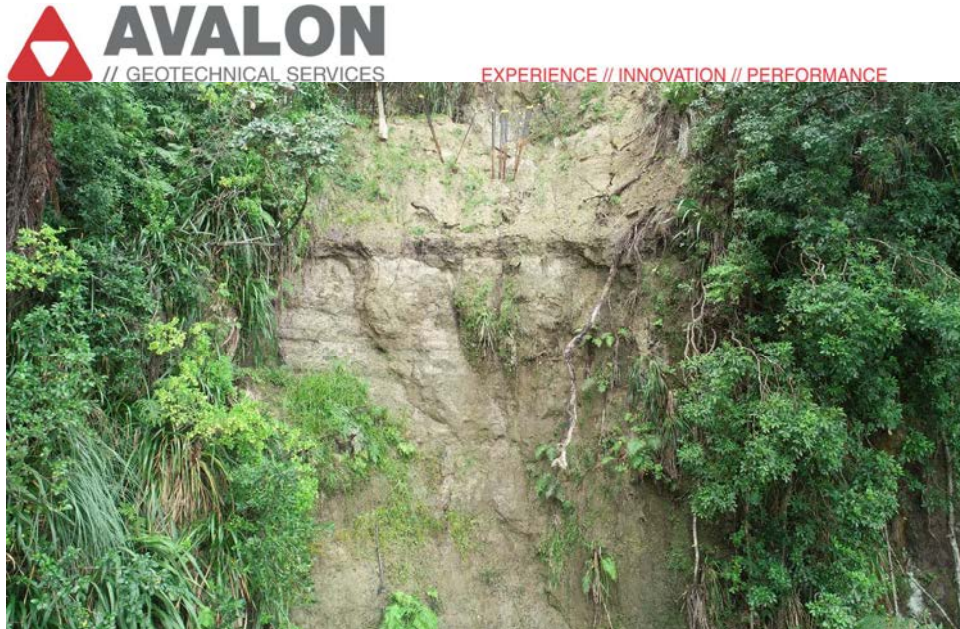
Underslip at Slip Area 2 – Continuation of the exposed underlying sandstone

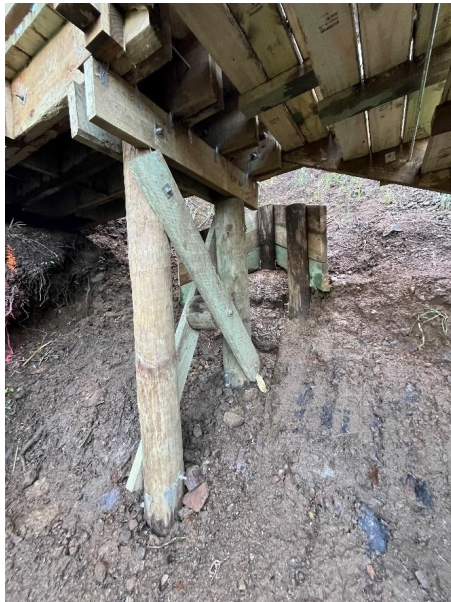
Photo 1: Deflector to protect structure foundations over slip

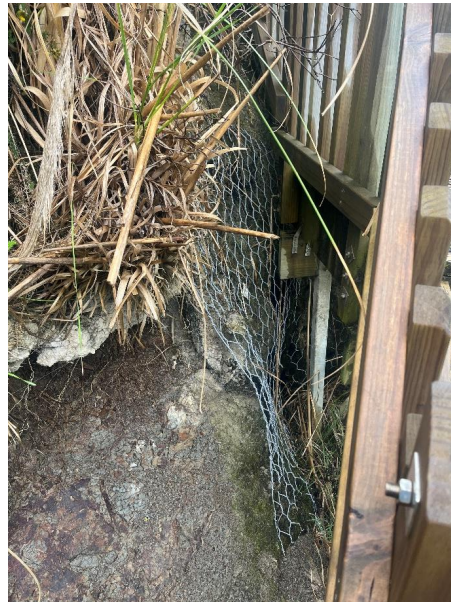
Photo 2: Staircase with mesh around foundation location

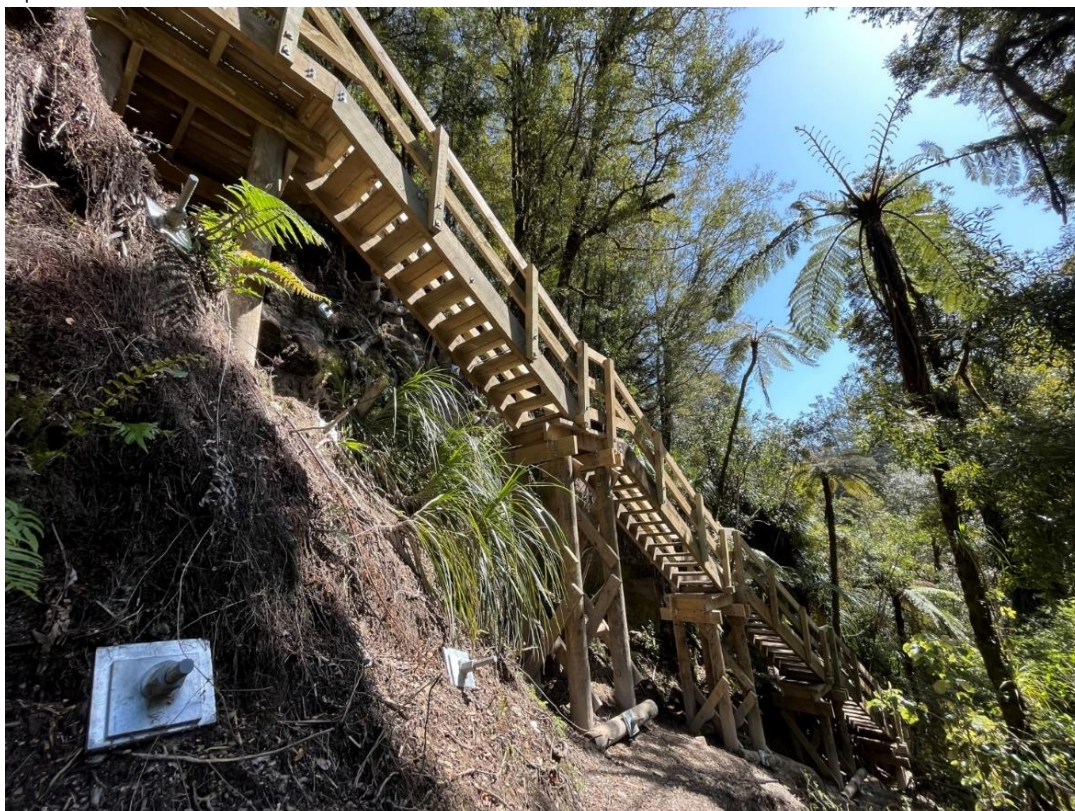
Figure 2: Similar staircase up steep rock face on Omanawa Falls Track

A staircase structure is recommended to traverse the slip face. The foundations are to be rock anchored into the cliff (Figure 3 below) which will provide stabilisation of the cliff in conjunction with supporting the structure. The structure foundations can have mesh installed above them to prevent loss of material. In addition to this, deflectors can be installed above the foundations to prevent small material moving down the slope from impacting the structure's foundations. The head scarp of the slip should also be mesh and rock anchored to prevent future extension of the slip face.

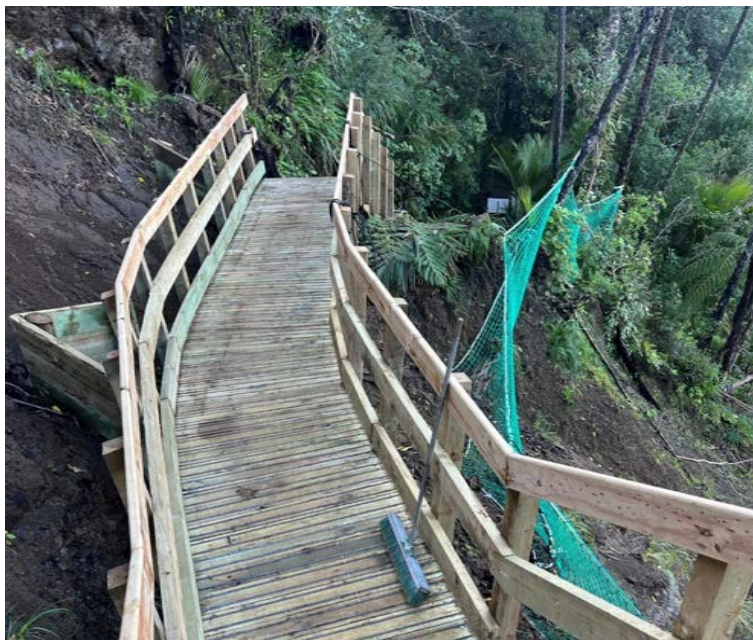
Figure 4: Boardwalk across slip face with deflectors at foundation locations

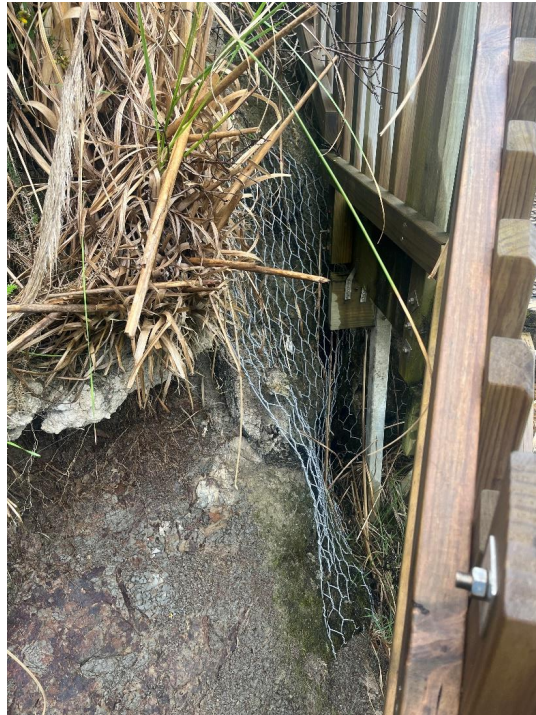
Figure 5: Localised rock mesh above foundations to protect structure.

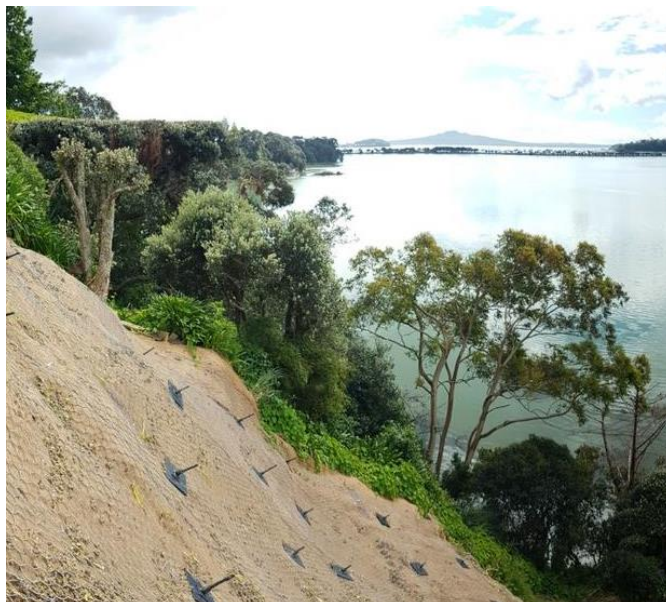
Figure 6: Rock anchor and mesh at top of slope to prevent future ground movement

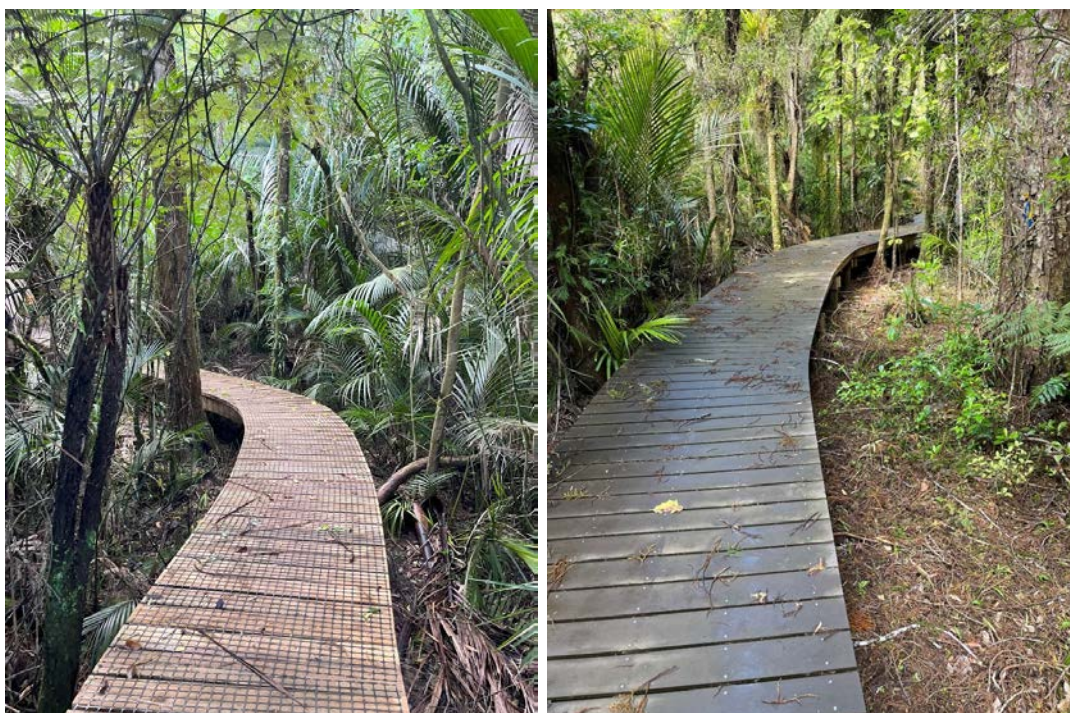
Figure 9 & 10: Boardwalk across wet areas where natural hydrology is to be maintained

The walkway along the northern valley will be situated between the Pā site and the valley wetland. Due to the amount of water in this area it is recommended to construct a boardwalk structure along this section of the walkway. The boardwalk structure has a very low impact on the ground and environment allowing the water to follow its natural flow maintaining the existing natural hydrology of the site.

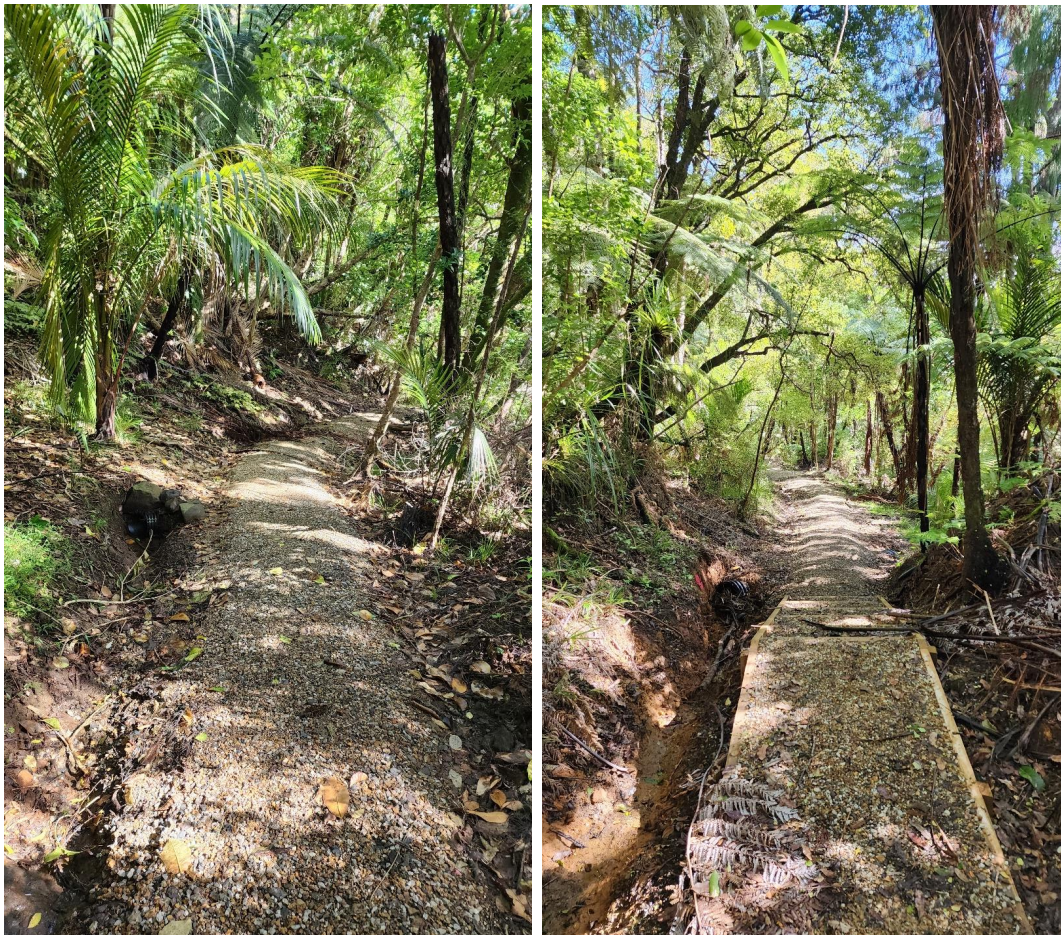
Figure 11 & 12: Typical aggregate track in bush setting with occasional small flights of boxed steps

The final link from the bottom of the northern valley back to the original track is recommended to be predominately aggregate track with the occasional flights of boxed steps. This ties in with the rest of the track network and is a cost-effective solution for this section of works.

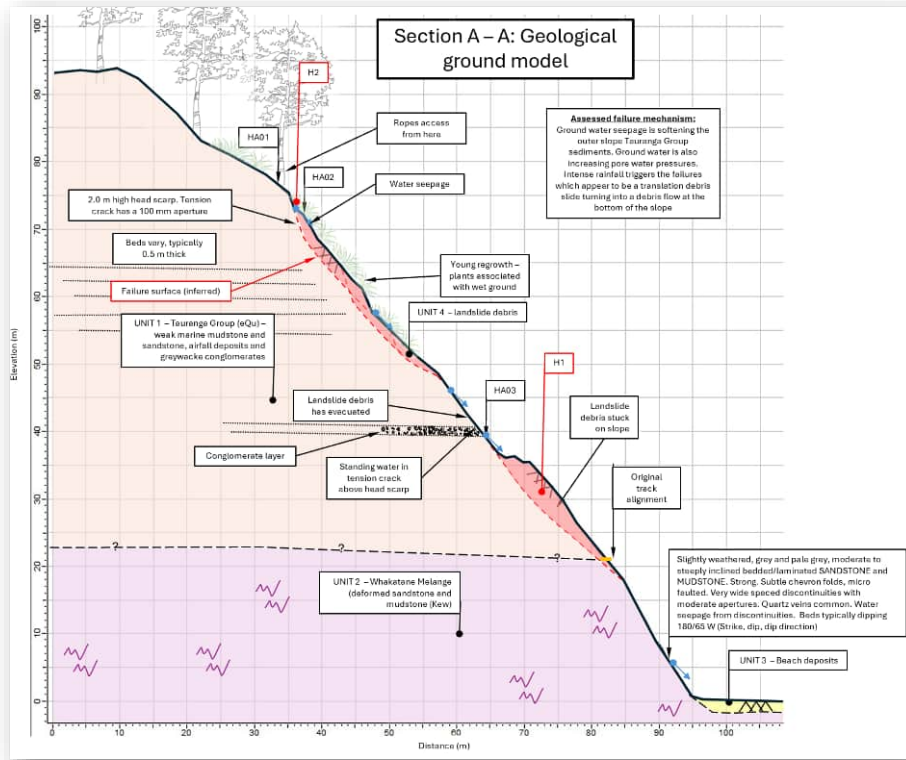
Figure 3: Geological ground model down 'slip 1' based on our onsite observations and the relevant geological maps.

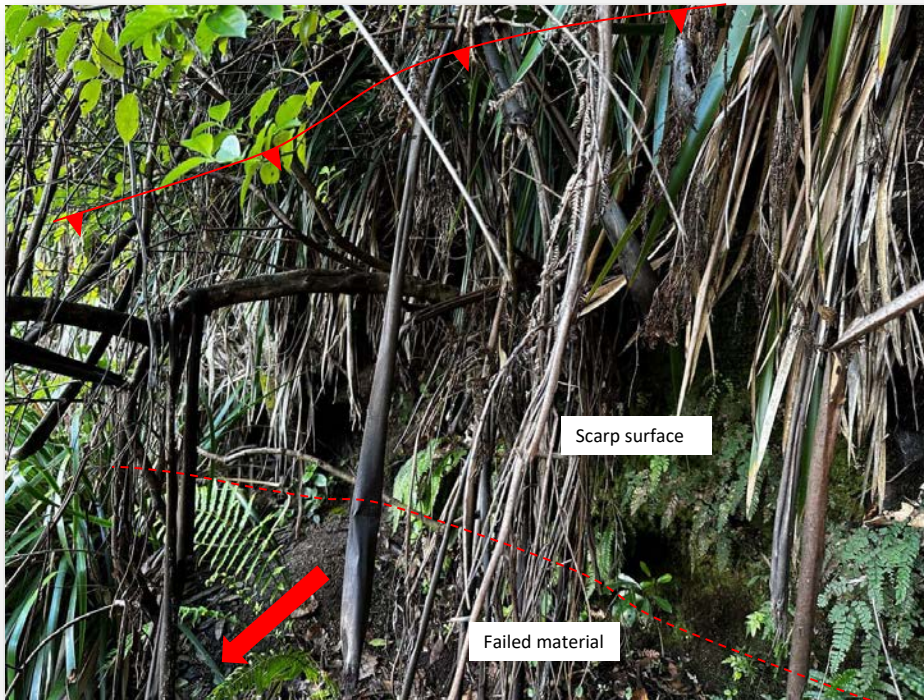
Photo 7: Head scarp 1. Looking south.

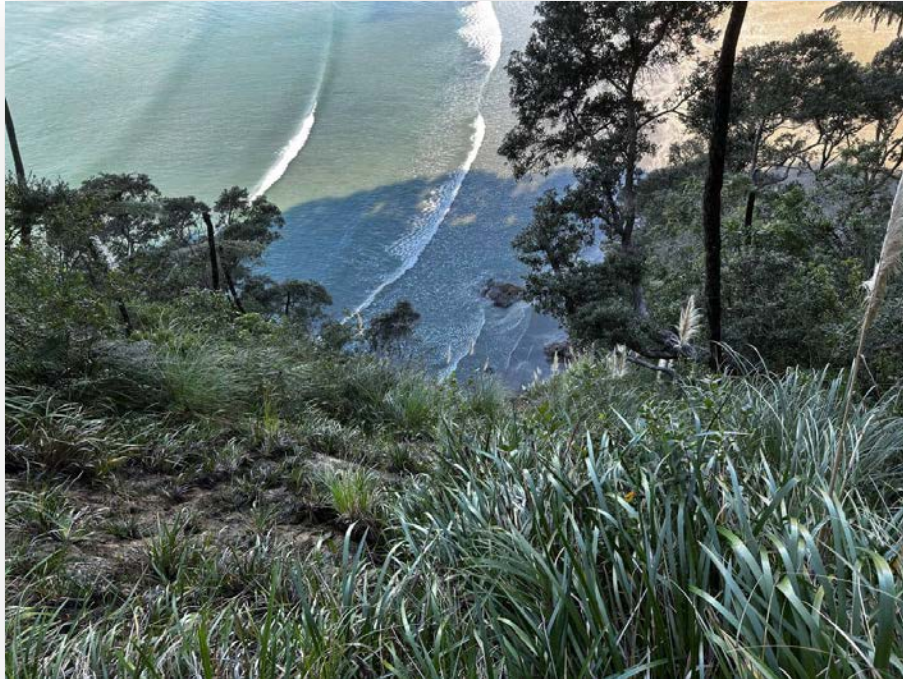
Photo 9: Looking down the landslide from slip scarp 3.

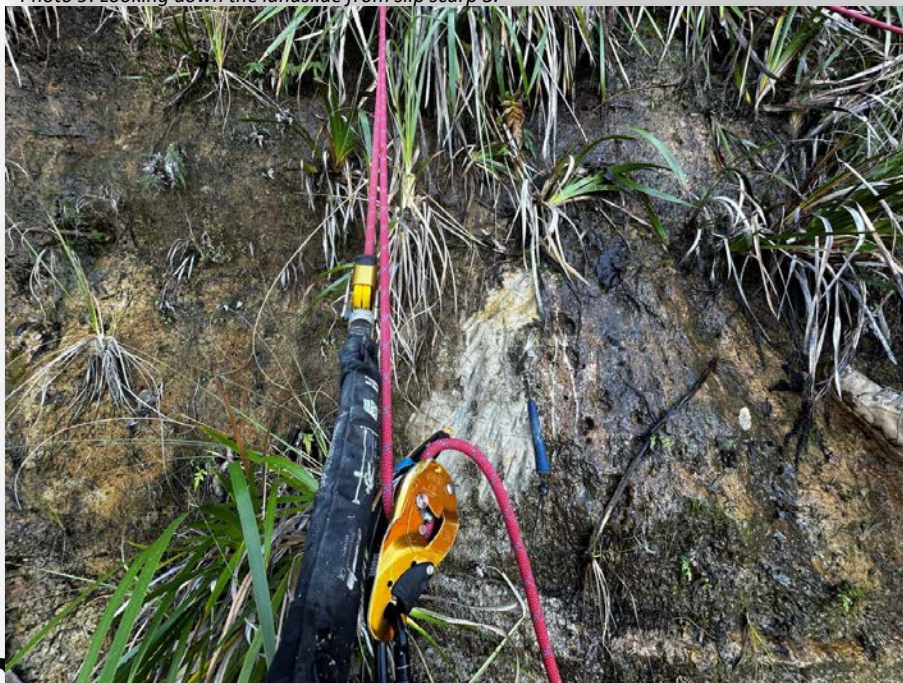
Photo 10: Looking at slip scarp 3. Ground water seepage. Geology hammer for scale and scratching exposing fine sand.

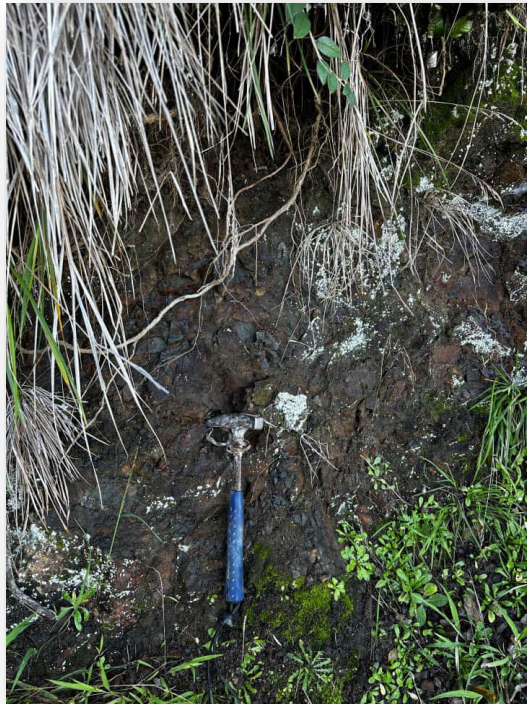
Photo 16: exposed bedrock on the upslope side of the original track alignment across the slip. The rock here is moderately strong to weak, oxidized and generally easy to pick at with a hammer when compared to the outcrop on the foreshore.

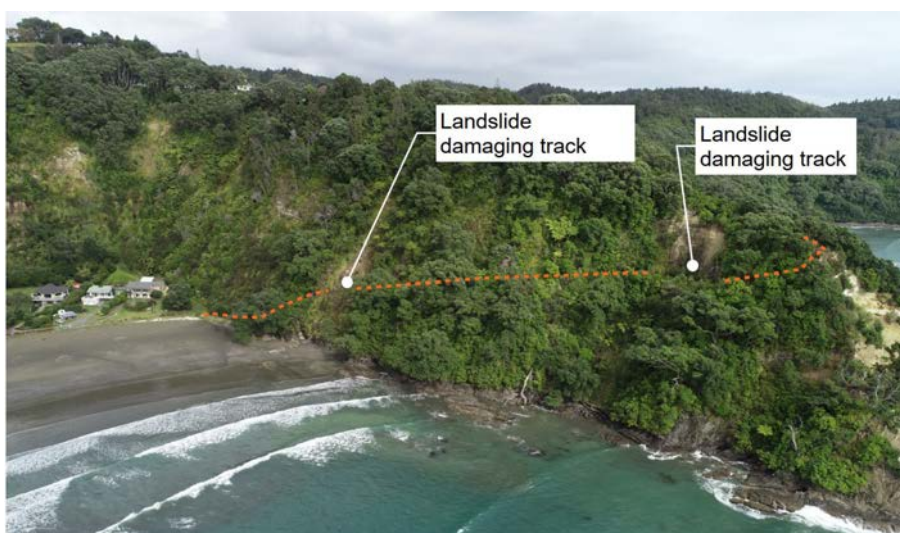
Figure 1.1: Two recent landslides damaging the existing track.

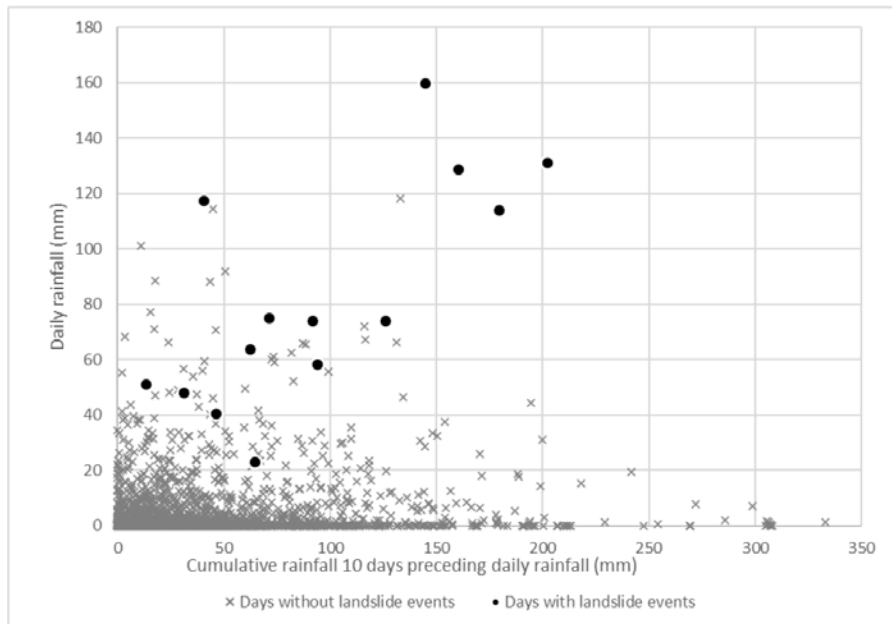
Figure 9.2: Daily rainfall (mm) vs cumulative rainfall for the preceding 10 days. Days where landslide events are highlighted and based on the existing historical landslide inventory of Ōhope and Whakatāne where landslide events have been accurately dated (Time period 2004-2011).

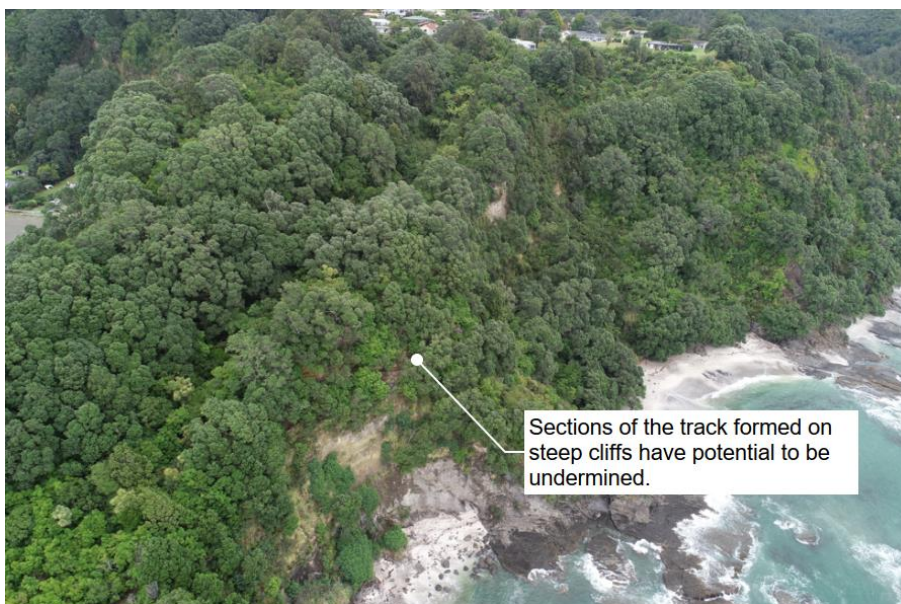
Figure 11.1: Example of the steep cliff and track leading down to Otarawairere Bay.

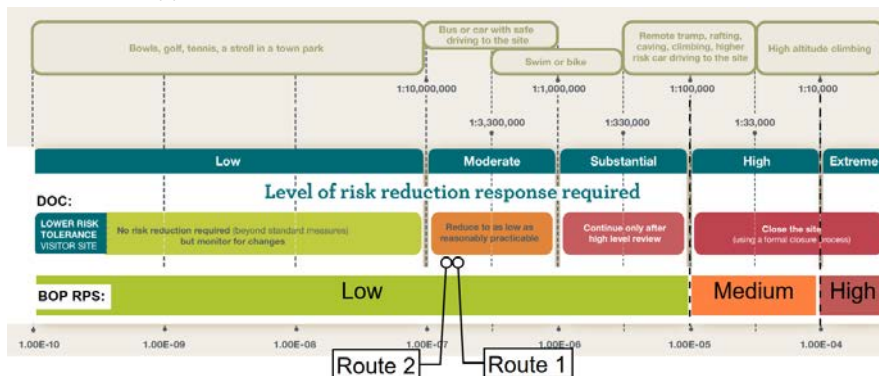
Copy of Figure 10.3: Route 1 and Route 2 total AIFR presented against the adopted risk thresholds.
