Extent of land flooded and river erosion following Cyclone Debbie – April 2017

Abstract

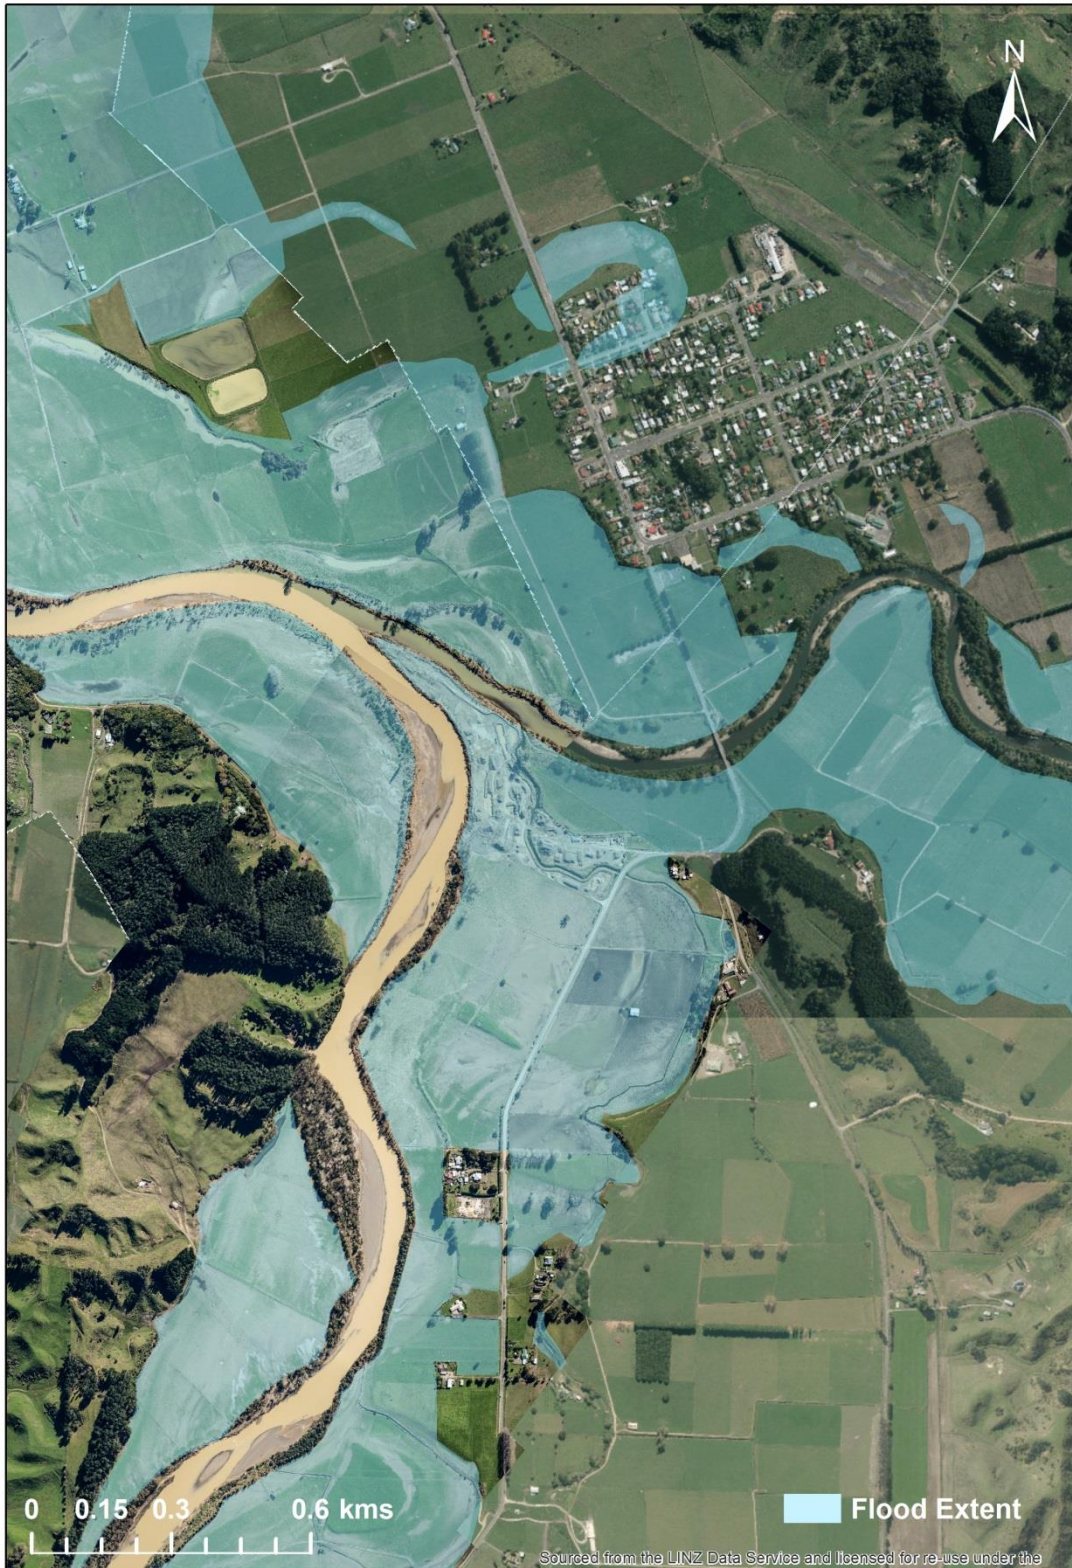
Figure 4: Flood extent on the Whakatāne and Waimana Rivers surrounding Tāneatua.

Land included in the mapping of flood extent was largely pasture and maize crop land (fig. 4); productive land cover types. Forestry and shrub land were not included as it was difficult to distinguish flood lines on this land cover type. In river islands were excluded from this study.
