ENGEO

Project Number 20136.000.001

Geotechnical Investigation

12 Huna Road, 234 State Highway 30, Whakatane, Bay of Plenty

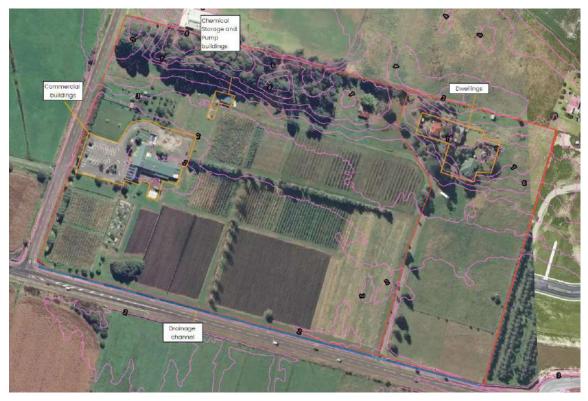
Figure 1: Site Plan

Site boundaries in red. Image taken from LINZ. NTS.

A site plan is presented in Figure 1 below:

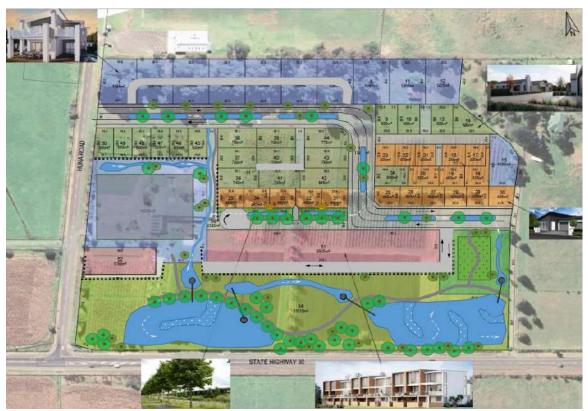
Figure 2: Development Concept Plans – Berry Farm Site

Excerpt from S&L Concept Plan 1 Ref: 20-30851-01-C1. NTS.

An excerpt of the proposed scheme is shown below in Figure 2:

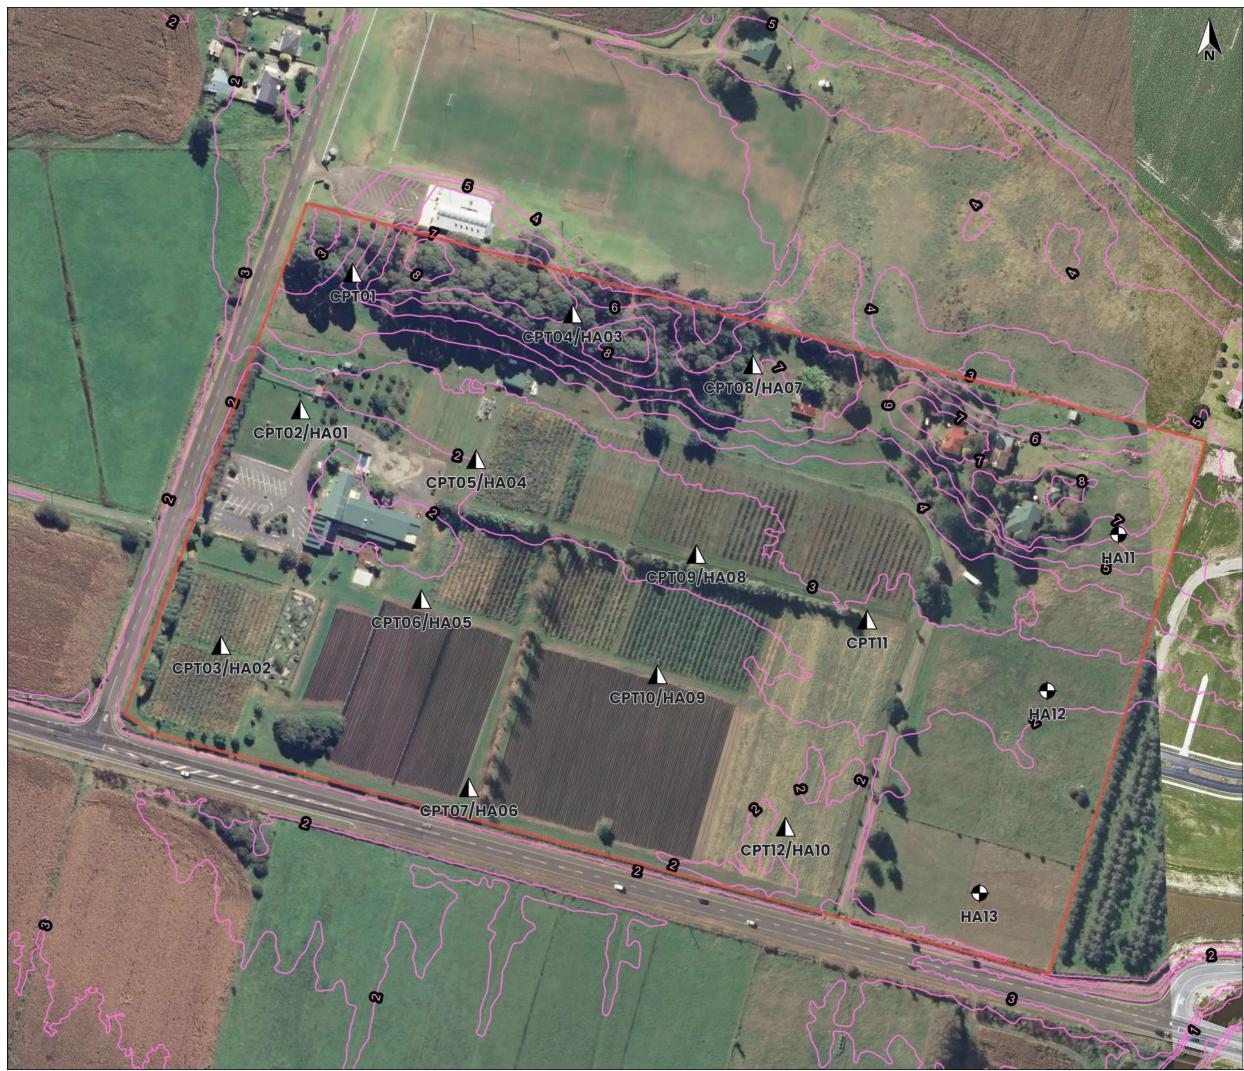
Site Plan

CPTs
Site Boundary
Hand Auger Boreholes

Testing locations are shown on the plan in Appendix 1. The hand auger boreholes were logged on-site by a geotechnical professional from ENGEO in accordance with NZGS: 2005 guidelines. The CPTs were carried out by Topdrill. Full geotechnical logs and CPT test results are presented in Appendix 2. A summary, of ground conditions encountered on-site is included in Section 4.2.1 below.
