Rūātoki Public Water Supply – Water Safety Plan

Whakatāne District Council

Pattle Delamore Partners Ltd

- Version 2.00, September 2018

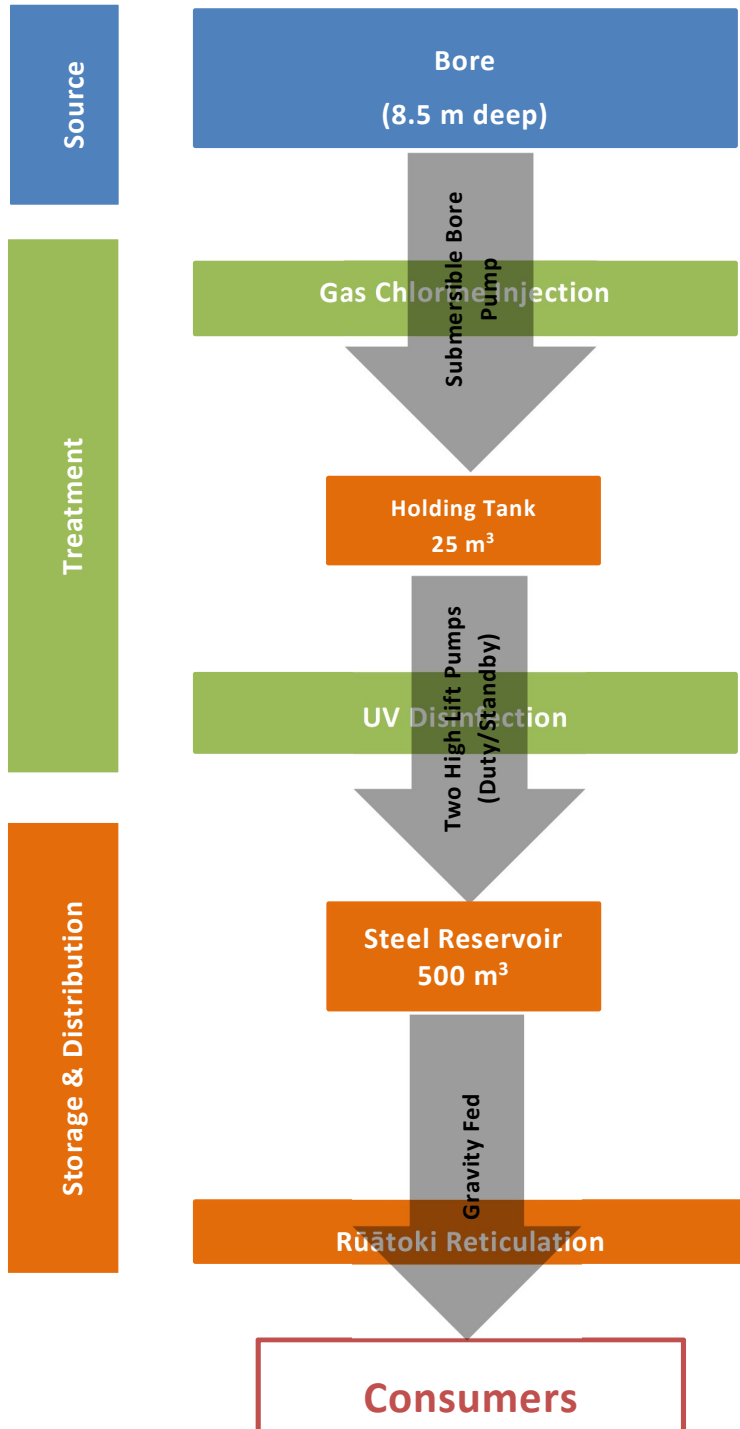
Figure 3: Schematic of Rūātoki Water Supply Scheme

A submersible bore pump supplies water to the scheme, its operation is dependent on reservoir water level; pump starts/stops are controlled by set maximum and minimum levels in the reservoir with the help of level sensors. Water is pumped to a 25 m³ holding tank situated at the pump station/ treatment plant site a few hundred metres away from the bore source.

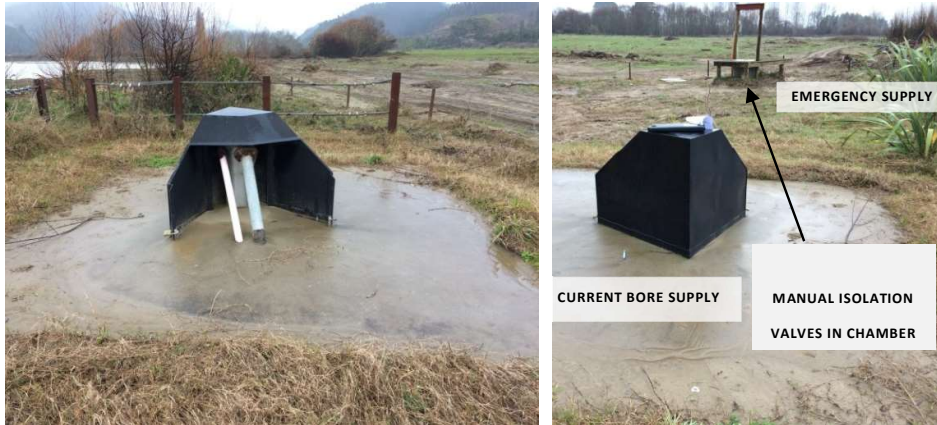
Figure 4: Bore Head with Steel Log Deflector (Left) and Emergency Supply and Isolating Valves (Right), prior to February 2018 River Intrusion

Water is abstracted from a shallow bore 8.5 metres below ground level (m bgl) and cased down to 6.6 m bgl. Prior to February 2018 the bore was located on the Whakatāne River bank approximately 40 metres away from the river. As a result of extreme weather events in February 2018 the river encroached onto the bore site resulting in breaking away of the bank exposing the bore casing. Emergency works have since been undertaken and WDC is working closely with MoH and the Bay of Plenty Regional Council to establish better protection arrangements for the bore site. Bore site prior to and after the February 2018 event is shown in Figures 4 and 5.

An inspection carried out as part of the CRA in July 2017 identified some non-compliant features of the bore headworks according to the protected bore requirements of the DWSNZ 2008. These included absence of a stock fence that provides a 5 metre perimeter exclusion zone from the centre of the bore, testing of cable and gland seals for adequacy and the recommendation of elevating the bore headworks above the 1% AEP flood level. A steel enclosure covers the bore headworks and acts as a log/debris deflector to protect the bore head (Figure 4).

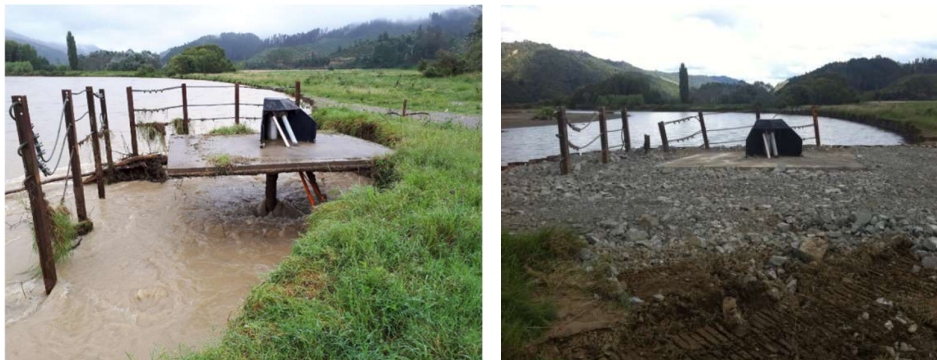
Figure 5: Bore Head at height of February 2018 floods (Left) and Emergency works underway (Right)

The February 2018 incident highlighted the extreme vulnerability of site to channel erosion. It is recommended that the bore site is moved to a secure location as soon as practicable and measures are put in place to protect the source. Protection of the source could include high frequency monitoring of site during extreme weather events in the short term, and working towards restoration of river bank and preventing further channel erosion in corporation with Bay of Plenty Regional Council in the long term.

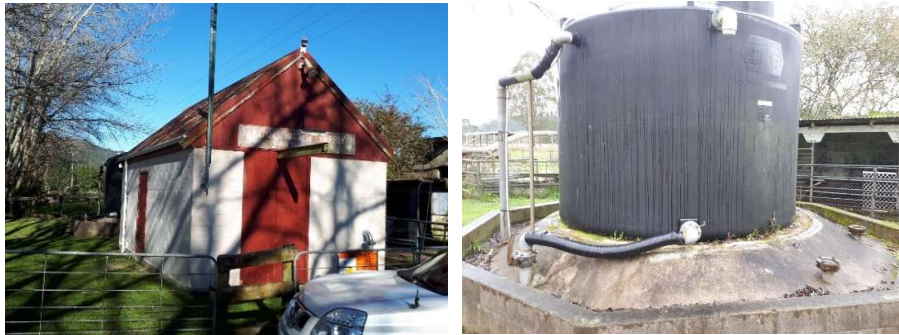
Figure 6: Rūātoki Treatment Plant housing UV Unit and Chlorine Cylinders (Left) and Holding Tank (Right)

A gas cylinder bottle weighs approximately 130kg which contains 70kg of chlorine gas. The cylinder is replaced once the weight reaches approximately 80kg. There are no additional chlorine cylinders stored on site; however, the cylinder weight is checked at least once a week by a treatment plant operator. Chlorine dose rate is set manually and there is no automatic flow proportional or water quality proportional dosing. Chlorine residual (Free Available Chlorine, (FAC)) leaving the treatment plant is monitored continuously and when it reaches outside operational limits the dose rate is adjusted manually to achieve the required FAC. During events that could change water quality such as during or immediately following storm events/earthquakes, treatment plant operators monitor the FAC levels frequently.

FAC, pH, Turbidity NTU, Flow and UV(I) are monitored continuously at the water treatment plant and the plant is designed to alarm when parameters exceed set limits. When certain parameters exceeded certain limits the plant also has the ability to automatically shut down by cutting off power to the bore pumps. During instances of automatic shut-down of the plant this can be manually overridden by water treatment plant operators to deliver water to the scheme provided appropriate procedures have been followed.

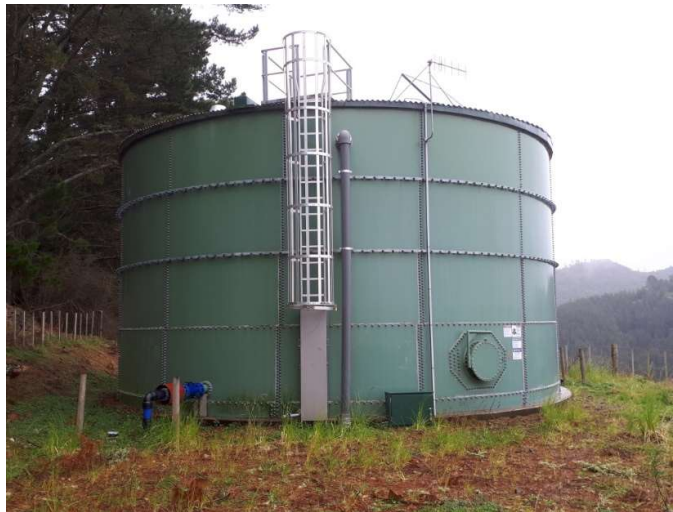
Figure 8: Steel Reservoir Constructed 2014

The reservoir has a storage capacity of 500 m³ available which is sufficient to meet average daily demand and fire-fighting flows and provide 24-hour emergency storage.

A plastic tank of capacity 25 m³ which was utilised as temporary storage during the construction of the steel reservoir remains adjacent to the new steel reservoir and can be used in emergency circumstances. This tank is connected to the system with appropriate valving to isolate it from the network when not in use.

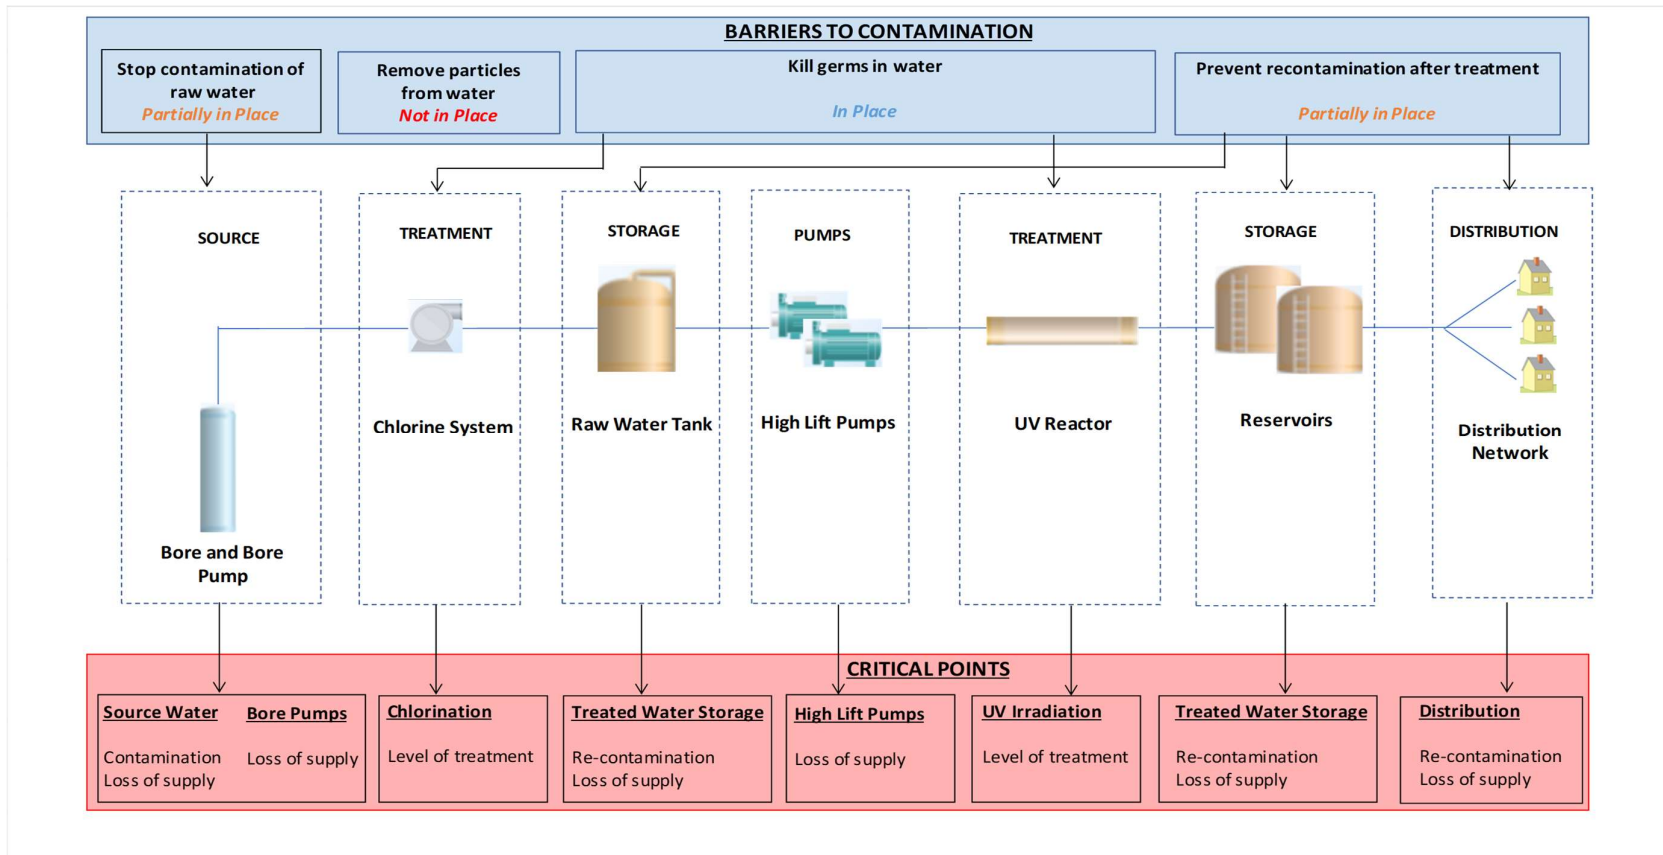
Figure 9: Barriers to Contamination and Critical Points of the Rūātoki Scheme

- To stop contamination of raw water;
- To remove particles from water;
- To kill germs; and
- To prevent recontamination of treated water.

Critical Points are areas in the scheme where there is potential for contamination or loss of supply of water. These were identified and presented in Table 5.

Figure 9 shows the Critical Control Points (CCPs) of the Rūātoki Scheme and the Control Parameters that are to be monitored and measured at each CCP.

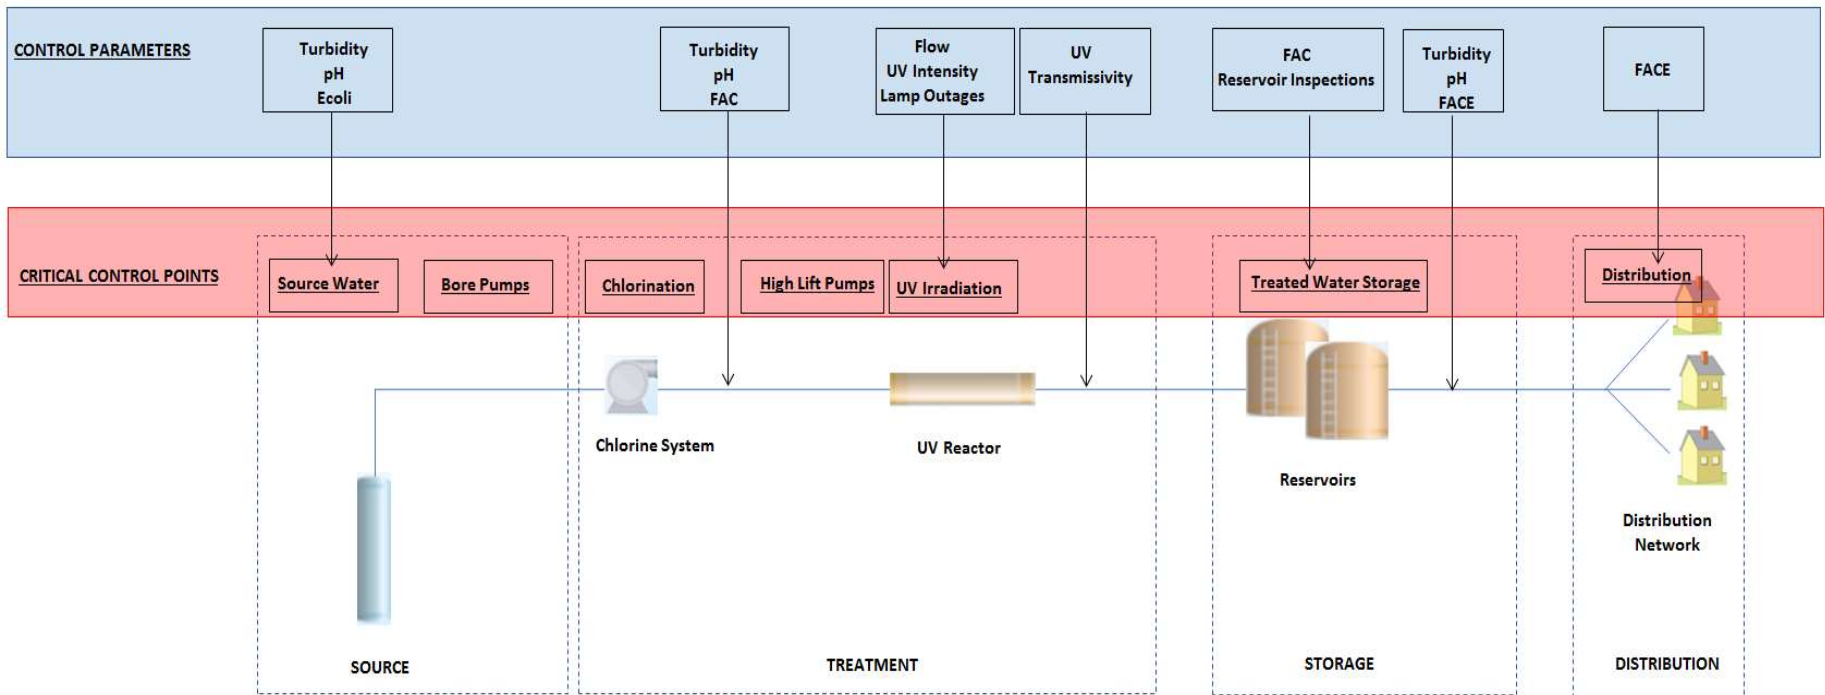
Figure 10: Critical Control Points and Corresponding Control Parameters for the Rūātoki Scheme for Source, Treatment, Storage and Distribution

Process Control Summaries have been prepared for the Treatment CCPs of the Rūātoki Scheme. Process control summaries have not been prepared for the Source, Storage and Distribution CCPs further to guidance from the DWA.

A description of each Treatment CCP can be found in Sections 9.1 (Chlorination) and 9.2 (UV Irradiation) and Appendix B sets out Process Control Summaries for each of the Treatment CCPs.
