Tāneatua Public Water Supply – Water Safety Plan

Whakatāne District Council

Pattle Delamore Partners Ltd

- Version 1.05, December 2018

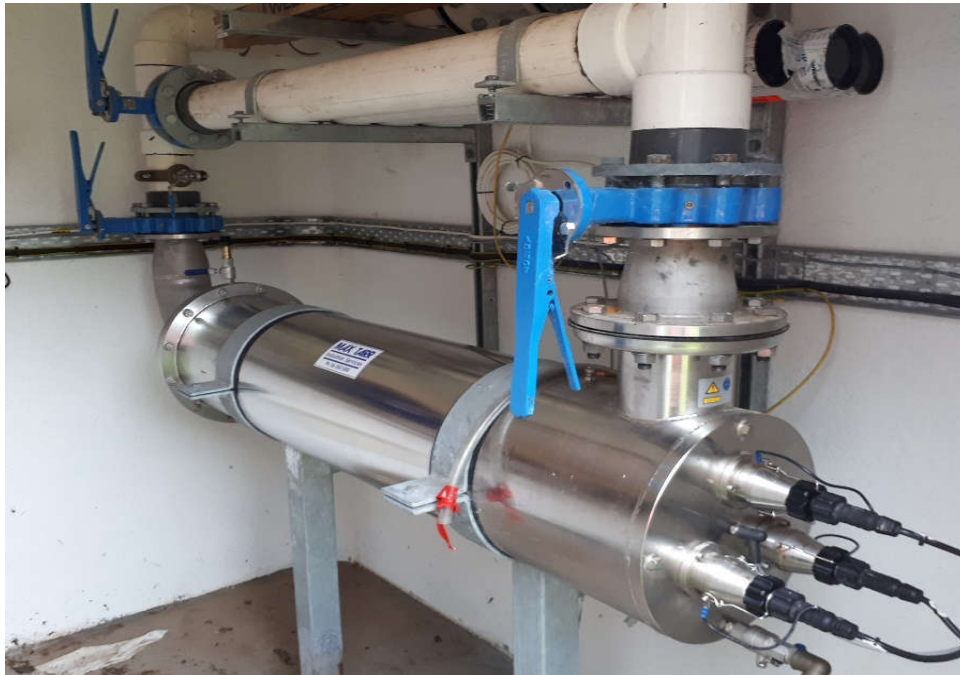
Figure 7: Ultra Violet Disinfection Treatment

The UV disinfection unit has been designed to deliver a UV dose of 40 mJ/cm^2 which is dependent on the flow rate of water, UV transmittance UV(T), and UV intensity UV(I) provided by the unit of the UV supplied. Current the water treatment system monitors flowrate, turbidity, and UV(T) and adjusts the UV(I) accordingly. No pre-treatment of water is carried out before entry into the UV disinfection unit. If turbidity exceeds set limits the bore pump stops and no water is delivered to the UV disinfection unit. The UV disinfection unit is maintained regularly by cleaning lamp sleeve(s), UV intensity sensor and lamp surface to prevent build up and therefore reducing the intensity of UV provided by the unit.

FAC, pH, Turbidity NTU, Flow and UV(I) are monitored continuously at the water treatment plant and the plant is designed to alarm when parameters exceed set limits. When certain parameters exceeded certain limits, the plant also has the ability to automatically shut down by cutting off power to the bore pumps. During instances of automatic shut -down of the plant this can be manually overridden by water treatment plant operators to deliver water to the scheme provided appropriate procedures have been followed.

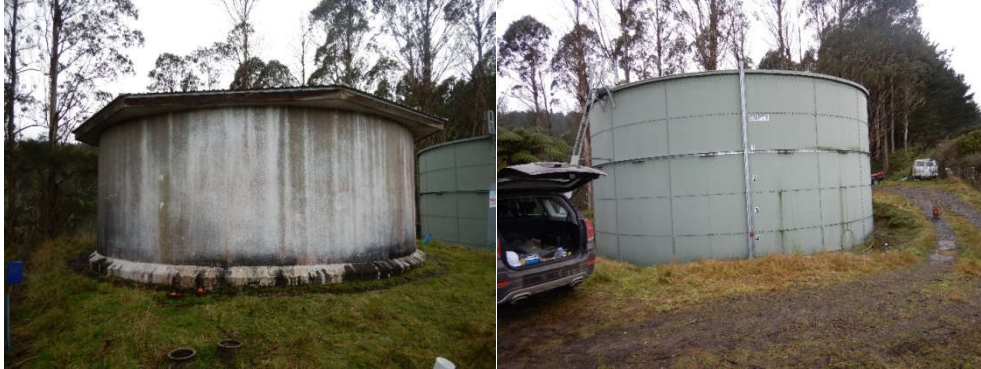
Figure 9: Concrete (Left) and Steel (Right) Storage Reservoirs

Treated water is pumped to two reservoirs located near State Highway 2 before being gravity fed to the Tāneatua reticulation system. The reservoirs consist of a concrete tank of capacity 227 m³ and steel tank of capacity 500 m³ and are connected in parallel. The total storage capacity of 727 m³ available is sufficient to meet average daily demand and fire-fighting flows and provide 24-hour emergency storage. The concrete tank is bottom fed and the only protection of the source is via check valves located on pipework at each bore head with no additional backflow prevention device on the rising main; therefore, there is minor potential of source contamination through backflow.

A 500 m³ steel reservoir replaced a 500 m³ timber reservoir in 2012 as part of capital work upgrades. Easements were obtained for access to the reservoirs and an access road constructed.

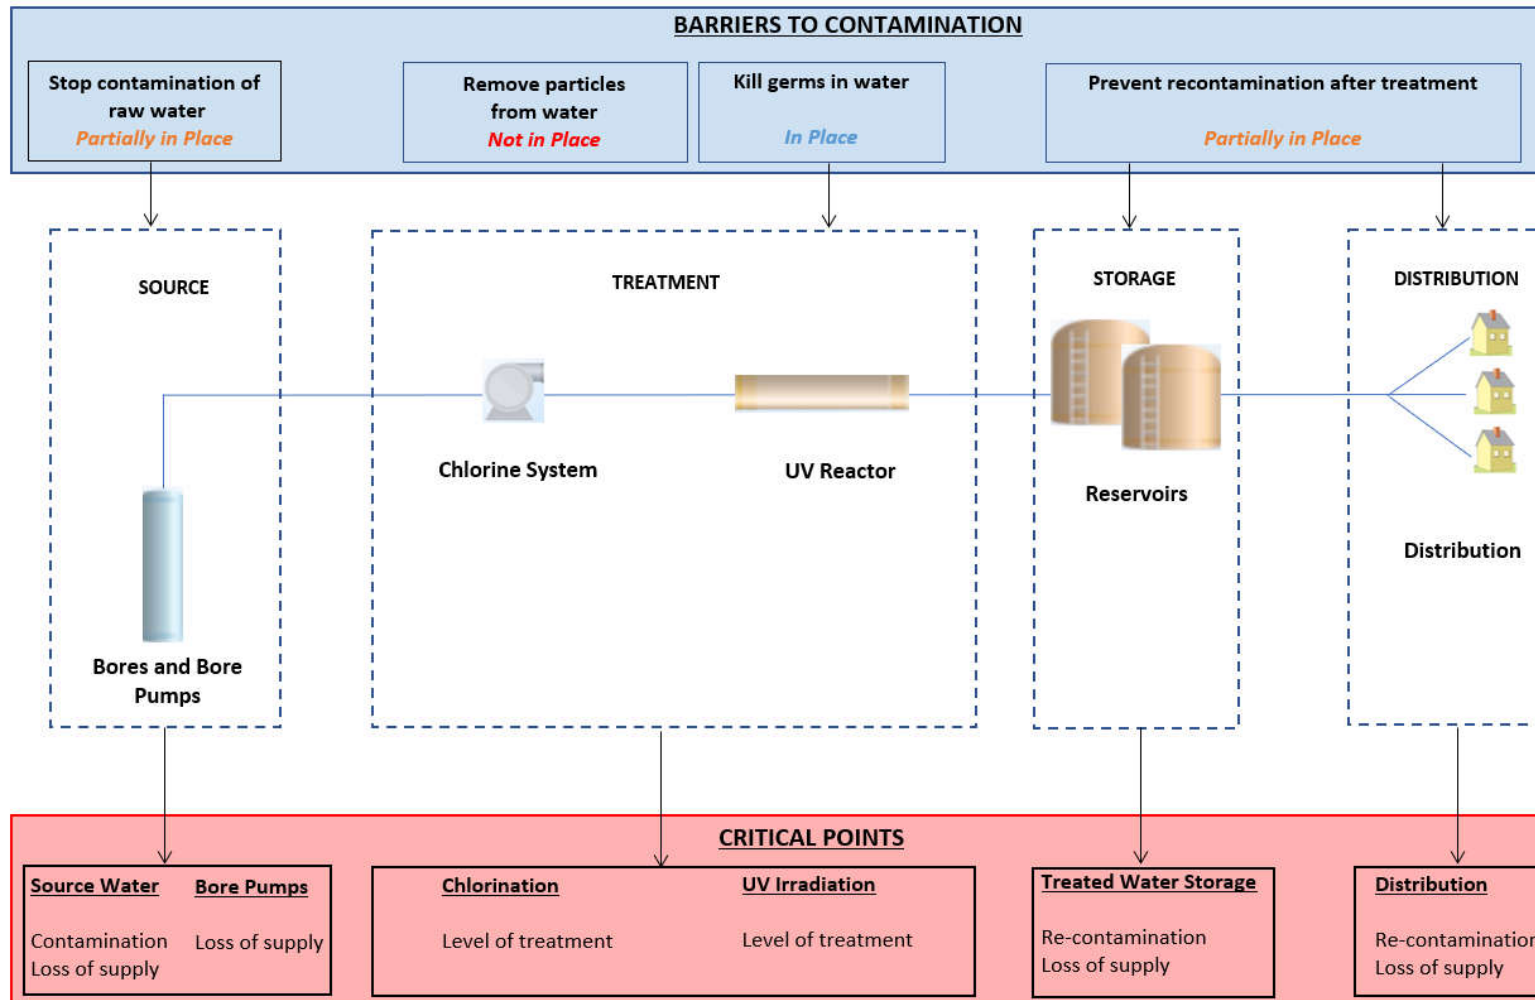
Figure 10: Barriers to Contamination and Critical Points of the Tāneatua Scheme

- To stop contamination of raw water;
- To remove particles from water;
- To kill germs; and
- To prevent recontamination of treated water.

Critical Points are areas in the scheme where there is potential for contamination or loss of supply of water. These were identified and presented in Table 6.

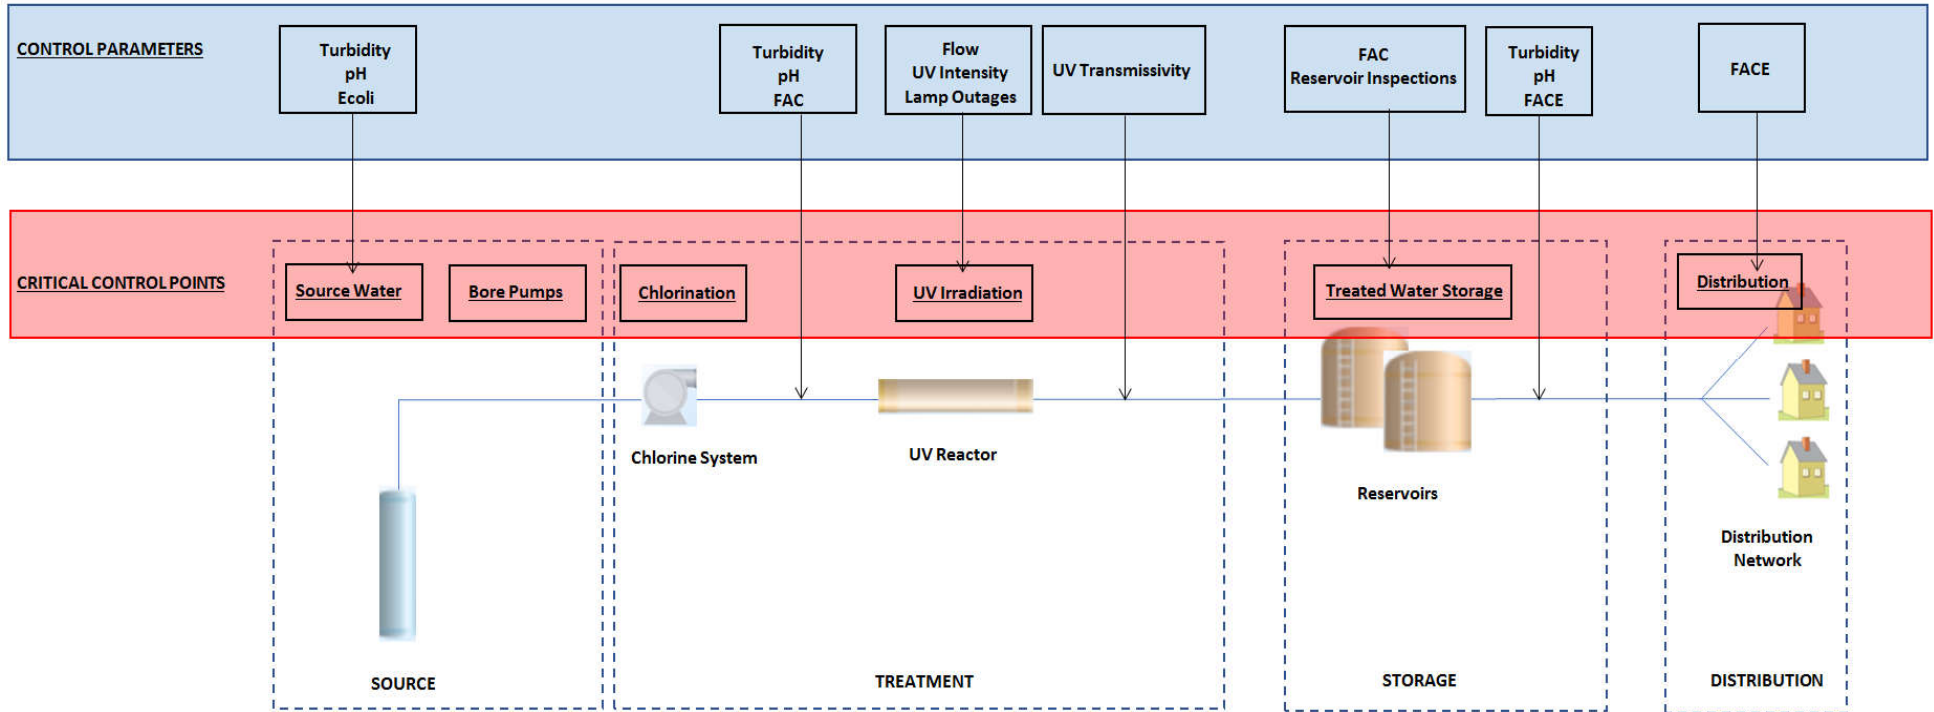
Figure 11: Critical Control Points and Corresponding Control Parameters for the Tāneatua Scheme for Source, Treatment, Storage and Distribution

Figure 11 shows the Critical Control Points (CCPs) of the Tāneatua Scheme and the Control Parameters that are to be monitored and measured at each CCP.

Process Control Summaries have been prepared for the Treatment CCPs of the Tāneatua Scheme. Process control summaries have not been prepared for the Source, Storage and Distribution CCPs further to guidance from the DWA.

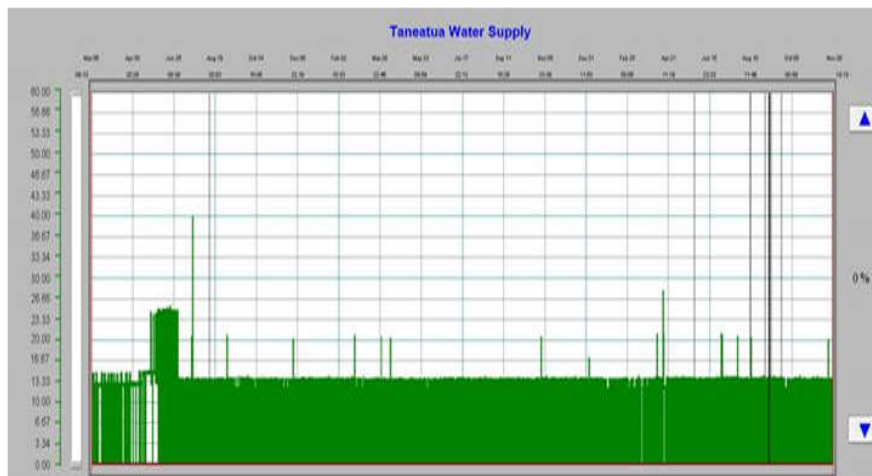
- The first consumer is the cemetery on WDC land which has a water tap, this is located at 75 State Highway 2 East on the supply line to the reservoir and is approximately 1,200 metres away from the source extraction. The second customer at 55 State Highway 2 East is approximately 1400 metres from the source extraction.

- Scada data indicates that the pump flow rate is pretty constant at 15 l/s, but does show an unusual peak of 40 l/s
- Calculating at the constant 15 l/s pump rate and based on the distance of 1,200 metres, 150mmØ uPVC pipe, the contact time to the cemetery land is approximately 24 minutes and the contact time to second customer is estimated at 27 minutes.
- Usually, contact time is calculated using peak flow (as it's the worst case scenario), in this case at 40 l/s the contact time is about 10 minutes.
- Based on these calculation, WDC will assess the risk to the first customer and investigate options such as:
 - costing of installation of contact tank
 - reviewing pump characteristics to see in settings can be modified to deliver a maximum pump rate of 11.7 l/s (this would give 30 minute contact time to cemetery)
 - signage to customers informing of the water status at the site
