Waimana Public Water Supply – Water Safety Plan

Whakatāne District Council

Pattle Delamore Partners Ltd

- Final, July 2018

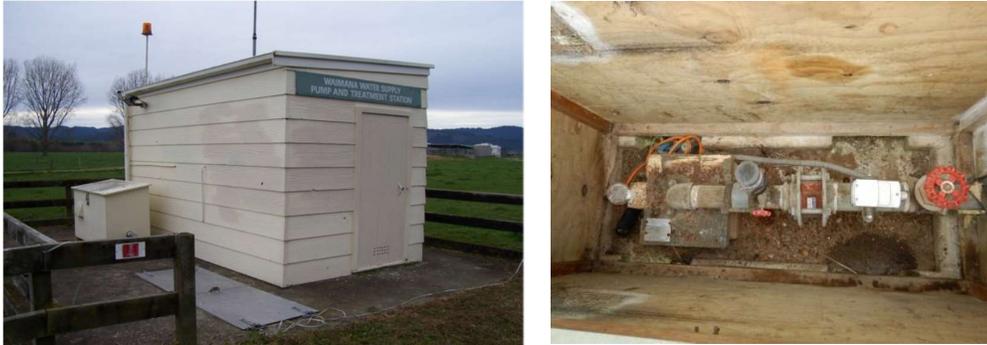
Figure 4: Waimana Pump Station/Treatment Plant Site (Left) and Underground Bore Headworks (Right)

A submersible bore pump pumps water depending on reservoir water levels; pump starts/stops are controlled by set maximum and minimum levels in the reservoir with the help of level sensors. The bore pumps water through the treatment plant to the storage reservoirs. There is a standby bore pump available for the Waimana site which is situated at the Valley Road treatment plant half an hour away. There are no high-lift or booster pumps in the system.

Bore headworks are situated below ground level and an inspection carried out as part of the catchment risk assessment identified some non-compliant features according to the protected bore requirements of the DWSNZ 2008. An inspection of the bore site reiterated Council's awareness that the 5-metre exclusion zone of livestock from the borehead was not present. High intensity grazing activities in the paddock made the 5-metre exclusion zone an immediate requirement and has since been rectified by WDC (November 2017). The CRA recommends extending the animal exclusion zone to as close to the groundwater protection zone (50 metres from the borehead) as practically possible due to the monitored E. coli exceedance responses to livestock effluent in the vicinity; however, it is understood that the fencing can only be extended as far as Council land ownership. The current newly constructed position is 100 metre perimeter and the closest side fence is approximately 12 metres from the bore head.

recommended that the bore headworks are located above ground and above the 1% AEP flood level.

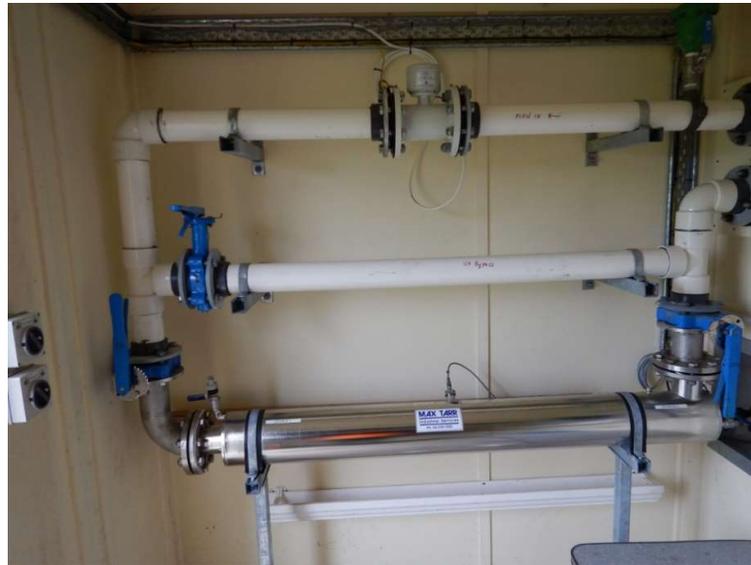
Figure 6: Ultra Violet Disinfection Treatment

The UV disinfection unit has been designed to deliver a UV dose of 40 mJ/cm² which is dependent on the flow rate of water, UV transmittance UV(T), and UV intensity UV(I) provided by the unit of the UV supplied. Spare UV lamps are stored on site in case of lamp outages. No pre-treatment of water is carried out before entry into the UV reactor. If turbidity exceeds set limits the bore pump stops and no water is delivered to the UV treatment unit. The UV unit is maintained regularly by cleaning lamp sleeve, UV sensor lens and lamp surface to prevent build up and therefore reduction of UV intensity.

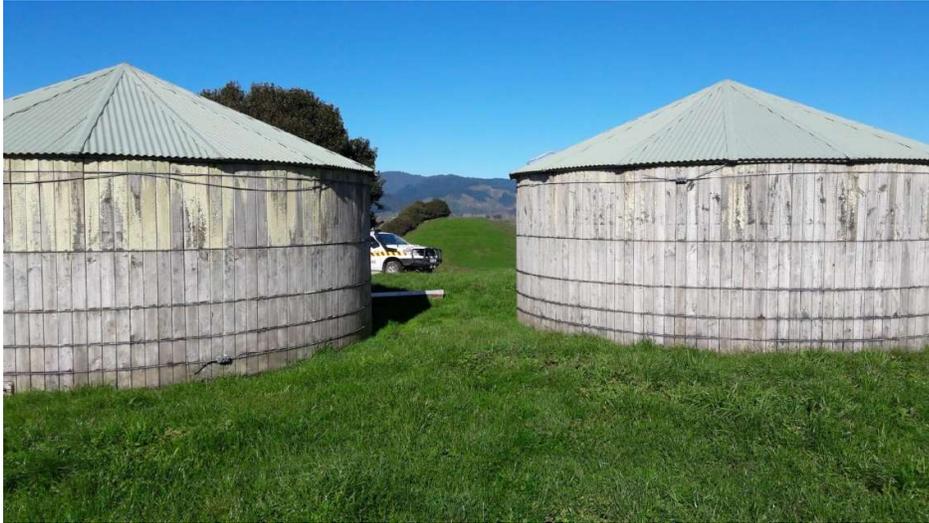
Figure 8: Two Timber Storage Reservoirs with Steel Roofs

Treated water is pumped to two reservoirs located on a nearby hill before being gravity fed to the Waimana reticulation system. The reservoirs are both timber and of capacity 91 m³ each (182 m³ total) and are connected in series. Both reservoirs have steel roofs installed and the liner replaced in 2010. The total storage capacity is more than sufficient to meet average daily demand and fire-fighting flows and provide 24-hour emergency storage.

Both timber reservoirs have been fitted with steel roofs and the liners have been replaced.

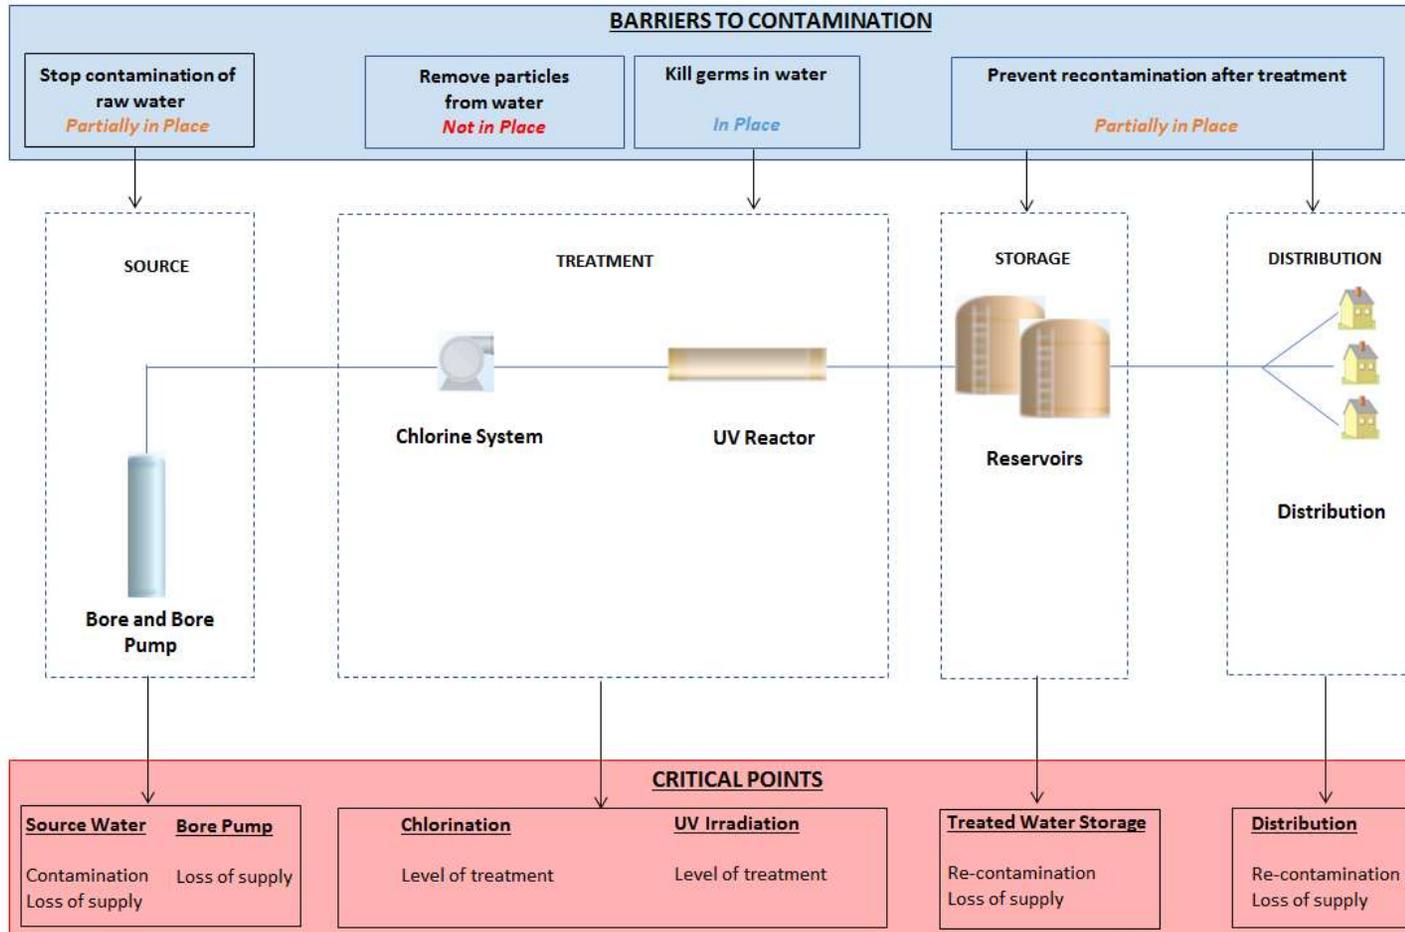
Figure 9: Barriers to Contamination and Critical Points of the Waimana Scheme

Critical Points are areas in the scheme where there is potential for contamination or loss of supply of water. These were identified and presented in Table 6.

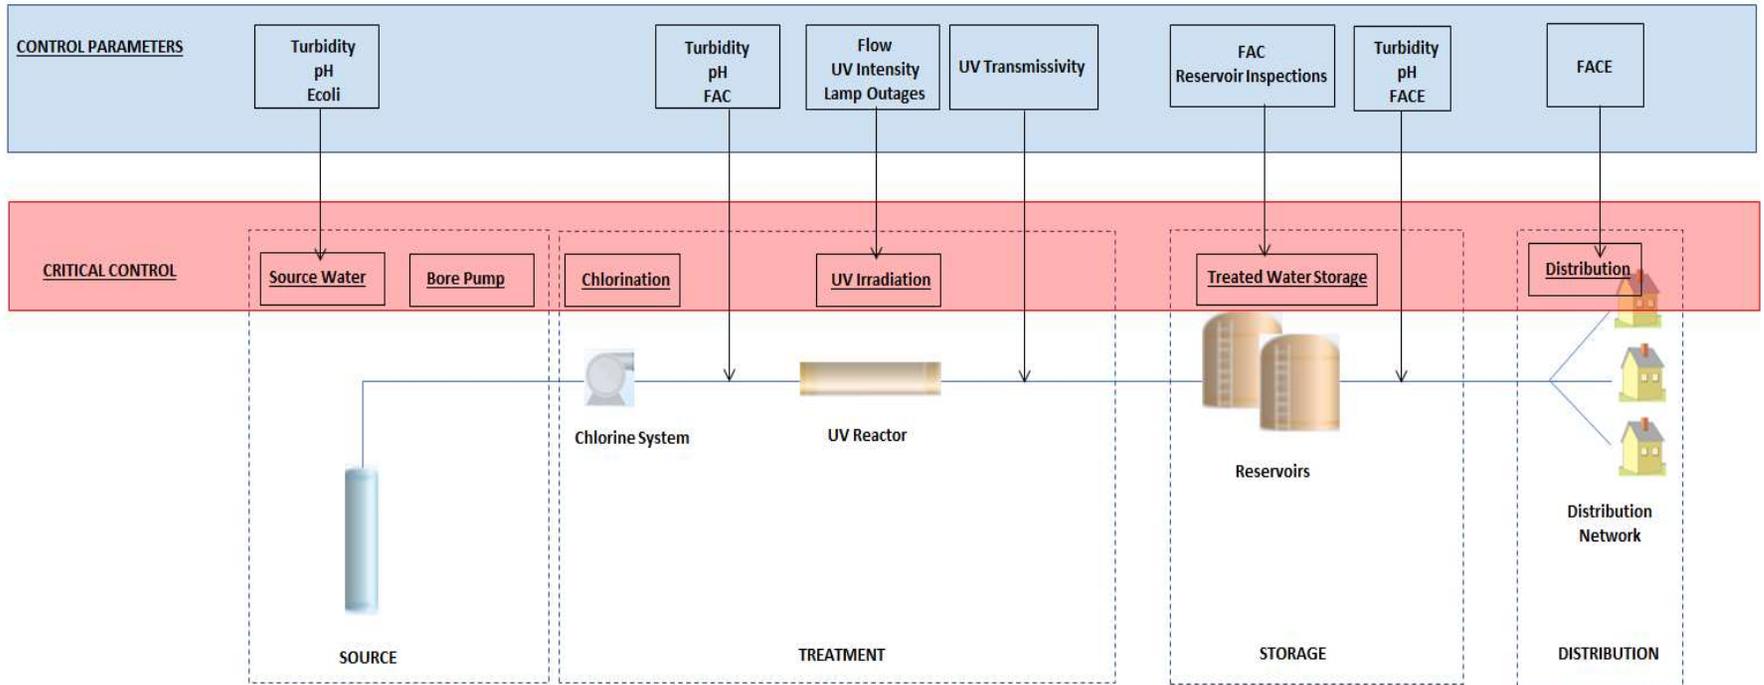
Figure 10: Critical Control Points and Corresponding Control Parameters for the Waimana Scheme for Source, Treatment, Storage and Distribution

Figure 9 shows the Critical Control Points (CCPs) of the Waimana Scheme and the Control Parameters that are to be monitored and measured at each CCP.
